# SERVICE BULLETIN

Classification:	Reference:	Date:
BT16-006	NTB16-070	July 26, 2016

## 2014 – 2015 TAXI; CONVERSION OF AUTO STEPS TO FIXED POSITION

**APPLIED VEHICLE:** 2014 – 2015 Taxi

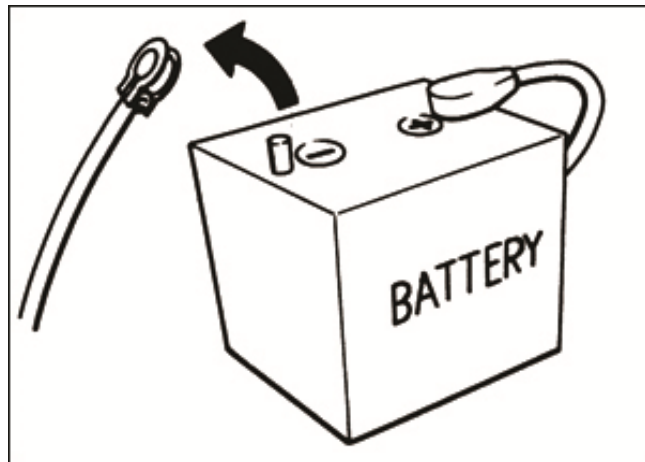
Figure 1

1. Disconnect the battery negative cable.

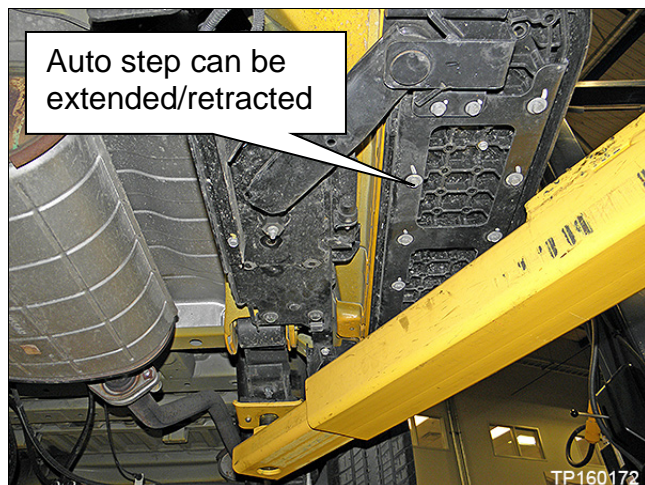
Figure 2

2. Place the vehicle on a lift and raise it high enough to reach the underside of the auto step.

**NOTE:** Make sure the lift points are positioned so the auto step can be manually extended and retracted (Figure 2).

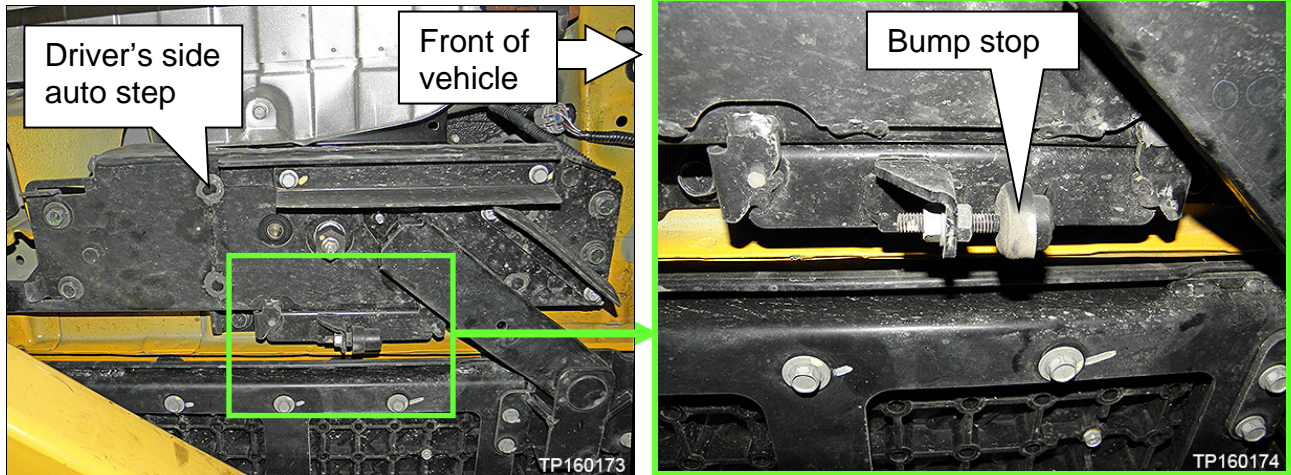
Figure 3

3. Remove the bump stop (Figure 3).

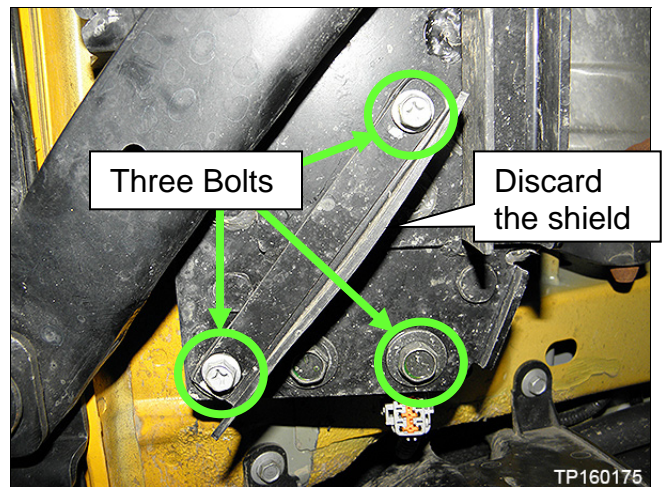
4. Remove the three bolts shown in Figure 4 from the auto step.

- Discard the shield.

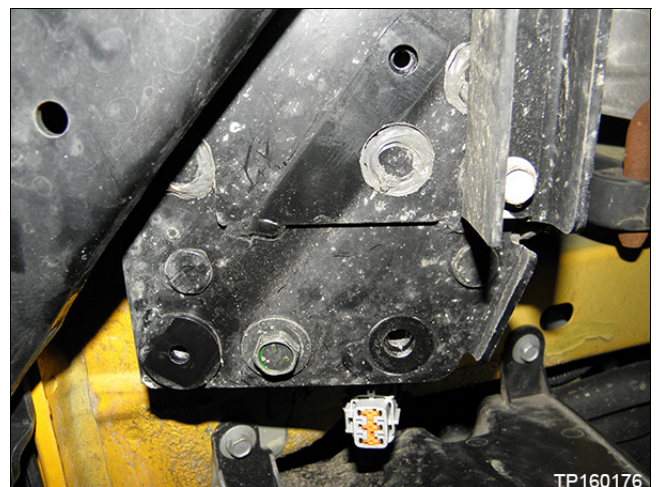
- Figure 5 shows bolts removed.

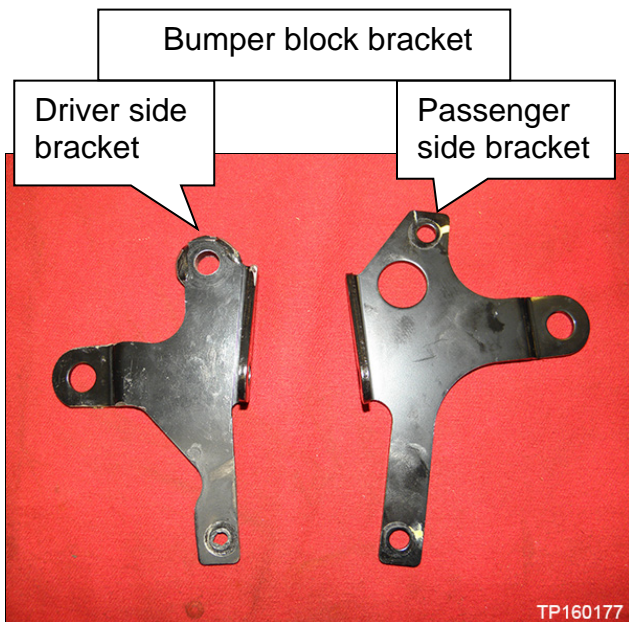
Figure 6

5. Install the bumper block bracket onto the auto step.

**NOTE:** Left and right side brackets are different (see Figure 6).

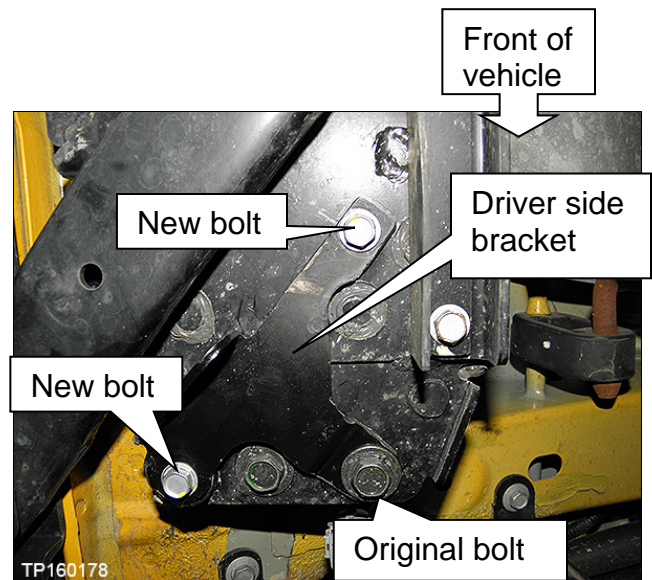
Figure 7

- Install using the bolt locations where bolts were removed in step 4.
- Two new bolts provided (see Figure 7).
  - Torque new bolts to: 7.2-10.8 N•m (0.7-1.1 kg-m, **5.3-8.0 ft-lb**)
- Reuse one original bolt (see Figure 7).
  - Torque original bolt to: 26-34 N•m (2.7-3.5 kg-m, **19-25 ft-lb**)

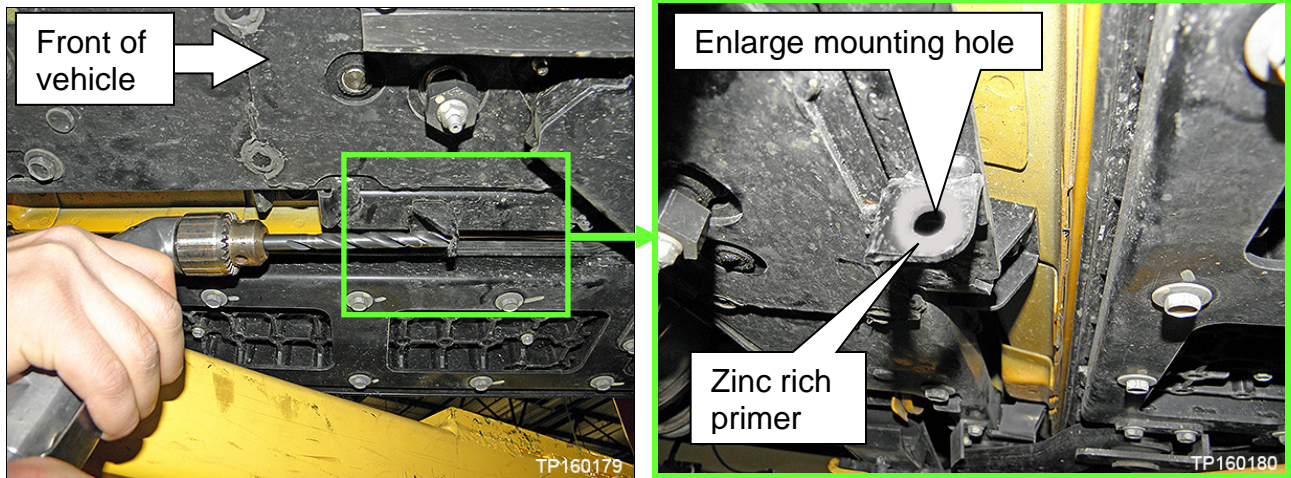
Figure 8

6. Enlarge the mounting hole that the bump stop was removed from in step 3 (see Figure 8).
  - a. Using a 3/8 inch drill bit, enlarge the hole to 3/8 inch (8.5 mm).
  - b. Apply zinc rich primer (see parts information) to the newly exposed metal.

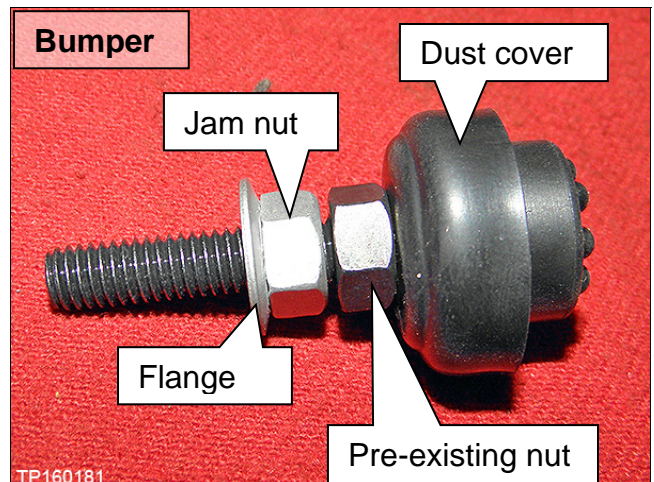
7. Fold back the dust covers on the three bumpers from the kit.
8. Install jam nuts onto the three bumpers with the flange facing away from the pre-existing nut (see Figure 9).

(2) See Figure 9 for illustration of bumper.

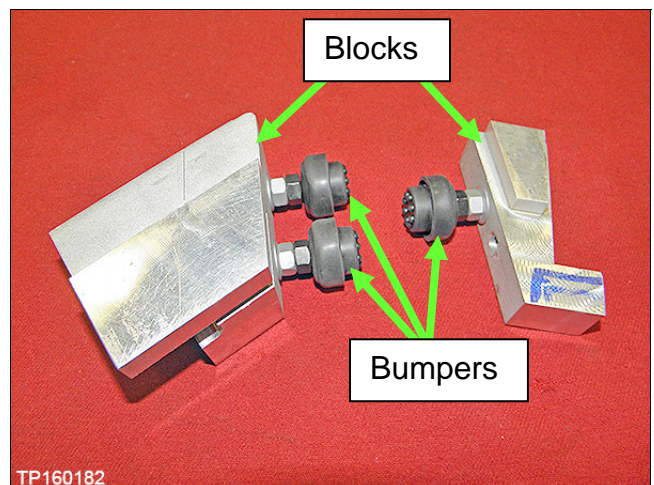
Figure 10

9. Install two bumpers onto one block and one onto the other (see Figure 10).
10. Thread the bumpers all the way into each block (Figure 10).

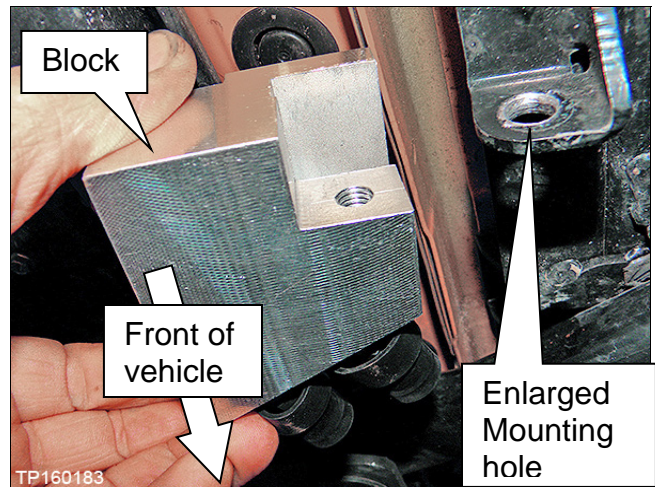
Figure 11

11. With the auto step completely retracted (closest to vehicle), install the block with two bumpers onto the mounting hole that you enlarged in step 6.

- Bumpers will face toward the front of the vehicle.

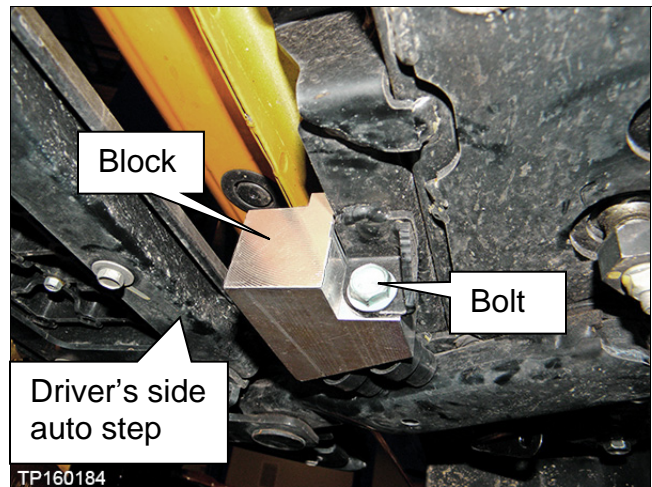
Figure 12

12. Secure with bolt.

- Torque bolt to:  
26-34 N•m (2.7-3.5 kg-m, **19-25 ft-lb**)

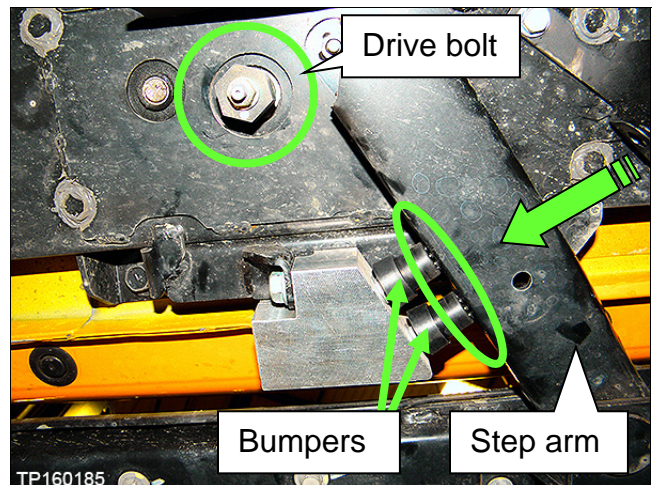
Figure 13

13. Manually rotate the drive bolt to extend the auto step outward until the step arm contacts the new bumpers.

**NOTE:** If the step is in the extended position, it can be mechanically retracted. Manually rotate the drive bolt (Figure 13) to retract the step.

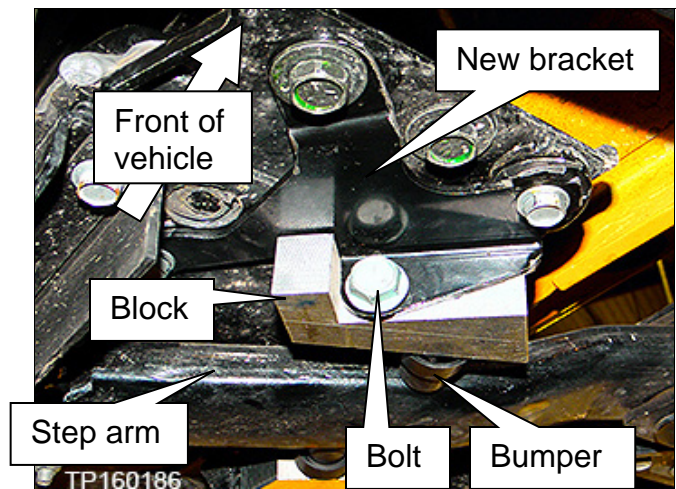
Figure 14

14. Install the second block (single bumper) with the bumper facing the step arm onto the new bracket installed in step 5.

- Torque bolt to:  
26-34 N•m (2.7-3.5 kg-m, **19-25 ft-lb**)

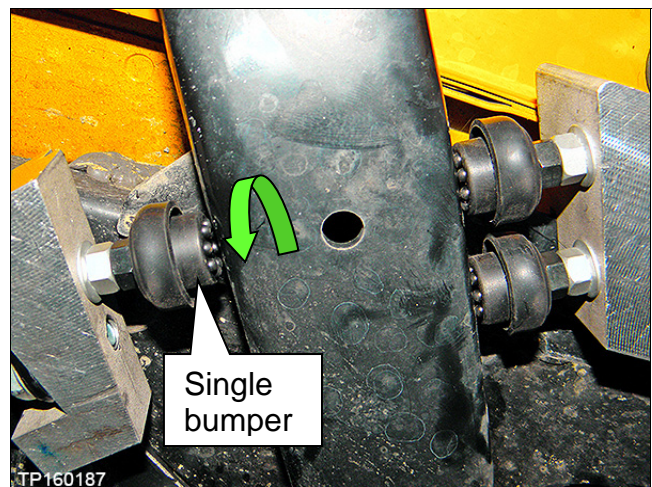
Figure 15

15. Rotate the single bumper, with fingers only, until it contacts the auto step arm.

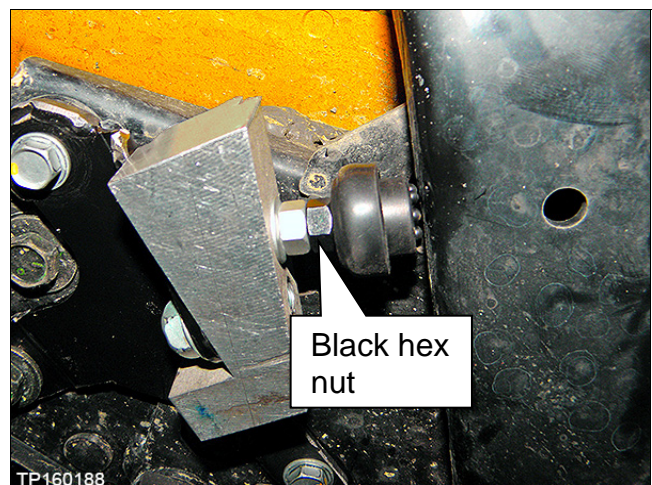
Figure 16

16. Use an open end wrench to extend the single bumper an additional **5** complete turns against the auto step arm.

- Use the black hex nut to rotate bumper the additional 5 turns.

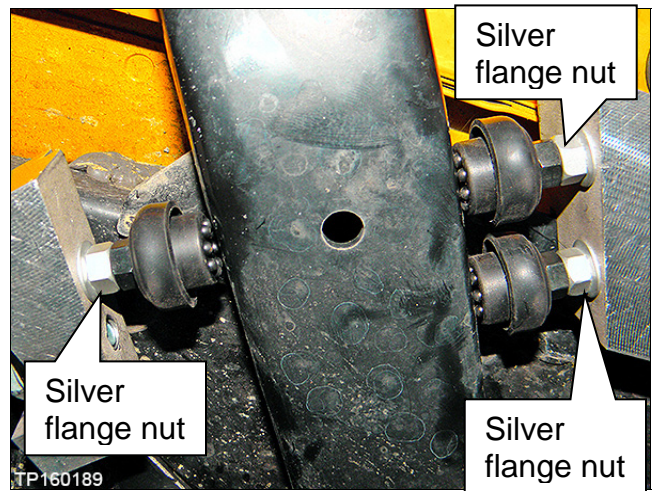
Figure 17

17. Tighten all three bumper flange nuts (silver nuts) against the blocks.

- Torque nuts to:  
7.2-10.8 N•m (0.7-1.1 kg-m, **64-95 in-lb.**)

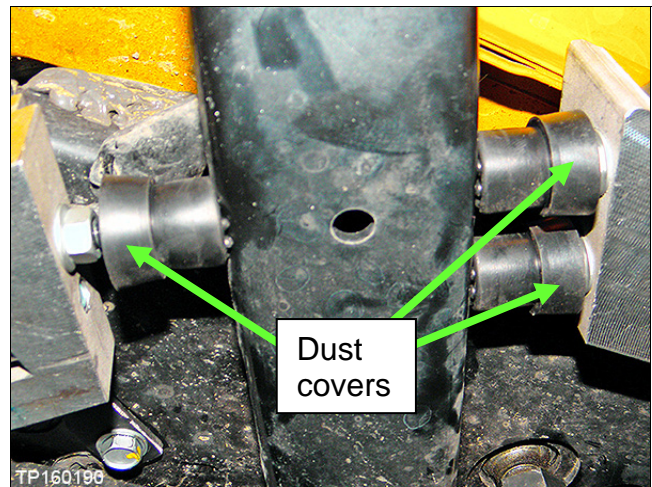
Figure 18

18. Fold the dust covers back into position.

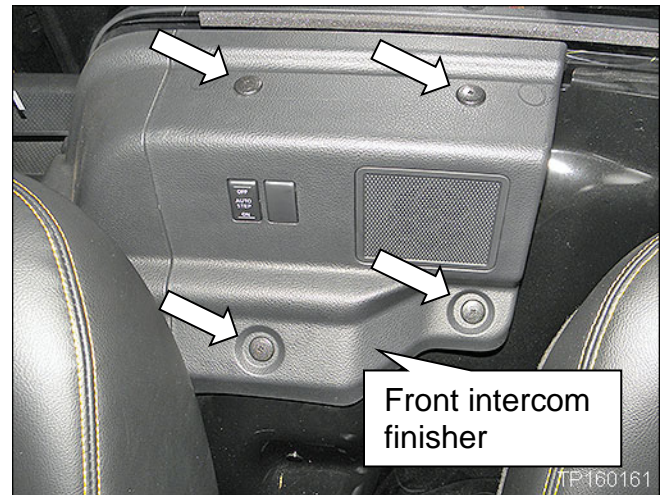
Figure 19

19. Remove the 4 plastic clips that hold the front intercom finisher.

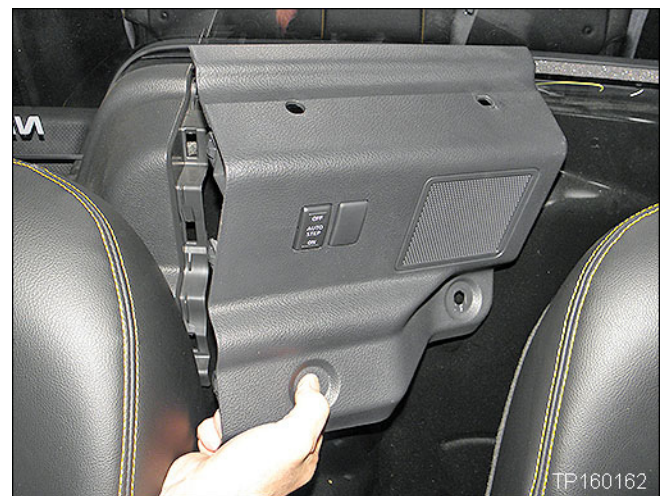
Figure 20

20. Snap the front intercom finisher loose.

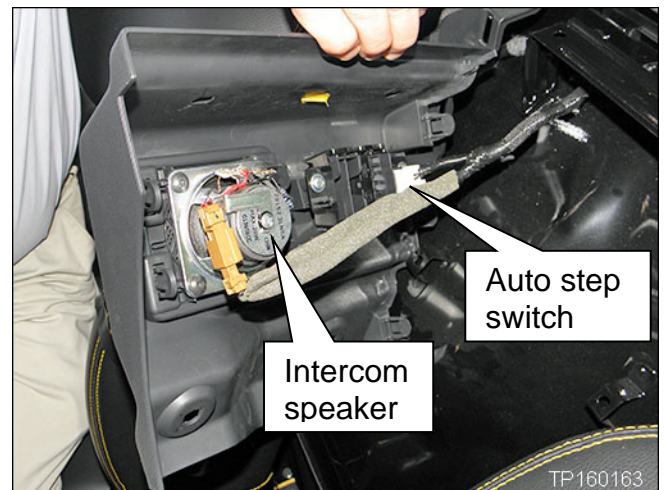
Figure 21

21. Disconnect the intercom speaker and the auto step switch.

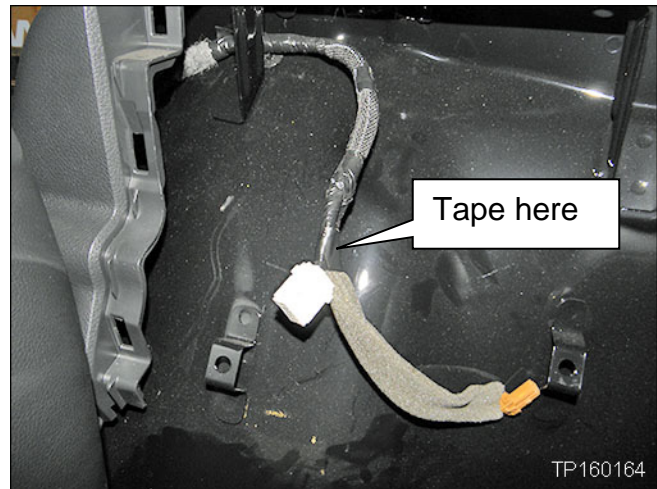
Figure 22

22. Tape the auto step switch connector to the harness as shown.

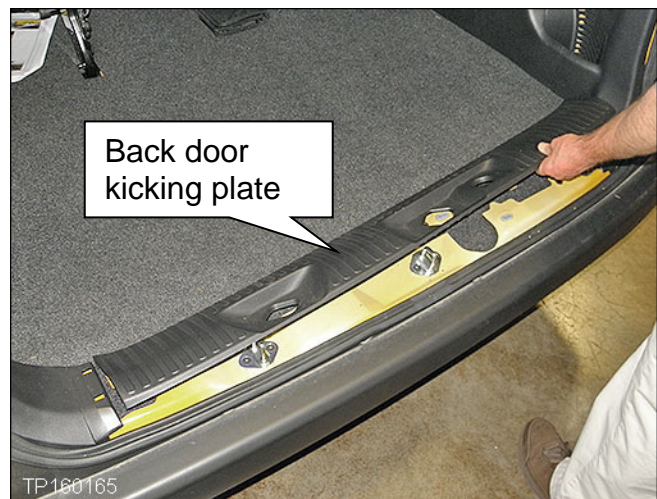
Figure 23

26. Snap loose and remove the back door kicking plate.

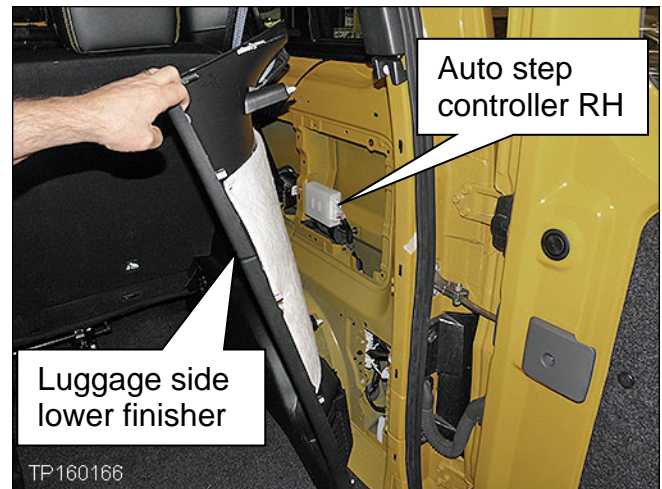
Figure 24

27. Partially snap loose the luggage side lower finisher RH.

28. Locate the auto step controller RH.

- The left side luggage lower finisher and auto step controller LH are a mirror image of Figures 24 and 25.

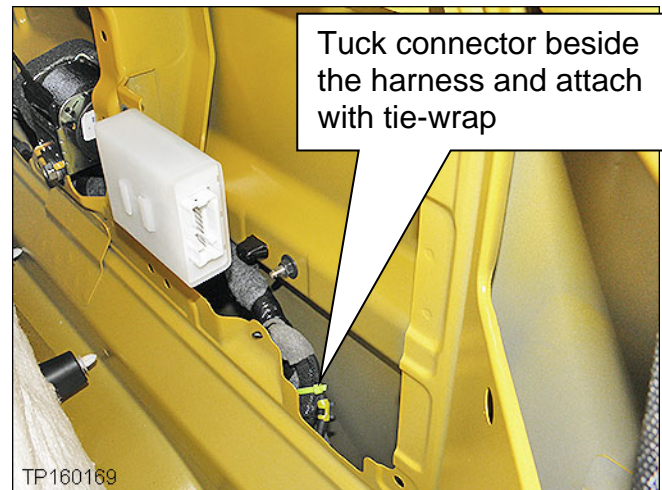
Figure 25

29. Disconnect the auto step controller.

30. Tuck the auto step controller connector beside the harness and use a tie-wrap to hold the connector to the harness.
