Technical Service Bulletin

15 Service info: crack on cylinder head cover in area of securing bolt for high-pressure fuel pump - V8TFSI

15 16 29 2045455/1 September 22, 2016.

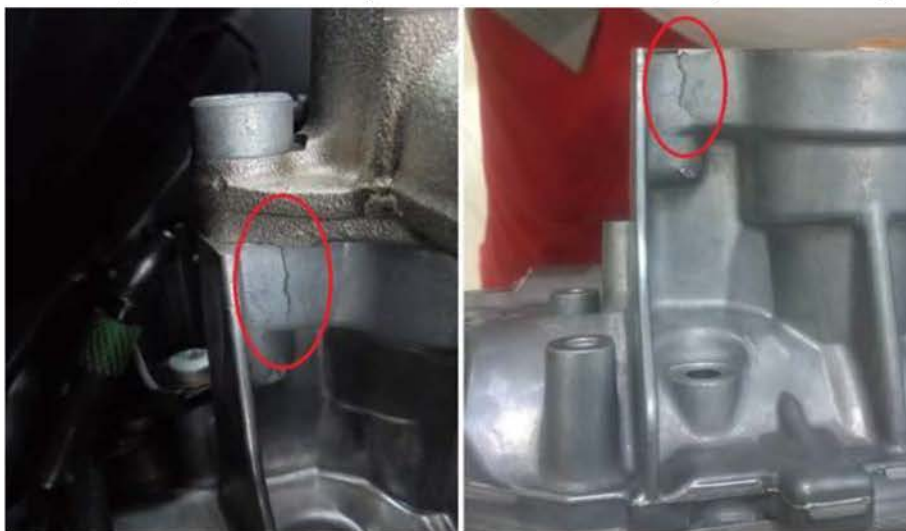
A crack appears to be on the cylinder head near the securing bolt of the high-pressure fuel pump.

This complaint is not a component-damaging crack. There is excess material on the cylinder head cover from the production process.

The cylinder head cover does not have to be replaced, this is an optical issue.
