SERVICE BULLETIN

Classification: EL15-032b	Reference: NTB15-099b	Date: September 6, 2016
------------------------------	--------------------------	----------------------------

SERVICE INFORMATION FOR DTCs C1A12 AND C1A16

APPLIED VEHICLES: 2016 Altima (L33) 2016 Murano Hybrid (Z52)
 2016 Maxima (A36) 2015-2016 Rogue (T32)
 2015-2016 Murano (Z52) 2016 Sentra (B17)

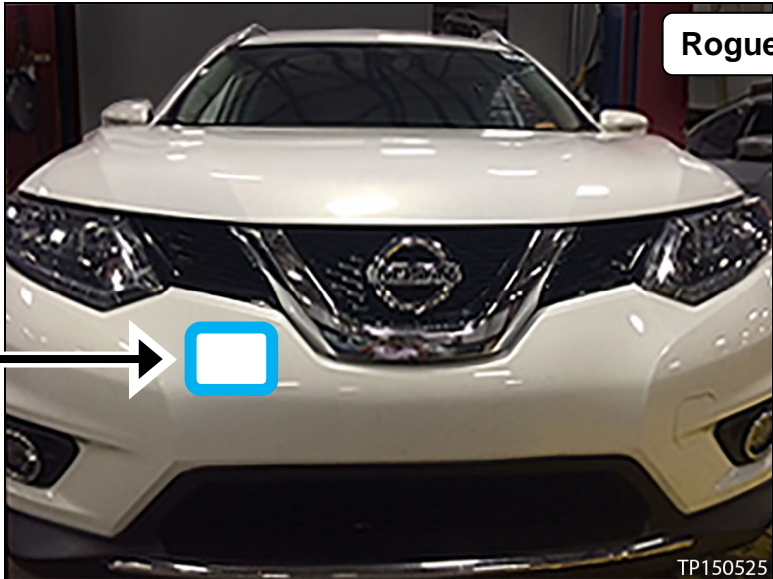
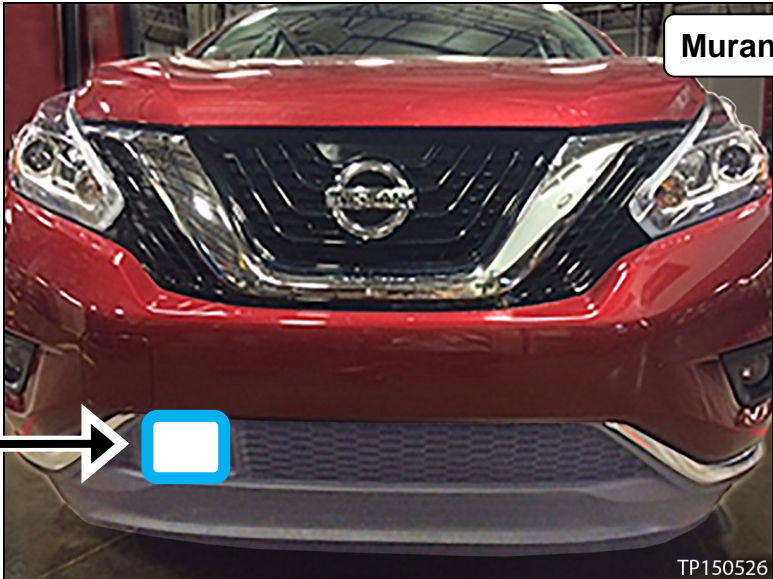
Location of ICC/distance sensor, behind or below bumper fascia

- Check the ICC/distance sensor lens or the bumper fascia in front of the sensor (see pages 2, 3, and 4). Remove any obstructions, including any clear bra or film, and clean off any stains (mud, dirt, road debris, dirty rain water, etc.), and then verify proper system operation.

- Inspect the bumper fascia in the area in front of the ICC/distance sensor (see pages 2, 3, and 4).
 - Check for stains and/or physical damage (for example, mud/dirt, road debris, dirty rain water, scrapes, punctures, misshapen surface).
 - If there is physical damage but not severe, clean the area in front of the ICC/distance sensor, perform an ICC/distance sensor alignment using CONSULT-III plus (C-III plus), and then verify proper system operation.
 - If an ICC/distance sensor alignment is not successful, inspect the ICC/distance sensor bracket for damage (see page 5).
 - If damaged, replace the ICC/distance sensor bracket, and then perform an ICC/distance sensor alignment again.

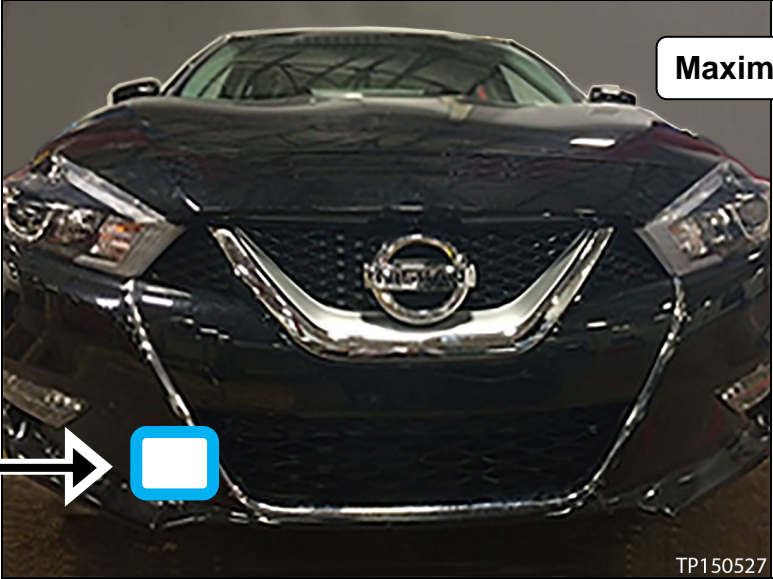
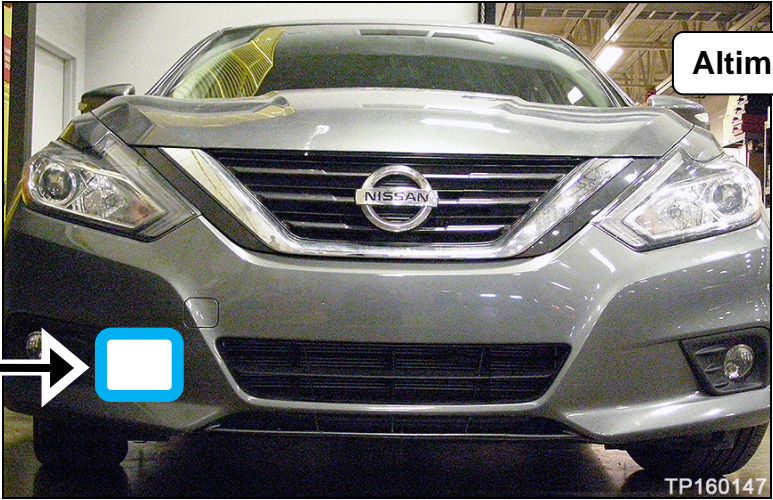
Location of
ICC/distance
sensor, behind
or below
bumper fascia

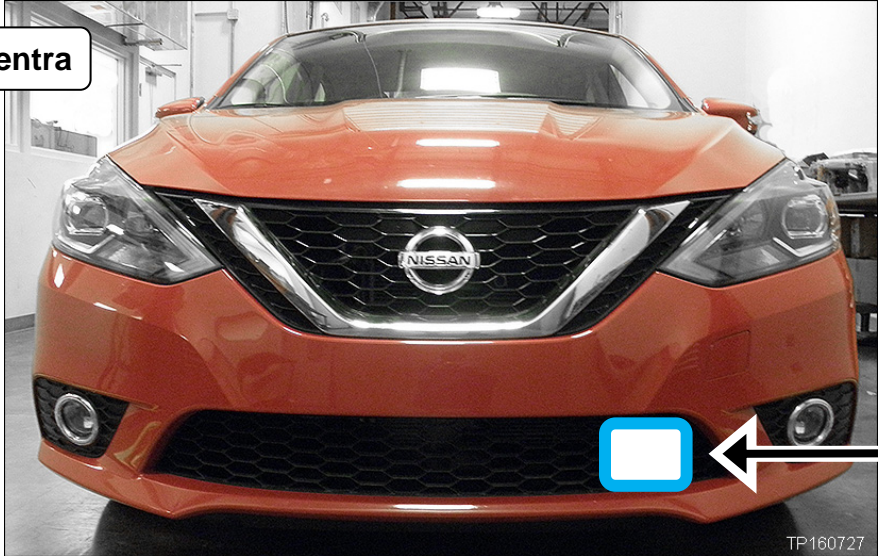
Sentra

Location of
ICC/distance
sensor, behind
or below
bumper fascia
