SERVICE INFORMATION

APPLICABILITY: 2006-2009MY Legacy Spec B and 3.0R Limited Models with Bilstein® Front Struts
NUMBER: 05-60-15
SUBJECT: Rattling Sound from Front Suspension While Driving
DATE: 07/27/15
 Inspection Method for Loose Strut Retaining Nut

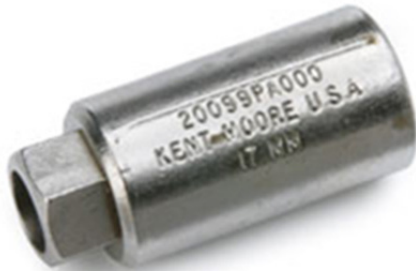
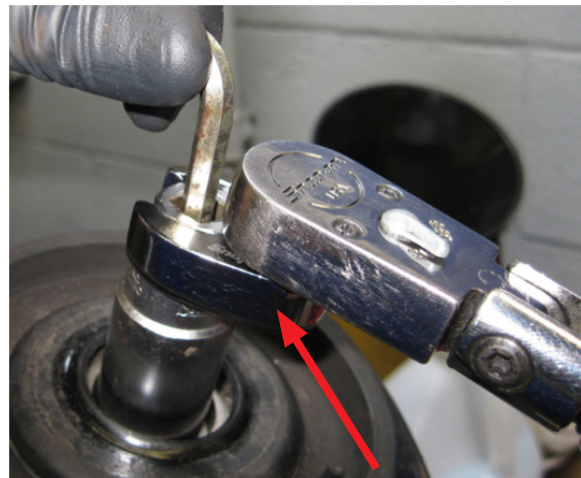
Use the special tool as shown to remove and tighten the locking nut; a 17mm Strut Lock Nut Wrench, p.n. 20099PA000 (SOA Essential Tool).

IMPORTANT NOTE: When using an extension which increases the overall “length” of the torque wrench, the torque values applied will change. Refer to the illustration and calculation formula provided on the last page of this bulletin for determining the revised torque specification when using an extension like a Crow’s Foot wrench shown in the example photo above.

IMPORTANT: To insure proper tightening torque of the nut and tension on top portion of the strut assembly are achieved, the special strut mount socket tool, part number 20099PA000 and a 6mm hex key wrench to hold the strut piston firmly **must** be used as shown on pg. 1.

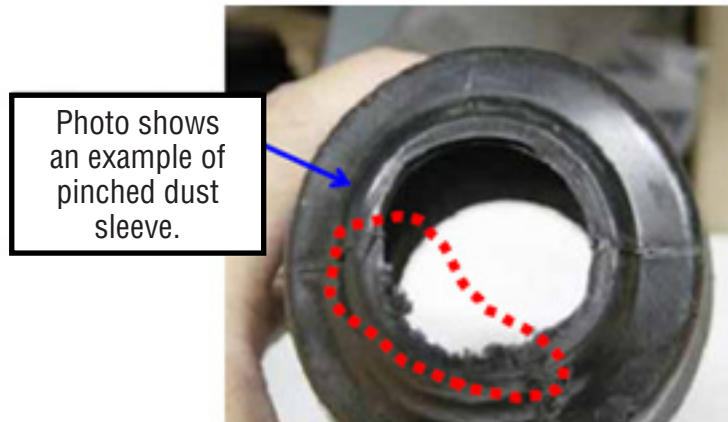
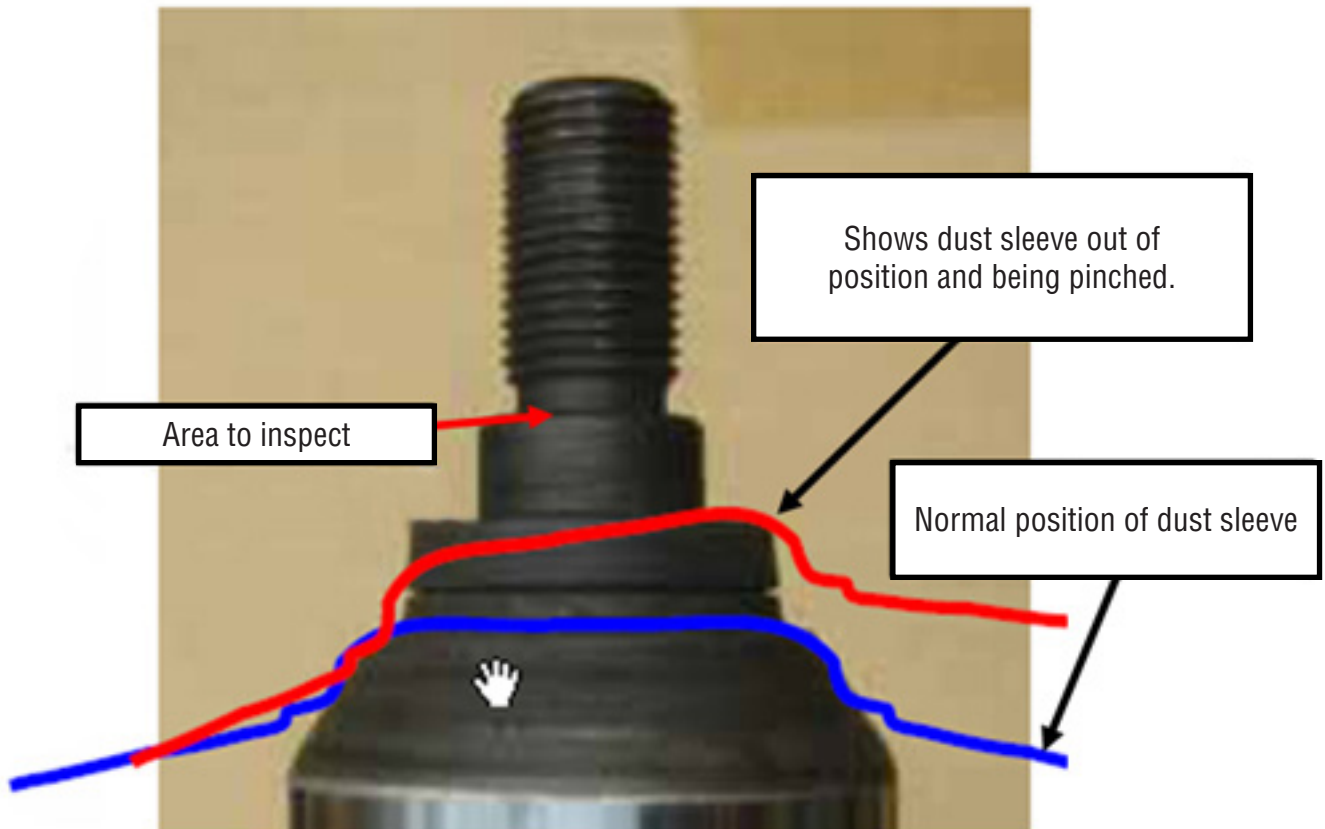
2. Remove the front wheel assembly then try to rotate the dust sleeve around the strut piston.
 - If the dust sleeve does not turn easily, the strut assembly will need to be disassembled for closer inspection.
 - If you are able to turn it easily, the procedure is complete. Further inspection to determine the source of the sound is necessary.

3. Once the strut has been disassembled, the area indicated in the photo above will need to be inspected closely for cracking.

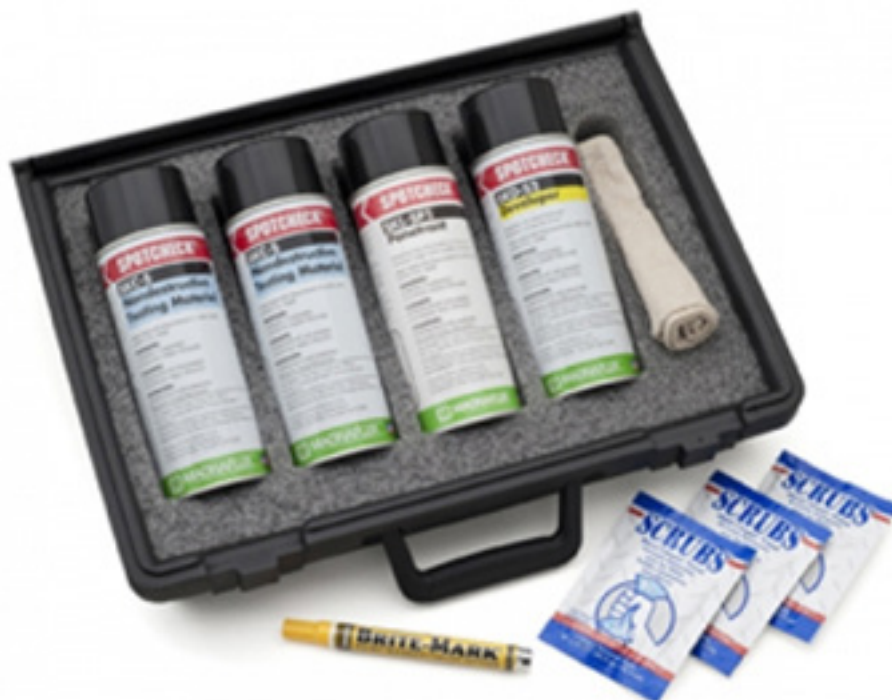
Magnaflux Spotcheck® SK-416 Penetrant Inspection Kit

The photo below shows a Magnaflux Spotcheck® SK-416 Penetrant Inspection Kit, which can be purchased from industrial equipment suppliers such as MX Industrial, (215) 322-8909 for \$99.00 (plus shipping), or online at: www.mxindustrial.com.

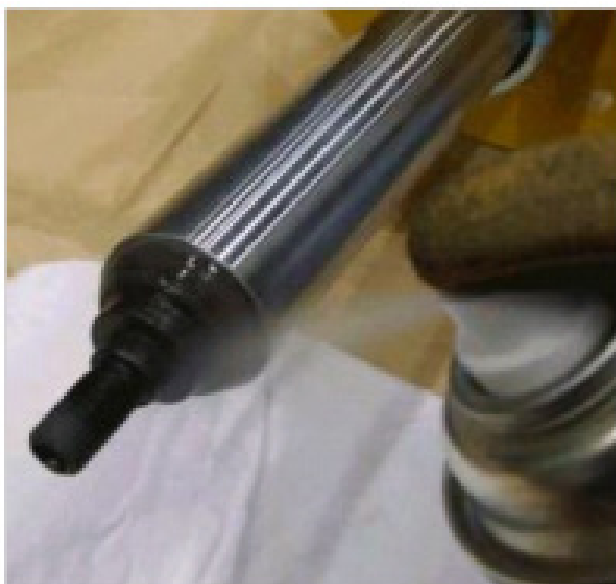
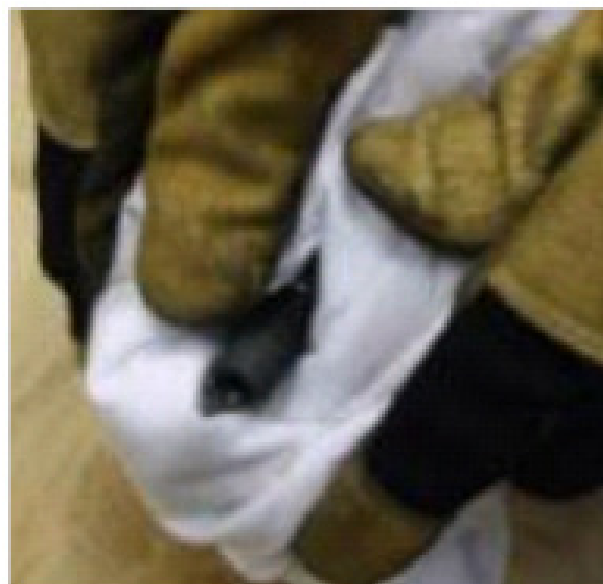
- (3-1) Clean the area to be inspected thoroughly of any dirt or grease with the cleaner.

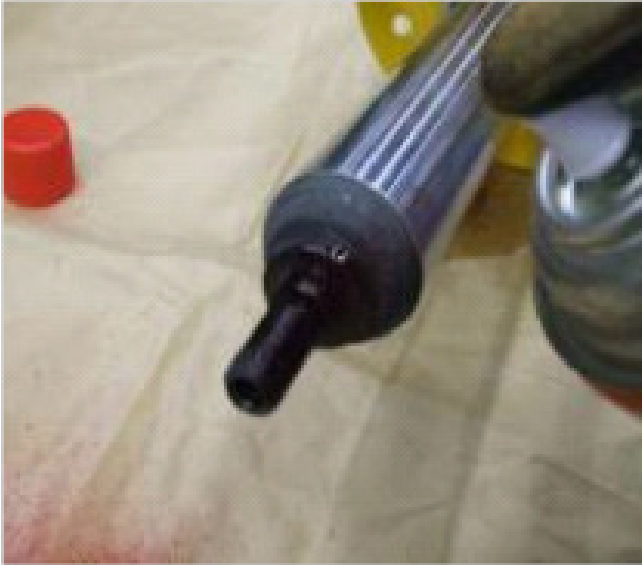
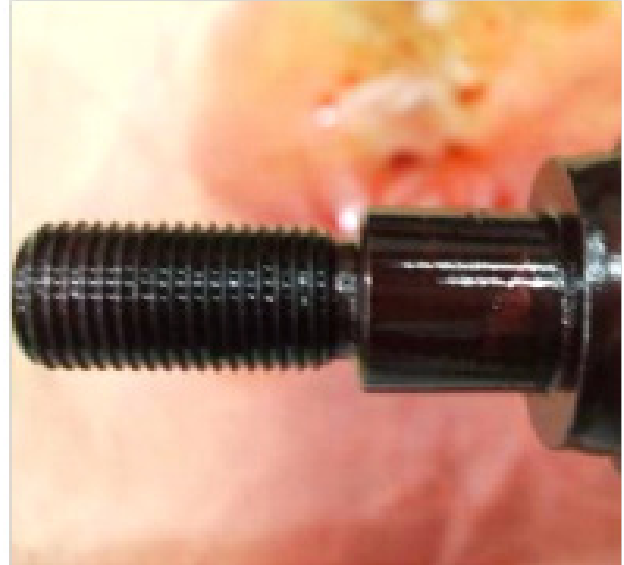
- (3-2) Apply penetrant evenly to the inspection area then allow to dwell (penetrate) for about 10 minutes.

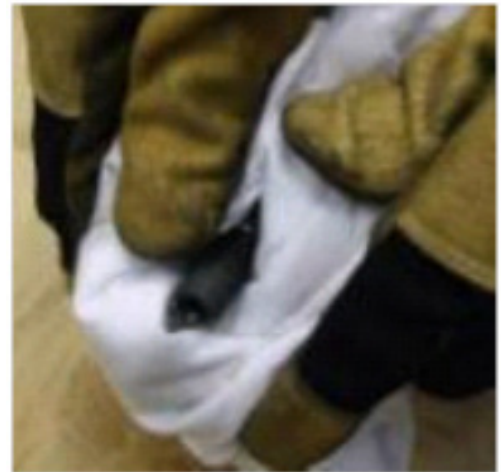
- (3-3) Remove any excess penetrant with a clean shop cloth sprayed with cleaner. **DO NOT** spray cleaner directly on the part. Otherwise, any defect the process is trying to show may be rinsed clean. (**NOTE:** some penetrant will remain in the threads.)

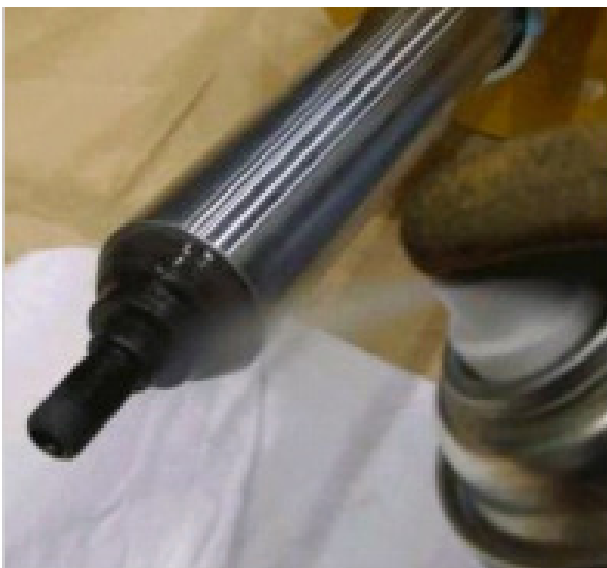
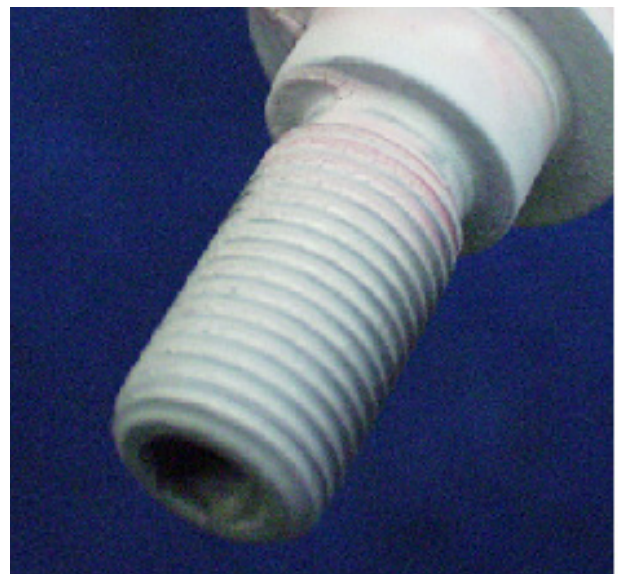
- (3-4) Apply the developer evenly to the threaded area and allow it to dry. The bolt will appear like it is coated with white powder as shown in the photo on the right.

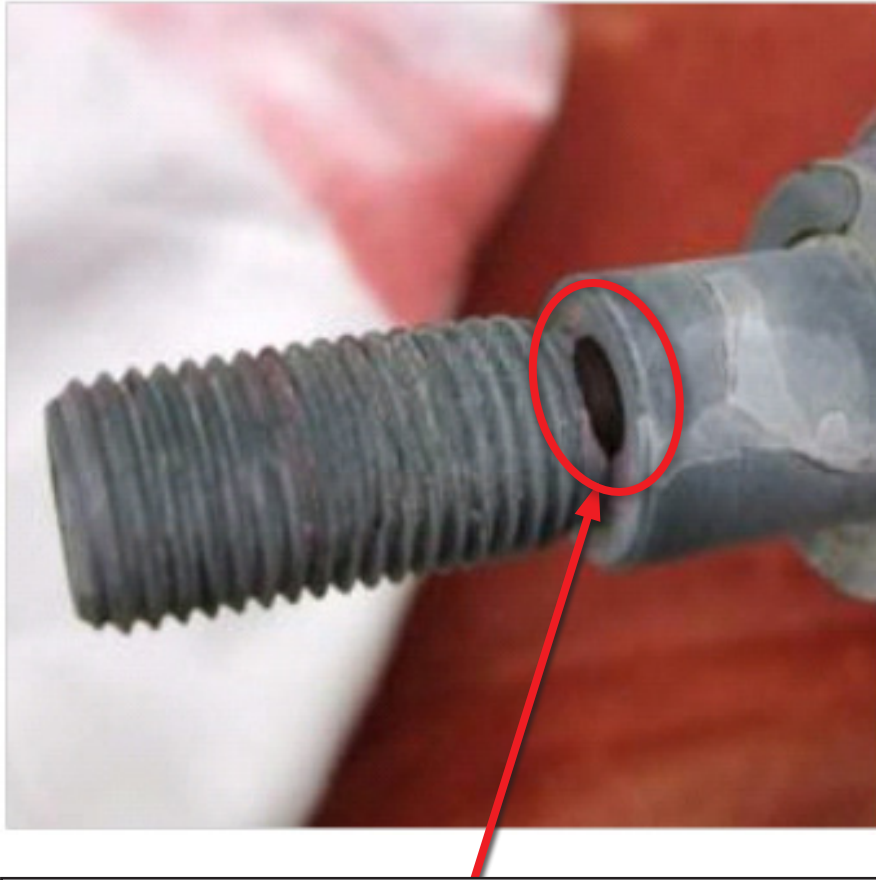
- (3-5) Check the developer for penetrant seepage. The strut in the photo below requires replacement.

The base of the threads as shown below is the focal point of the penetrant inspection. After applying the developer, watch carefully for a red line to appear indicating the presence of a crack. If a crack is present, the penetrant indication will eventually widen and blur as it appears in the photo.

- (3-6) If the penetrant inspection reveals no cracking, wash away any remaining penetrant materials thoroughly with the cleaner and wipe dry with a clean shop cloth. If a crack is found, replace the strut.
4. Reassemble the strut assembly following the procedure in the applicable Service Manual. **NOTE:** be sure to use a **NEW** self-locking top nut, part number 902350027 and torque it to 70 Nm (51.6 ft. lbs.).

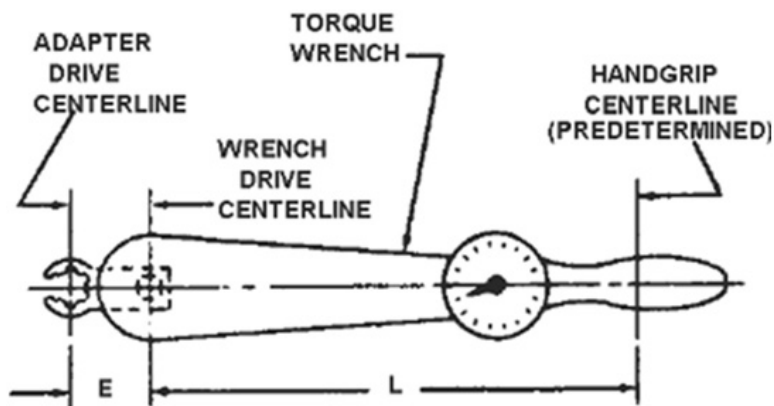
Revised Torque Specification Calculation Formula:

$T = 51.6$ ft. lbs. (Current Torque Specification)

$L = 10"$ (Length of Torque Wrench)

$E = 1.5"$ (Length of "Extension" / Crow's Foot in this example)

$Y =$ "New" Torque Specification

Calculation Formula: $T \times L \div L + E = Y$

Example: $51.6 \times 10 = 516$ (T)

$10 + 1.5 = 11.5$ (L)

$516 \div 11.5 = 44.9$ (Y)

The "New" Torque Specification is **44.9 ft. lbs.**
