**SERVICE BULLETIN**

**APPLICABILITY:** 2013 Legacy & Outback Models with 2.5L FB Engines

**SUBJECT:** Surface Treatment Change To Oil Control Piston Rings

**NUMBER:** 02-143-13R  
**DATE:** 09/19/13  
**REVISED:** 10/10/13

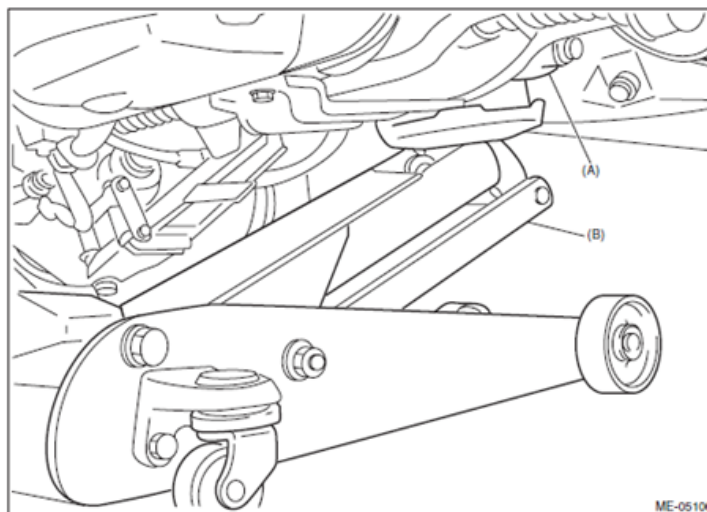
- When draining the engine oil, do not remove the engine oil filter. Leave the existing oil filter in place through engine disassembly, reassembly, installation and initial startup after engine reassembly.
- When removing the engine, there is no need to remove the transmission case cover (CVT only) or to disconnect / disturb any of the transmission harness connectors. While raising the transmission with the service jack placed under the front differential as shown in the illustration below, **only raise it enough to access and remove the engine mounting hardware**. Raising it too high can push the transmission up into the bulkhead / transmission tunnel and possibly cause damage.

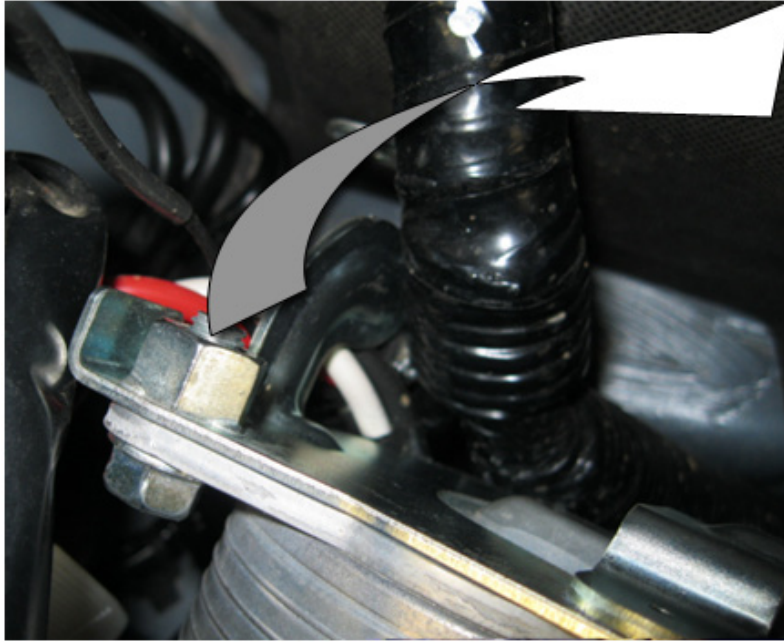
- When removing the CVT fluid cooler, leave it attached to the mounting bracket and remove it as an assembly (3 bolts) from the transmission. Disconnect just the engine coolant hoses from it and leave the 2 short CVT fluid lines alone. Hook one of the cooler's mounting bracket "ears" behind the bulkhead harness as shown in the photo below to keep the cooler assembly out of your way. Use a shop cloth between the "ear" and the bulkhead harness to prevent any chafing.

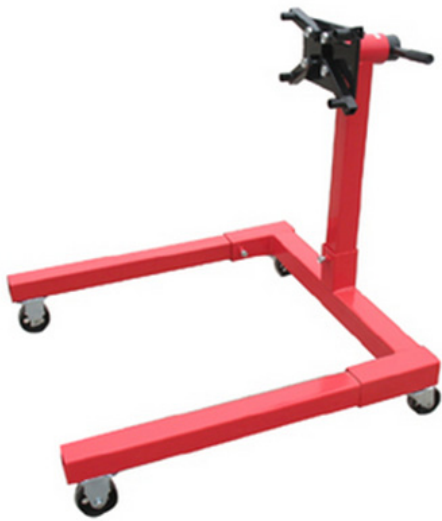
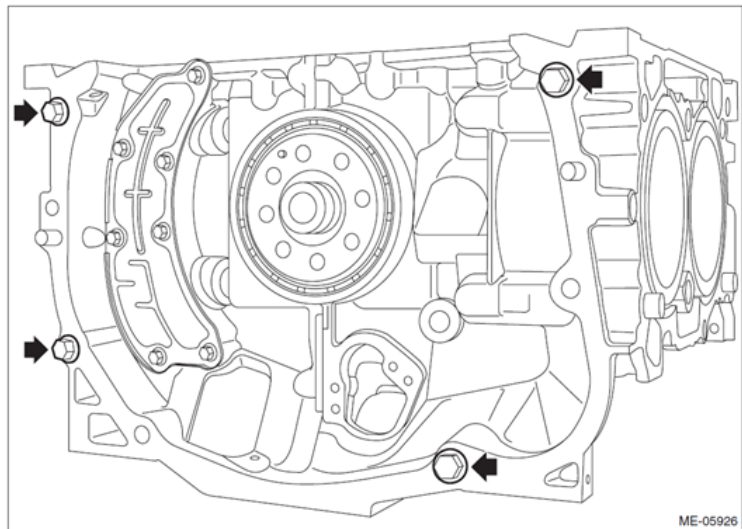
- Once the engine is removed, if you are using a generic engine stand (preferable since engine rotation is necessary), use the four mounting holes on the engine block shown below to mount it. Do not use the studs in the upper oil pan as the upper oil pan has to be removed to access the connecting rod bolts. **NOTE:** The connecting rod bolts are one-time-use and must be replaced.

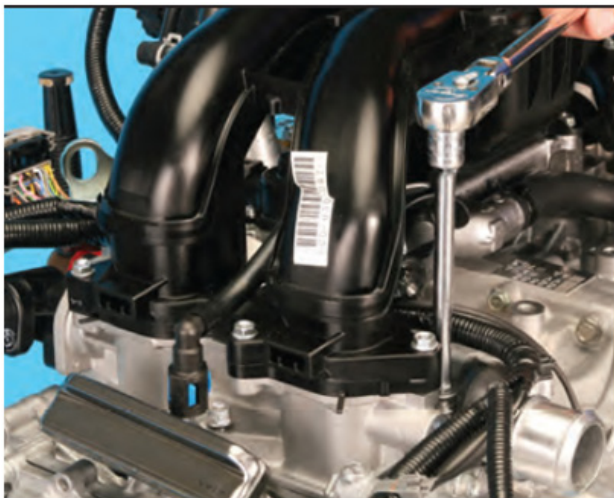
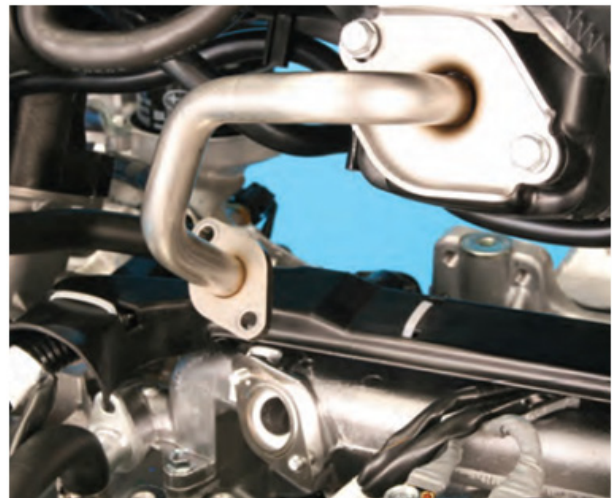
- When removing the intake manifold, as shown in the photos below, leave the TGV assemblies attached to the upper intake, remove the 2 nuts holding the EGR tube to the water pipe then remove the complete assembly from the cylinder heads as a unit.

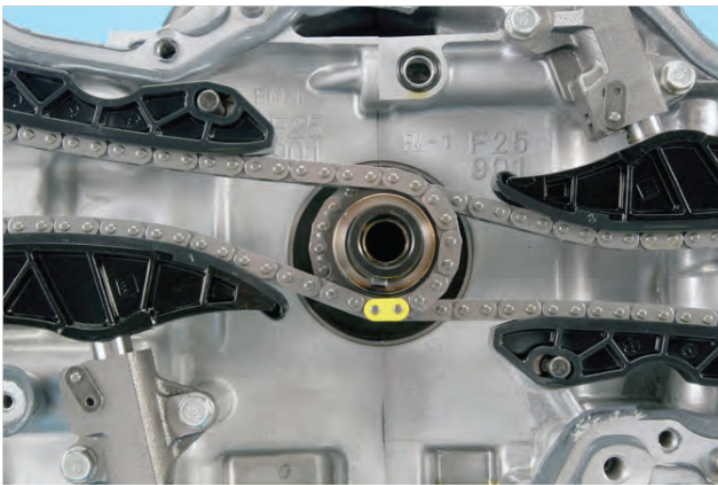
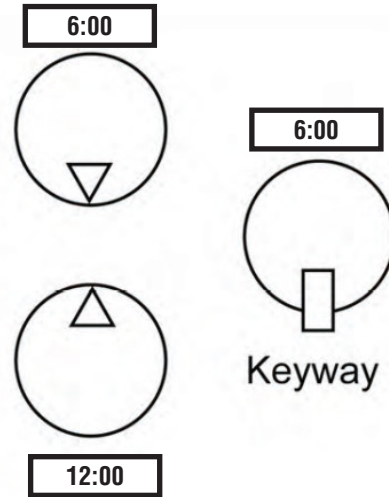
- Begin timing chain removal by positioning the crankshaft keyway at the 6:00 position. The RIGHT bank intake camshaft timing mark ( $\Delta$ ) must be at 6:00 with right bank exhaust timing mark at 12:00 (camshafts will be unloaded).

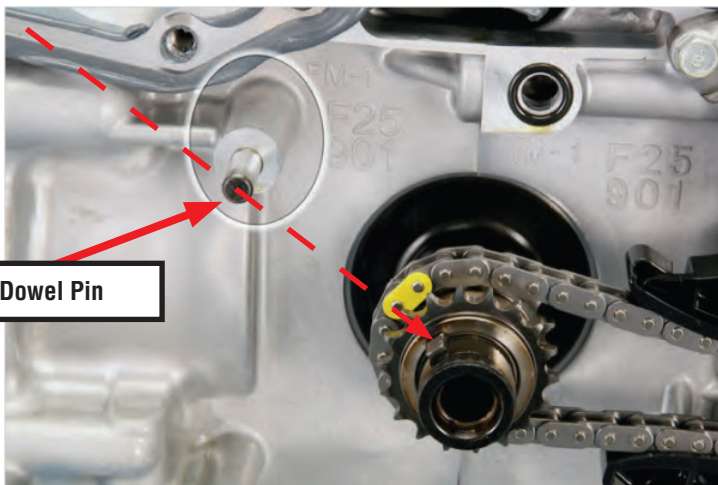
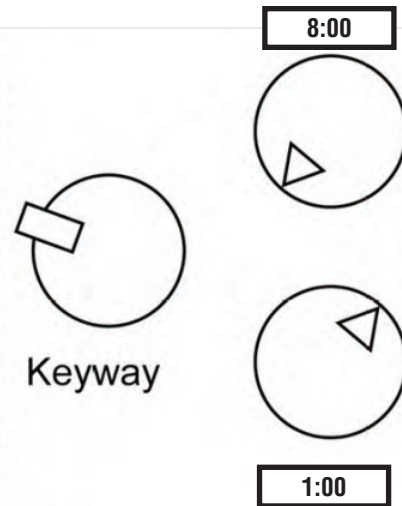
- Compress the chain tensioner by hand, insert a pin through the lever into the access hole to lock the plunger in place then remove the 2 bolts, tensioner, guides and right side timing chain.
- After turning the crankshaft **CLOCKWISE**, repeat the procedure for the LEFT side with the timing marks ( $\Delta$ ) positioned as shown below. Align the crankshaft sprocket keyway with RH chain dowel pin (shown in red below).

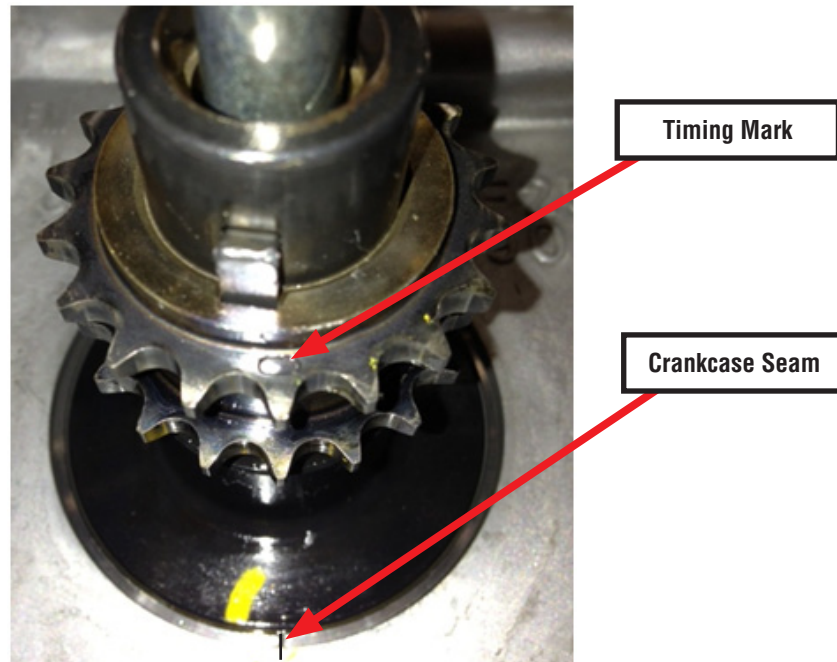
- Compress the chain tensioner by hand, insert a pin through the lever into the access hole to lock the plunger in place then remove the 2 bolts, tensioner, guides and the left side timing chain.
- After the left chain is removed, turn the crankshaft in a **COUNTER CLOCKWISE** direction until the timing mark on the crankshaft sprocket (NOT the keyway) is back to the 6:00 position as shown below. This positions all the pistons away from TDC and prevents accidental contact between the pistons and valves.

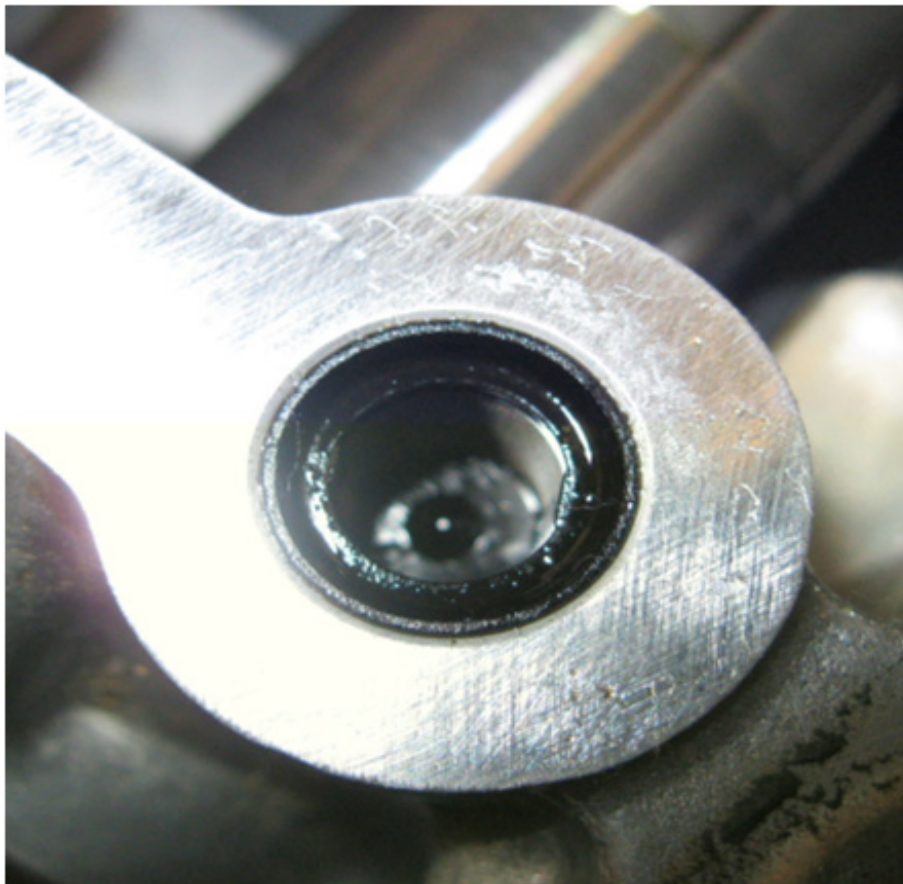
- ALWAYS install new connecting rod bolts as they are one-time use items.
- It is very important to take the time necessary to thoroughly clean the old silicone sealer from all the removed components before reassembly. It is a good idea to clean the surrounding areas then use tape to block off any oil passages in the front cover and cam carrier so any small bits of removed silicone debris are kept from entering the oil passages and possibly causing problems after reassembly. Once all the old sealer has been removed, remove any block-off tape, rinse out any oil passages thoroughly with brake cleaner and shop air.
- Don't forget to clean (**without removing**) the filter screens in the cam carriers (one filter in each) as shown in the photo below.

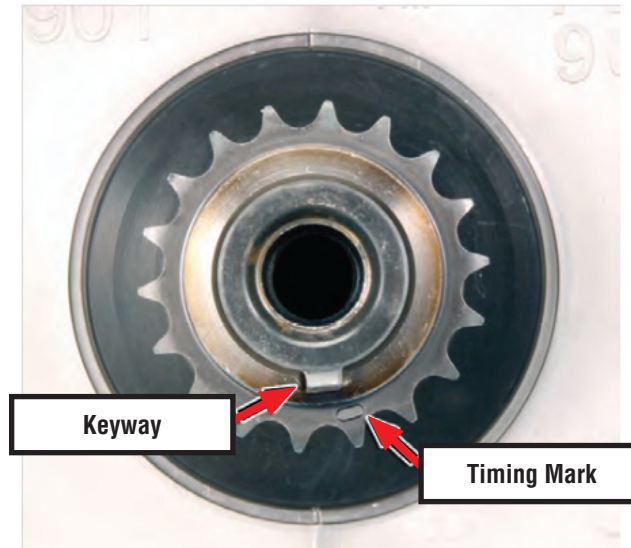
- To begin timing chain re-installation, turn the crankshaft **COUNTER-CLOCKWISE** until the crankshaft sprocket keyway is back to the 6:00 position. NOTE: The keyway is **NOT** a timing mark.

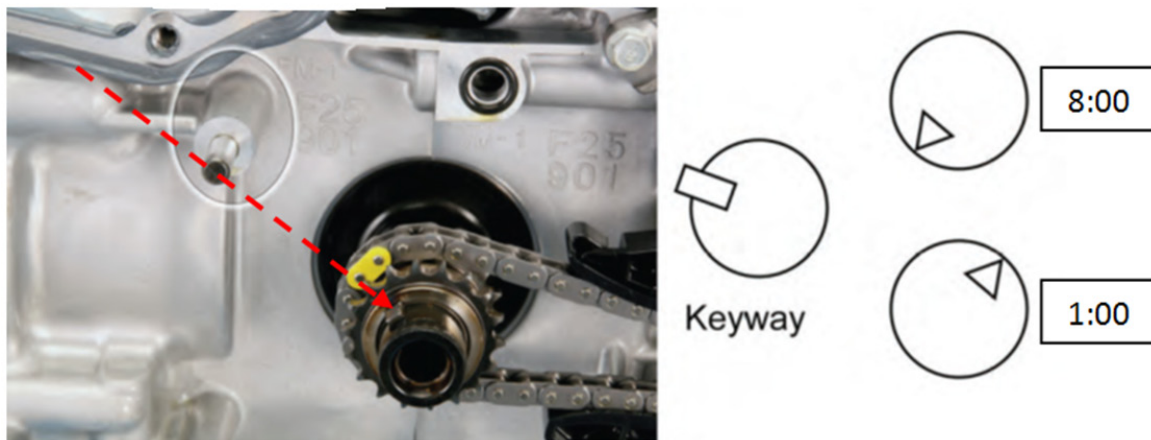
- Arrange the timing marks as shown below, turning the crankshaft **CLOCKWISE** into position. Align the indicator link with the timing mark on the crankshaft sprocket, keyway with the dowel pin.

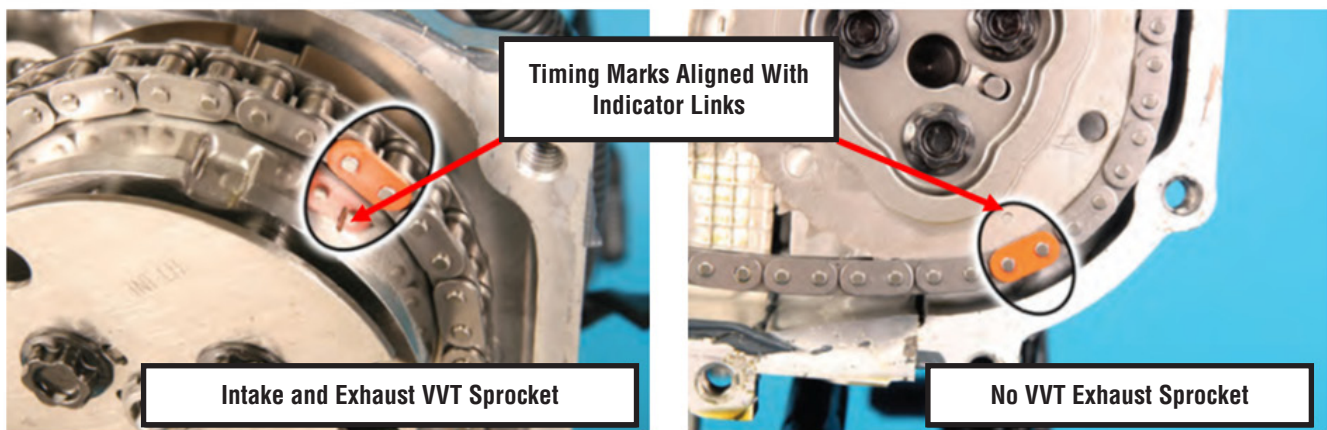
- Align the indicator links to the timing marks found on the outside of the sprocket assemblies as shown in the photos below (Exhaust sprocket face images will vary with / without exhaust VVT).

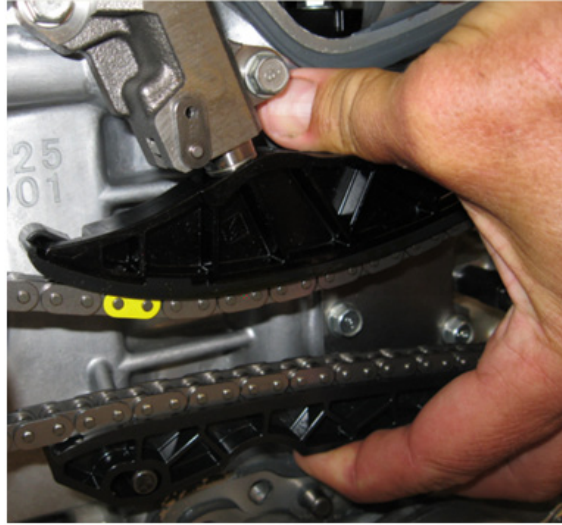
- Install the chain guides and tensioner. Once proper positioning has been confirmed, pull the pin to release the tensioner. With your hand, grab and squeeze the upper and lower chain / guides together as shown in the reference photo below to allow the plunger in the tensioner to fully extend and “click” into its furthest notch.

- Same as the left side, align the indicator links to the timing marks found on the cam sprocket assemblies. Install the chain guides and tensioner. Once proper positioning has been confirmed, pull the pin to release the tensioner. With your hand, grab and squeeze the upper and lower left side chain / guides together to allow the plunger in the tensioner to fully extend and click into its furthest notch as shown in the previous (right side) photo.

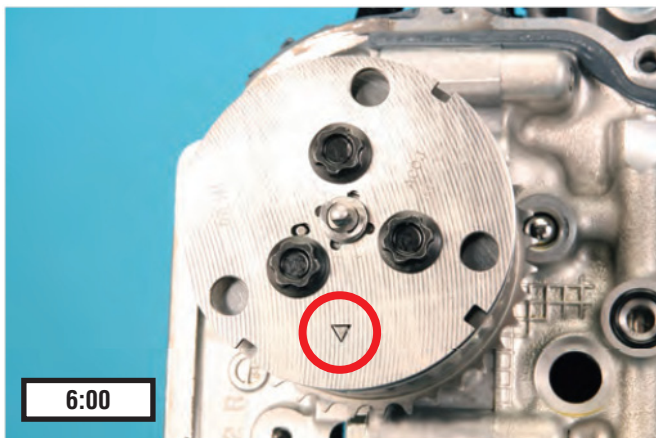
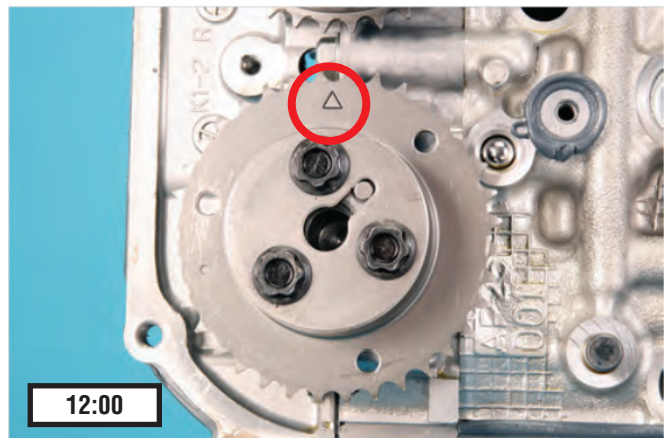
- Rotate the crankshaft COUNTER-CLOCKWISE until the crankshaft sprocket timing mark is at the 6:00 position. Position the cam sprocket timing marks as shown below; intake 6:00, exhaust 12:00.

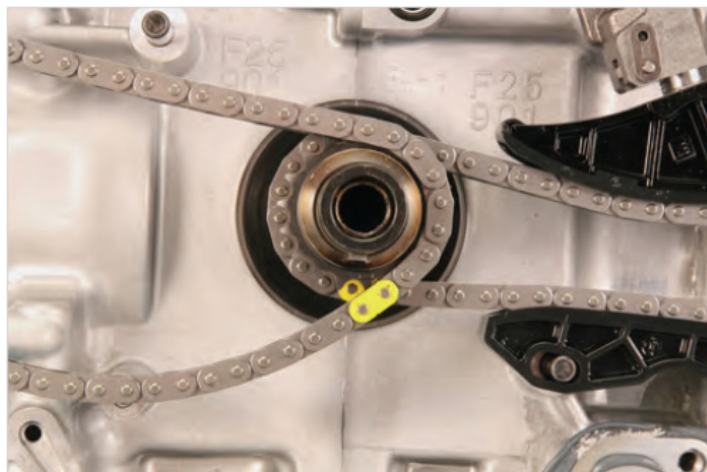
- Align the indicator link with the timing mark on the crankshaft sprocket as shown below.
