**FORD:**

2015 Transit

This article supersedes TSB **15-0118** and **FSA 15B39** to update the Service Procedure.

**ISSUE**

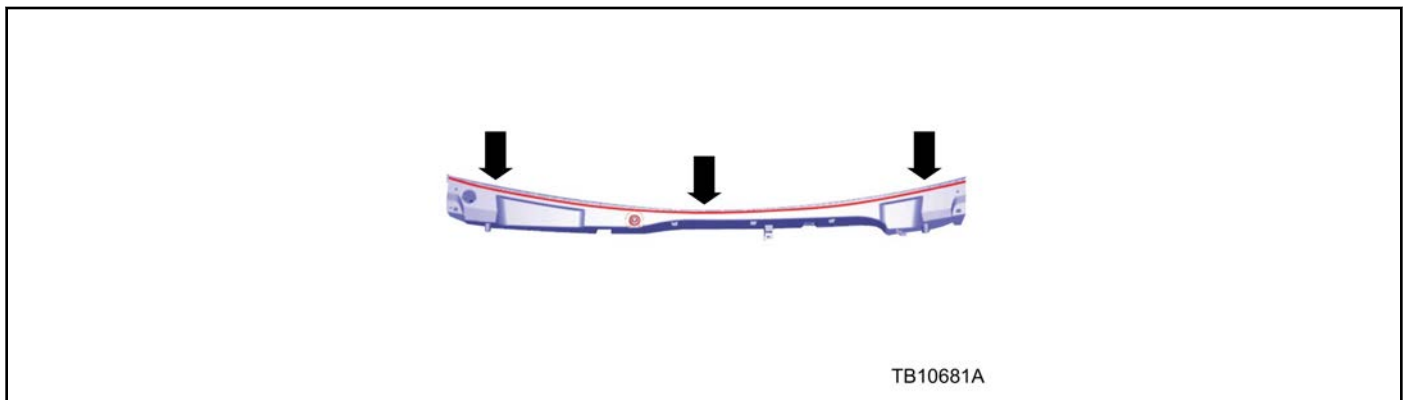
Figure 1 - Article 17-0014

1. Check the vehicle repair history. Was the vehicle previously repaired under FSA 15B39 or TSB 15-0118?
  - a. Yes - this article does not apply. Refer to the Powertrain Control/Emissions Diagnosis (PC/ED) manual for normal diagnostics.
  - b. No - proceed to step 2.
2. Connect the Ford Integrated Diagnostic System (IDS) service tool or equivalent scan tool to the data link connector (DLC). Check for diagnostic trouble codes (DTCs). Is DTC P00BD, P1247, P1548, P061B, P2195, P2198, P2196, P2197, P0171, P0172, P0174, P0175, P0131 or P162F stored in the PCM memory or is there a customer drivability issue?
  - a. Yes - proceed to Step 2.
  - b. No - this procedure does not apply. Refer to the PC/ED manual.
3. Remove the cowl panel grille. Refer to Workshop Manual (WSM), Section 501-02.
4. Clean the back of the cowl panel grille with a clean cloth. (Figure 1)

5. Apply the leaf screen foam seal along the back of the cowl panel grille. (Figure 1)

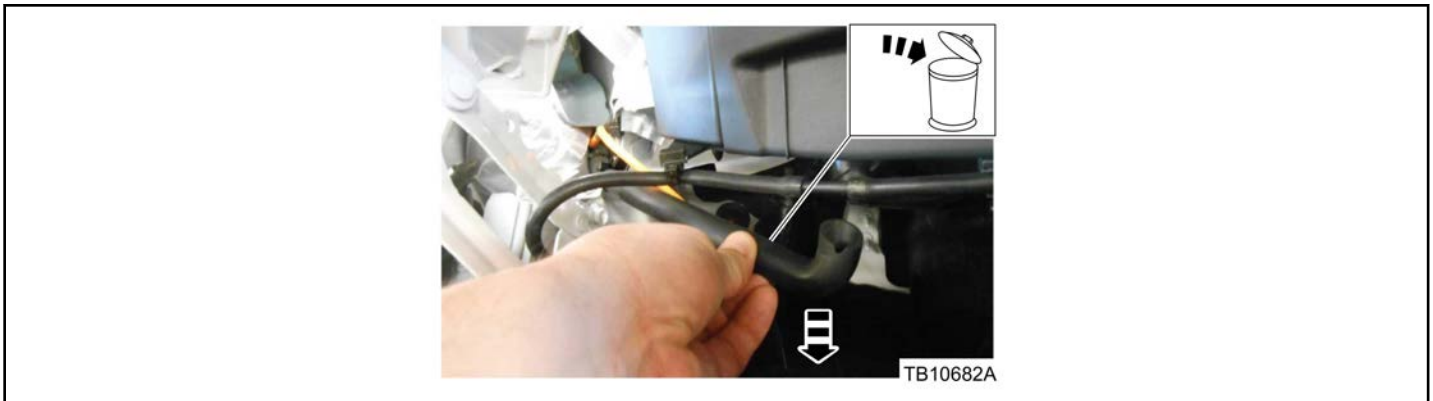
Figure 2 - Article 17-0014

6. Remove and discard the drain hose from the right side of the cowl panel grille. (Figure 2)

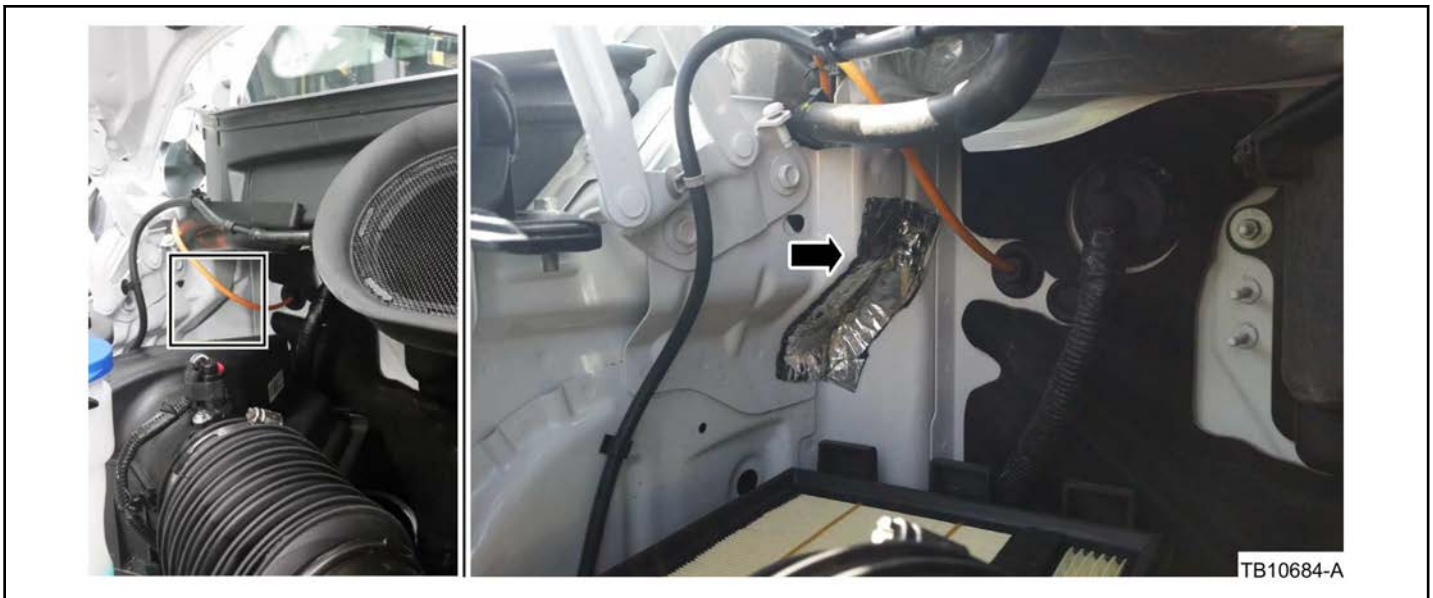
Figure 3 - Article 17-0014

7. Remove the engine air cleaner cover. Refer to WSM, Section 303-12.
8. Clean the body joint between the right inner fender and dash panel with a Motorcraft® metal surface prep wipe or equivalent. (Figure 3)

9. Cut the mastic patch to 8 cm x 13 cm (3 in x 5 in) and apply the patch to the body joint. (Figure 3)
10. Remove and inspect the air cleaner element to determine if it is dry/damp or saturated with water or ice.
  - a. Element dry/damp - clean any debris from the air cleaner tray and reinstall the element. Normal engine operation will dry the element if damp.
  - b. Element saturated with water or ice - install a new element.
11. Reinstall the engine air cleaner cover. Refer to WSM, Section 303-12.
12. Is the vehicle a low roof model?

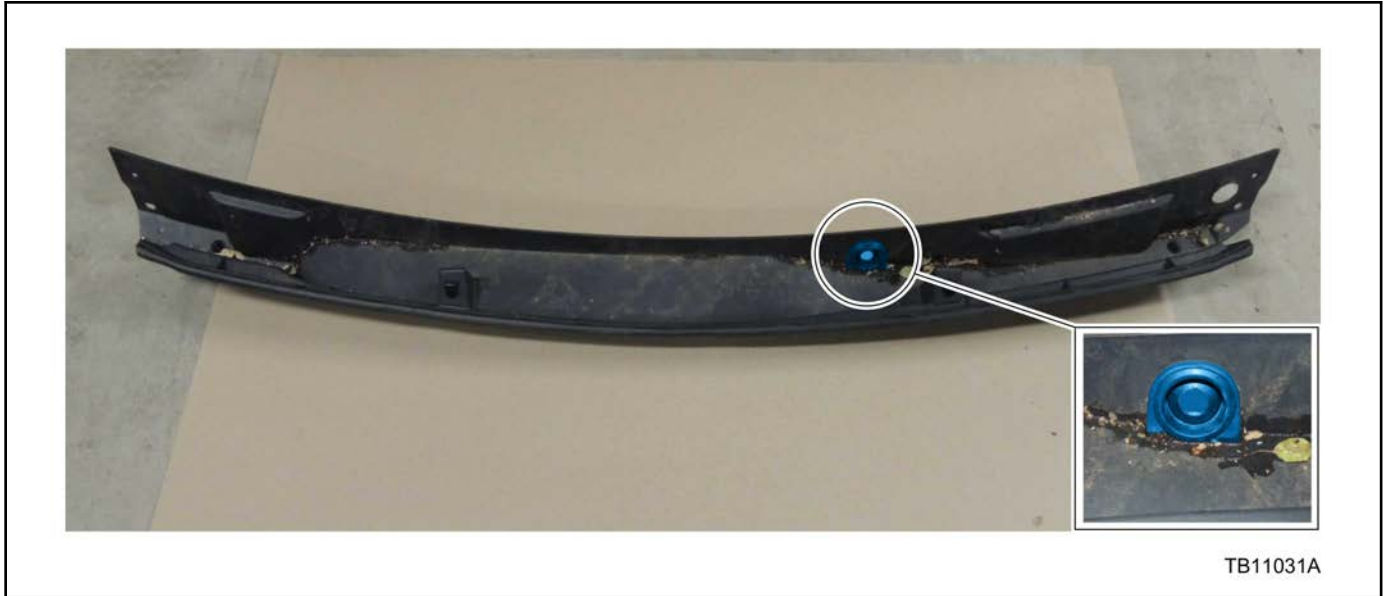
Figure 4 - Article 17-0014

- a. Yes - the vehicle is a low roof model. Replace the right side windshield wiper arm grommet on the cowl panel grille and proceed to Step 13. (Figure 4)

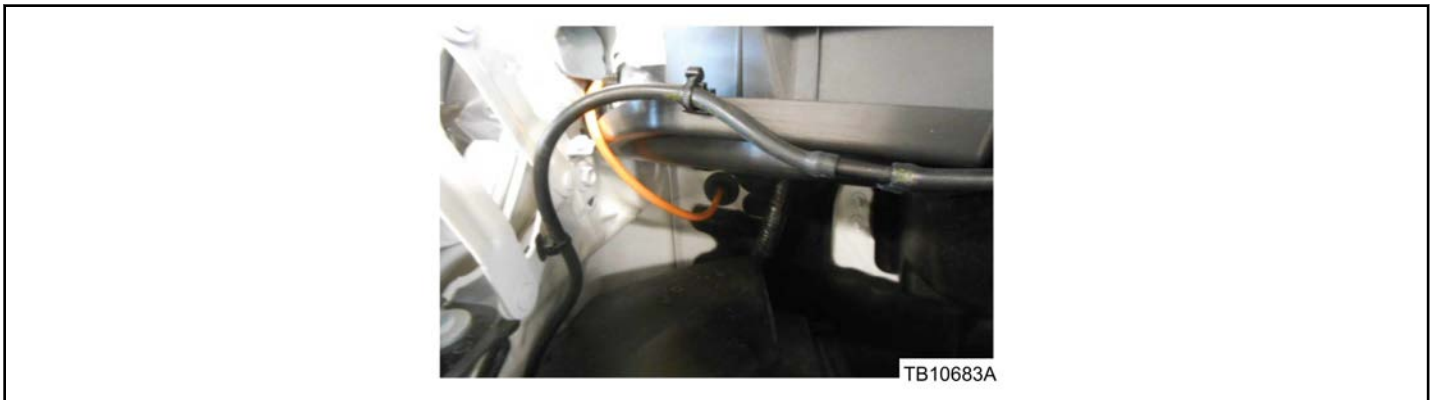
Figure 5 - Article 17-0014

- b. No - the vehicle is a medium or high roof model. Proceed to Step 13.
13. Reinstall the cowl panel grille. Refer to WSM, Section 501-02.
14. Install a new water diverter on the right side of the vehicle. (Figure 5)

- a. Install the outboard end of the diverter into the sheet metal tab behind the hood hinge.
  - b. Snap the diverter onto the cowl panel grille.
15. Route the orange antenna wire in front of the diverter and route the washer hose under the inboard end of the diverter. Attach the washer hose clip to the front edge of the diverter. (Figure 5)
