51969-01908 Version 9

Recall: Front Passenger's Airbag Inflator May Produce Excessive Pressure After Long-Term Exposure To High Absolute Humidity

Supersedes 14-030, dated September 15, 2015, to revise the information highlighted in **yellow**

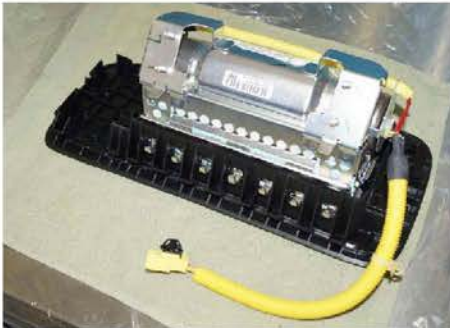
4. Place the airbag face-down on a clean shop towel as shown.

- The orientation of the airbag is critical because if the inflator is installed incorrectly, the harness will be too short when you reinstall the airbag.
- The brackets between the various models are similar but may differ from the example shown.

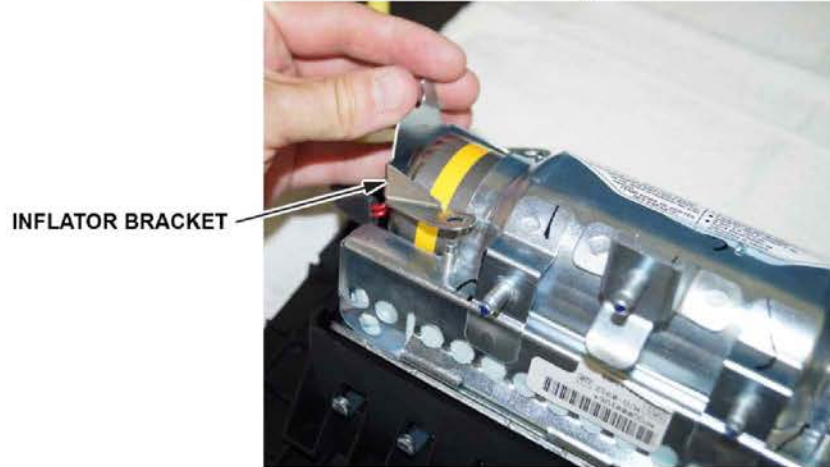
11. Remove the inflator bracket.

NOTE: You can only remove one of the brackets, as the other is welded to the airbag housing.

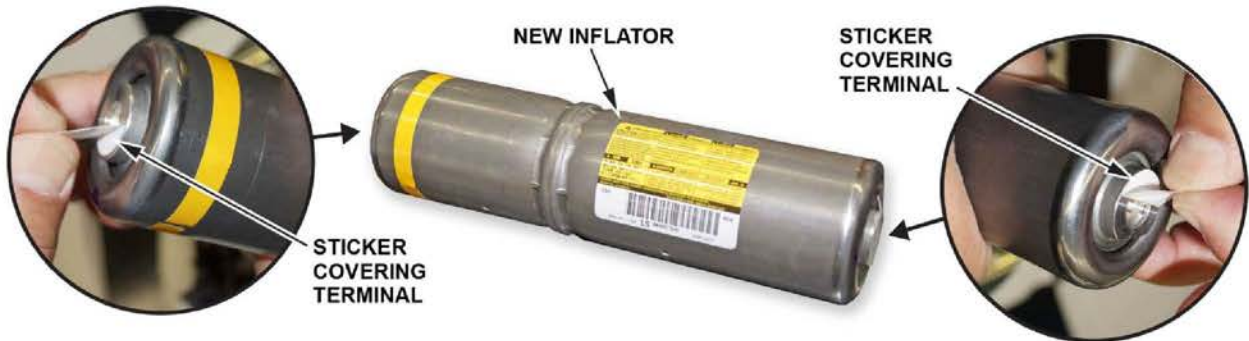
15. Remove the stickers covering the terminals on both sides of the new inflator.
