December 19, 2015

02025 Version 4

Safety Recall: Driver's Airbag Inflator Can Be Over-Pressurized

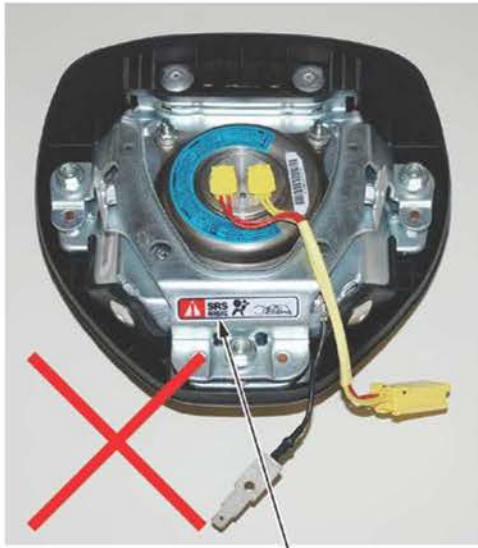
- If there is nothing unusual about the airbag or the inflator, go to step 6.
- If there are any unusual markings, like an incorrect label or a model year written in marker, the airbag and inflator may not be the correct airbag and/or inflator for the vehicle or it may be a counterfeit part. For more information about counterfeit airbags, you can refer to safercar.gov, enter keywords **MANAGING COUNTERFEIT**, and select **Recommended Dealer Guidance for Managing Counterfeit Air Bags** from the list. **If you suspect that the airbag or inflator is counterfeit, do not continue this procedure.** Contact your DPSM for assistance.

NON-STANDARD
SAFETY LABEL

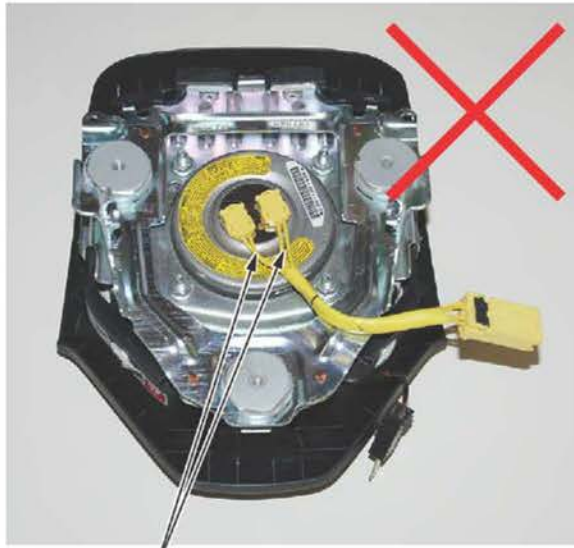
NON-STANDARD
WIRES

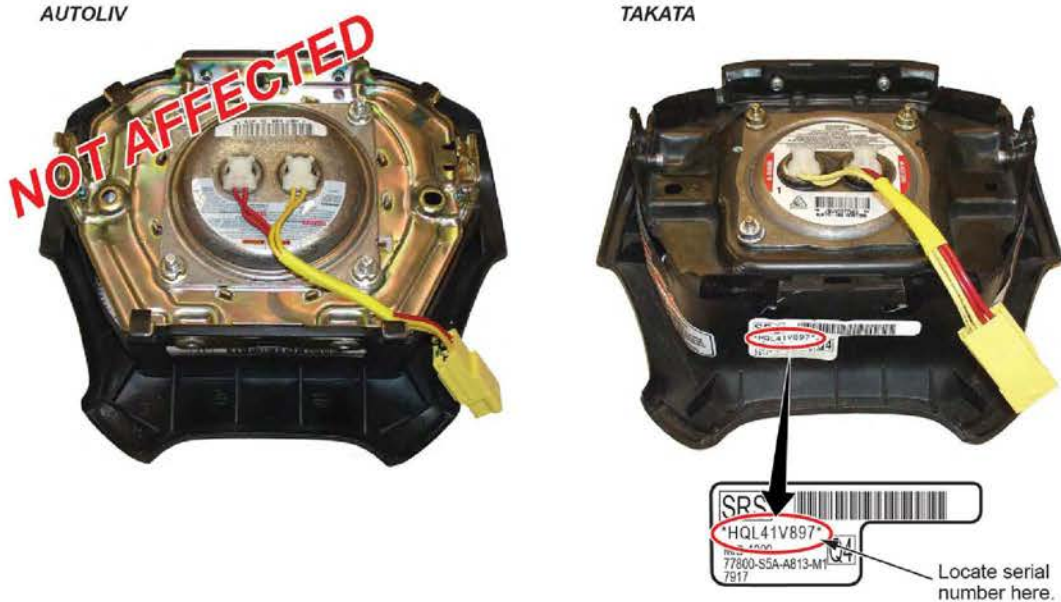
6. **Civic only** - Determine if the airbag is made by Autoliv or Takata by comparing the inflators to those in the images below.

NOTE: The Autoliv serial number label is different from the Takata label; the Autoliv has 11 characters, the Takata has 9.

- If the airbag is made by Autoliv, the airbag is OK. Reinstall the airbag using new Torx bolts. Torque the bolts to **9.8 N-m (7.2 lb-ft)**. If you already received a replacement inflator, return the unopened kit to American Honda.
- If the airbag is made by Takata, go to step 7.

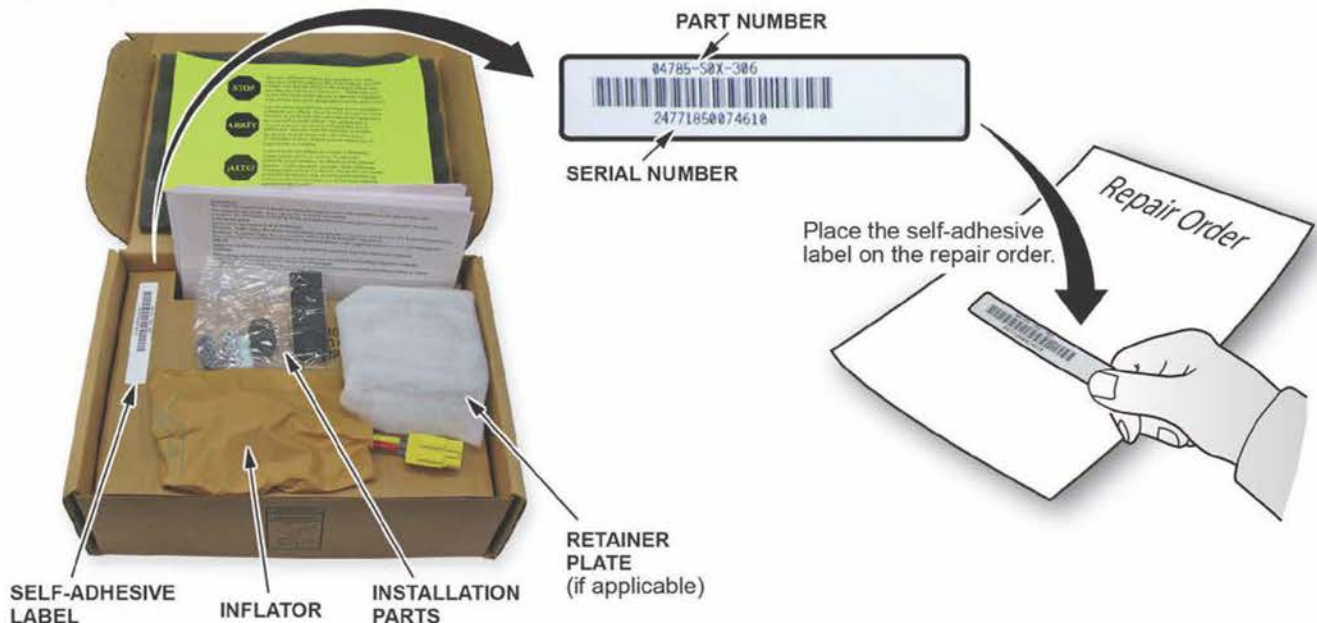
7. Peel the label located inside the inflator box from its backing and attach it to the RO. For the warranty claim to be paid, the **replacement inflator part number that you received** must be included in the warranty claim.

- The replacement part number is printed on the top part of the label and the serial number is printed on the bottom. **Make sure you attach the label to the RO and give it to the warranty clerk.**
- There may also be a colored sticker located in the kit, ignore it because it is not used.
- Not all inflator kits have a label included. In those cases, write the serial number and part number from the side of the inflator box on the RO. The part number always starts with 047.

INFLATOR PARTS BOX

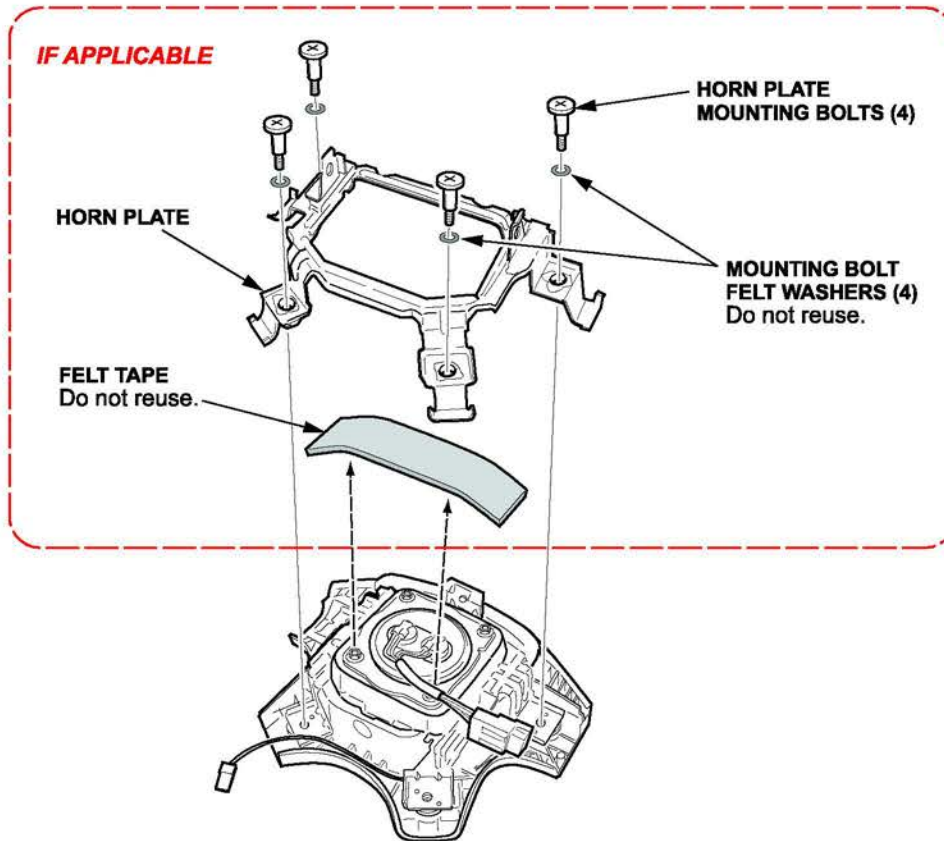
8. If there is no horn plate installed, go to step 9. If there is a horn plate installed, remove the four horn plate mounting bolts, the mounting bolt felt washers, the horn plate, and remove the felt tape covering the lower two inflator locknuts. The felt washers and felt tape will not be reused.

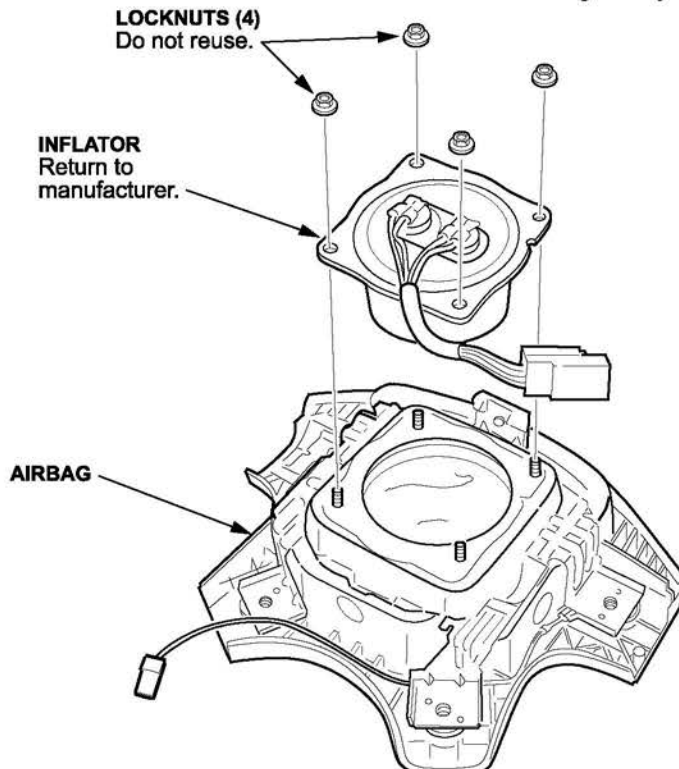
9. Using needle-nose vise grips or a 3/8 in. 6-point socket, remove the four locknuts from the inflator. The locknuts will not be reused.

NOTE: Do not remove the inflator from the airbag until you complete step 10.

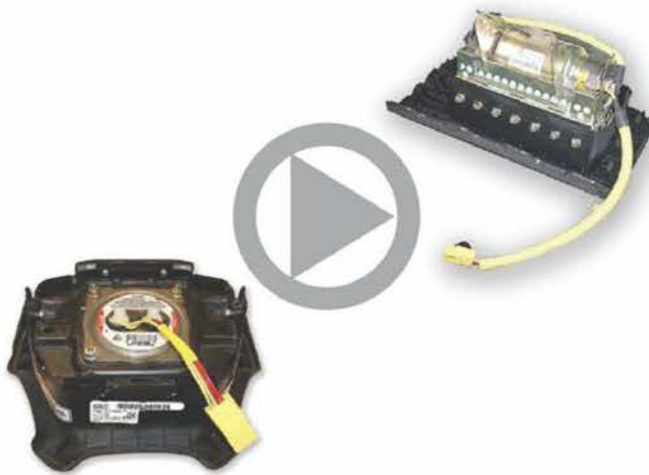
Click on the image below for a short video about the different variations of the driver's and front passenger's replacement inflators involved with the recalls related to Takata inflators. While both the driver's and front passenger's inflators are shown in the video, this is informational only. Replace inflators only as directed by the iN VIN status inquiry.

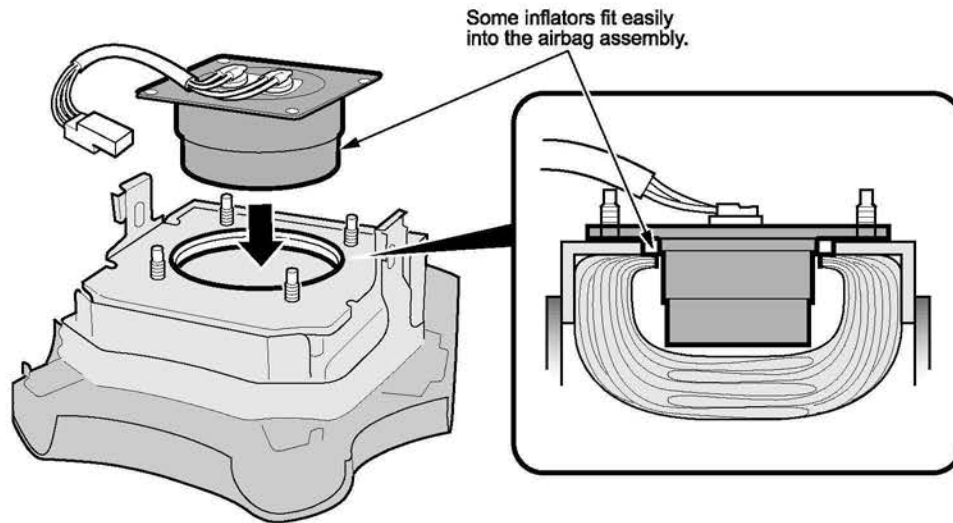
Refer to **Driver's Inflator Type 1** in the video.

- Insert the inflator into the opening.

NOTE: Make sure the inflator wires are positioned toward the bottom of the airbag. If you install the inflator incorrectly, you may not be able to reconnect the SRS airbag harness.

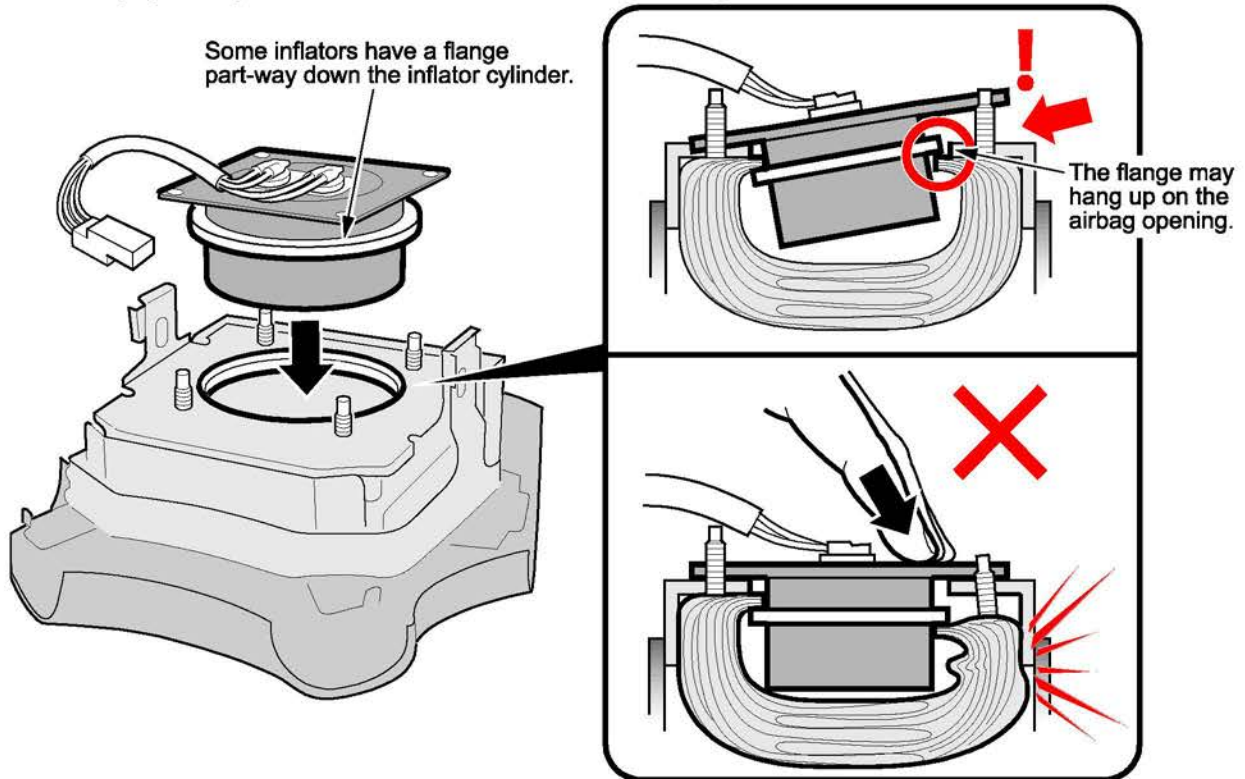
Refer to **Driver's Inflator Type 2** in the video.

- Insert the airbag inflator into the opening. Do not force it into the airbag module.

NOTE: Make sure the inflator wires are positioned toward the bottom of the airbag. If you install the inflator incorrectly, you may not be able to reconnect the SRS airbag harness.

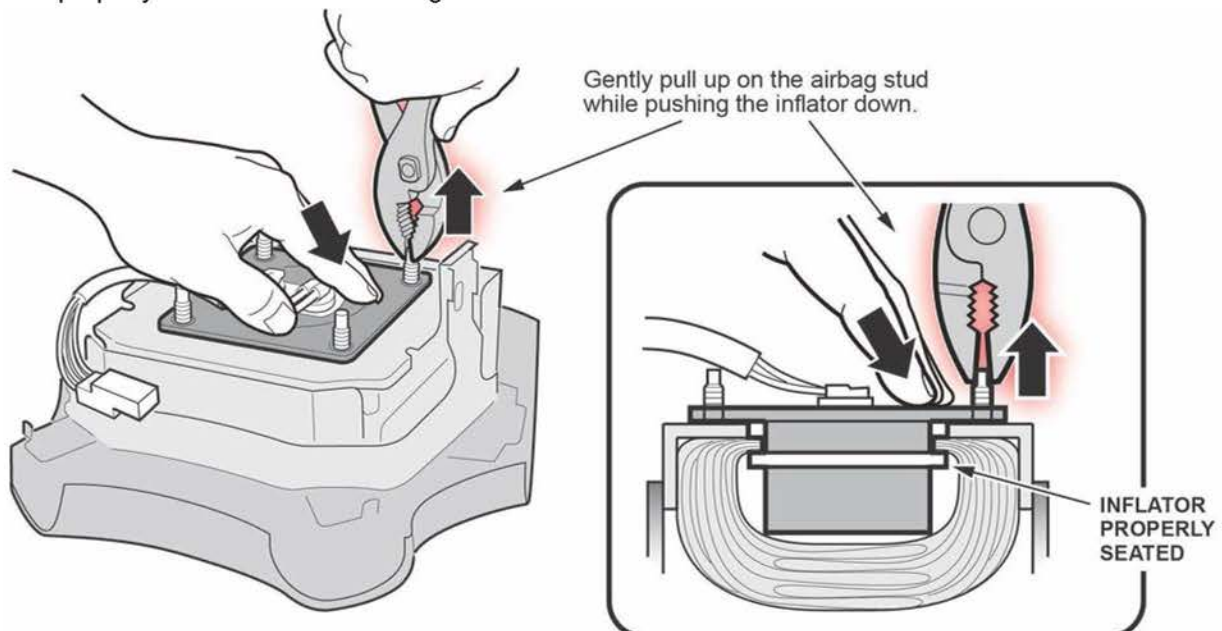
- Using a pair of pliers, gently pull up on each stud up while pushing the inflator module down until the airbag is properly seated within the airbag module.

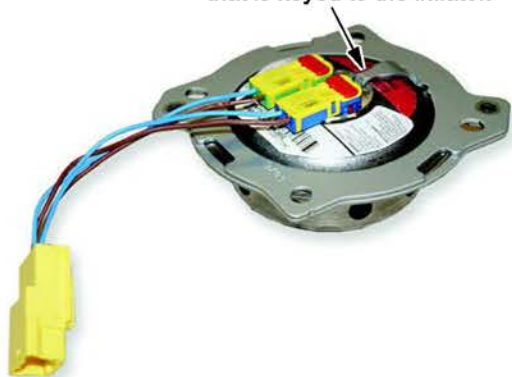
The inflator is held down by a directional retainer that is keyed to the inflator.

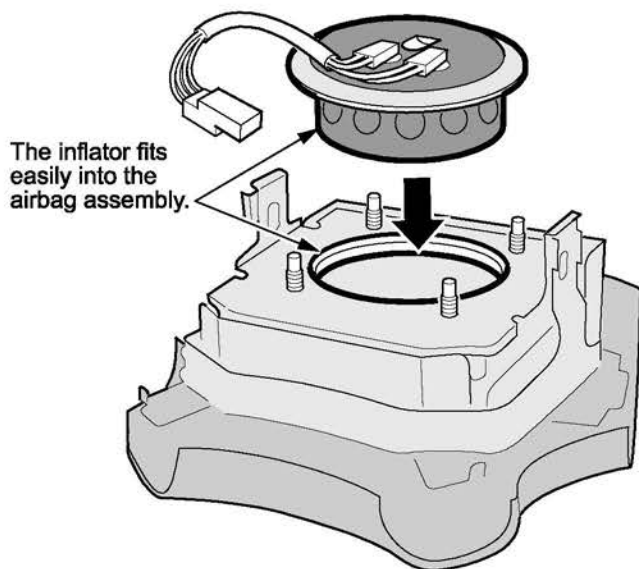
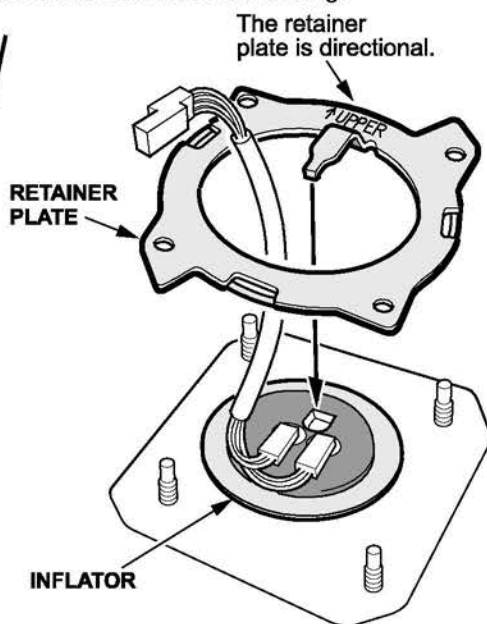
- Place the inflator into the opening with the inflator harness toward the bottom of the airbag.

- Install the bracket onto the studs. Make sure the locator tab fits into the locator hole as shown.
NOTE: Make sure the harness comes out through the center opening. Do not install the bracket over the harness wires.

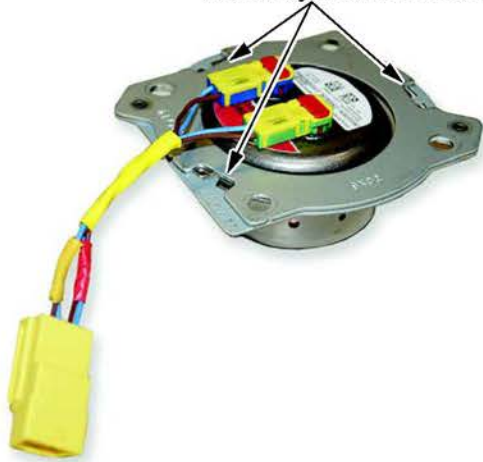
The inflator is held down by a directional retainer that is keyed to the inflator.

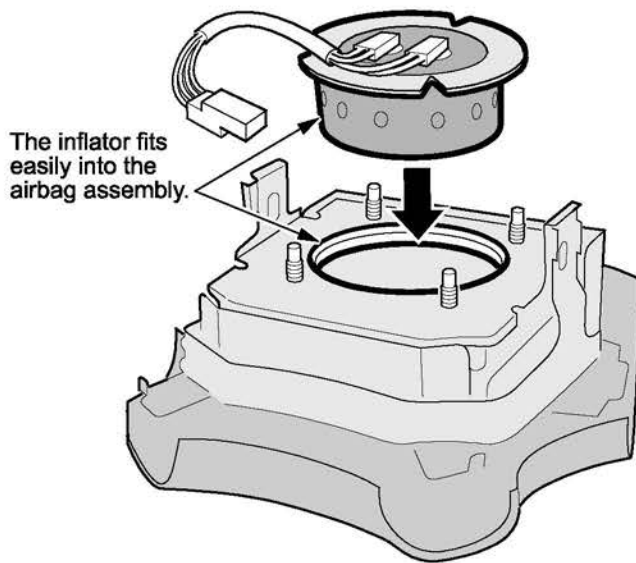
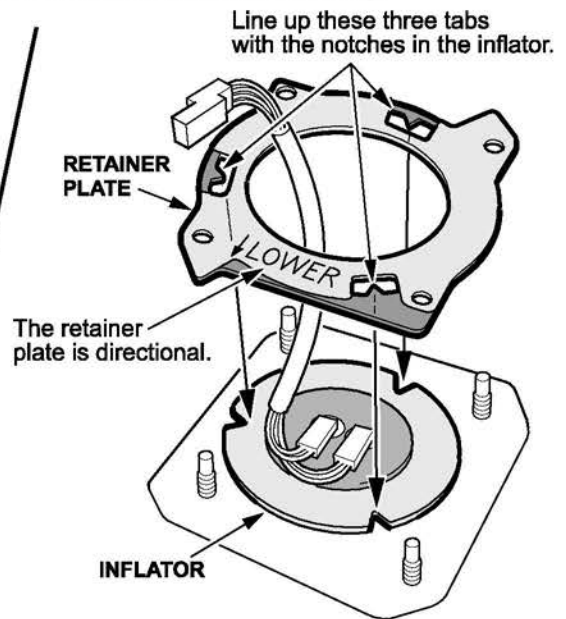
- Place the inflator into the opening with the inflator harness toward the bottom of the airbag.

- Install the bracket onto the studs with the stamp **LOWER** at the bottom of the airbag.
- Make sure the three tabs and notches are properly aligned.

- The tabs and notches are designed to align in one direction only. If the tabs and notches are not aligned, the inflator and bracket are not installed correctly.
- Make sure the harness comes out through the center opening. Do not install the bracket over the harness wires.
