TECHNICAL BULLETIN

LTB00836NAS1

Tailgate Trim Panel Detached From Tailgate

Discovery Sport (LC)

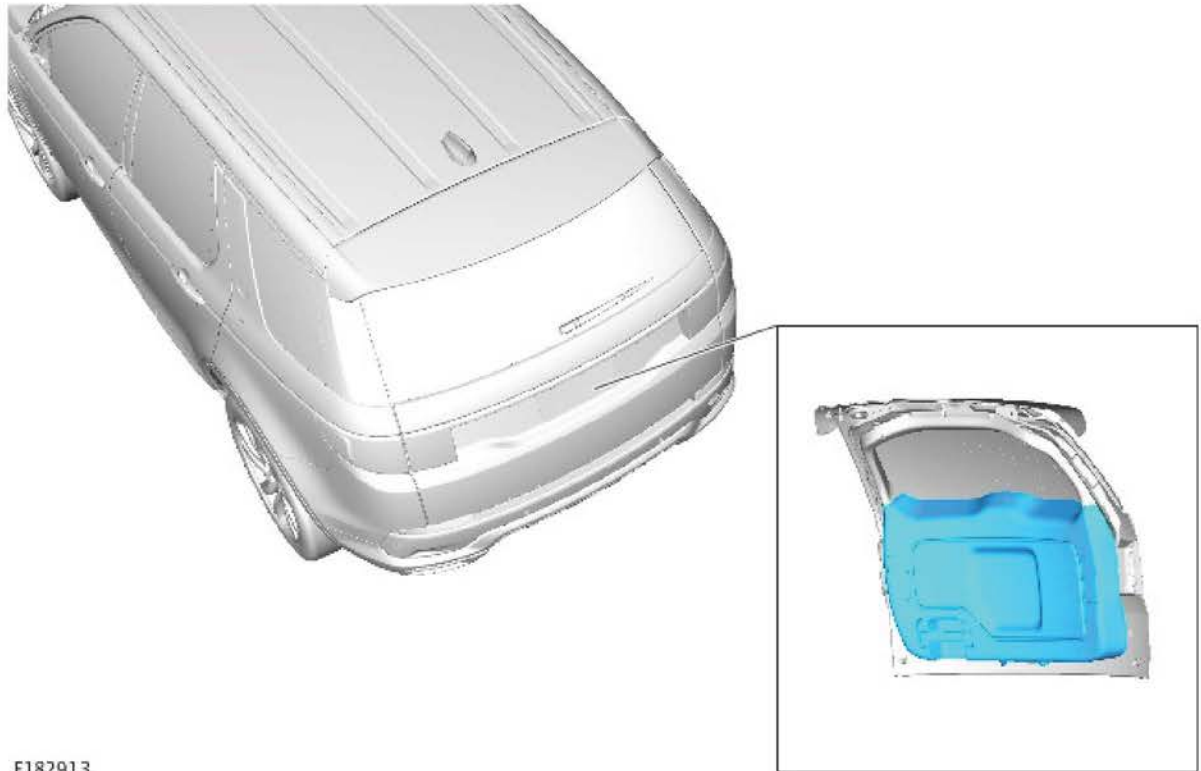
E182913

1Component location.

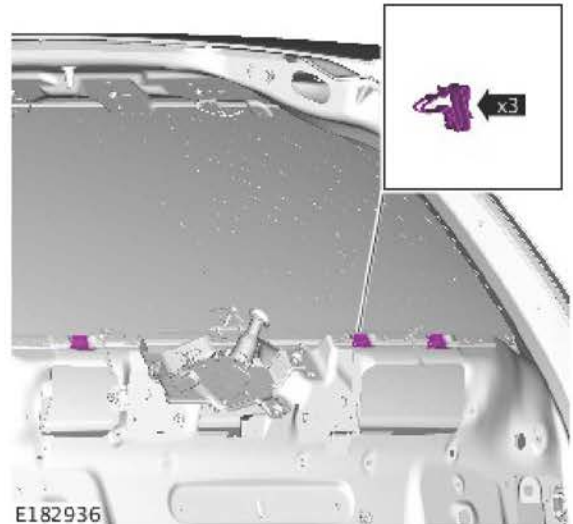
E182936

**NOTE: the three tailgate clips must be centralized and pushed fully onto the tailgate.**

Install the three new tailgate trim panel clips to the tailgate.

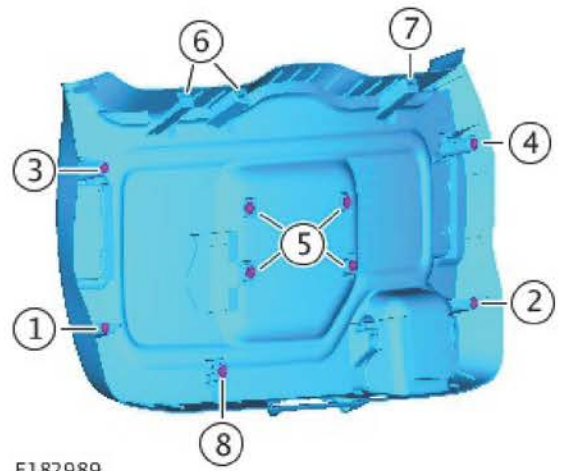
E182989

**NOTE: the tailgate trim panel clips must be installed into the tailgate in the order shown.**

Install the tailgate trim panel, (see TOPIx Workshop Manual section 501-05: Interior Trim and Ornamentation).
