**TECHNICAL BULLETIN**  
**LTB00836NAS2**  
**12 OCT 2015**

**Tailgate Trim Panel Detached From Tailgate**

**Discovery Sport (LC)**

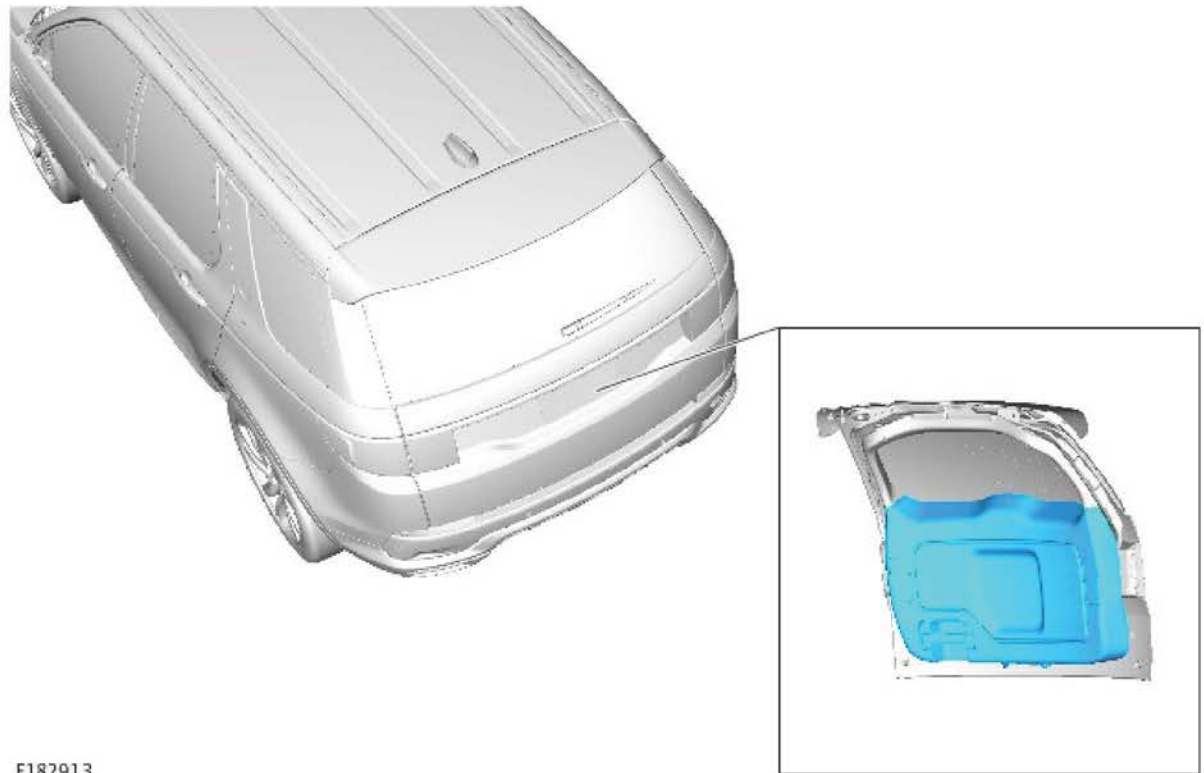
E182913

**1Component location.**
