TECHNICAL BULLETIN  
LTB00836NAS3  
21 JUN 2016

Tailgate Trim Panel Detached From Tailgate

**Discovery Sport (LC)**

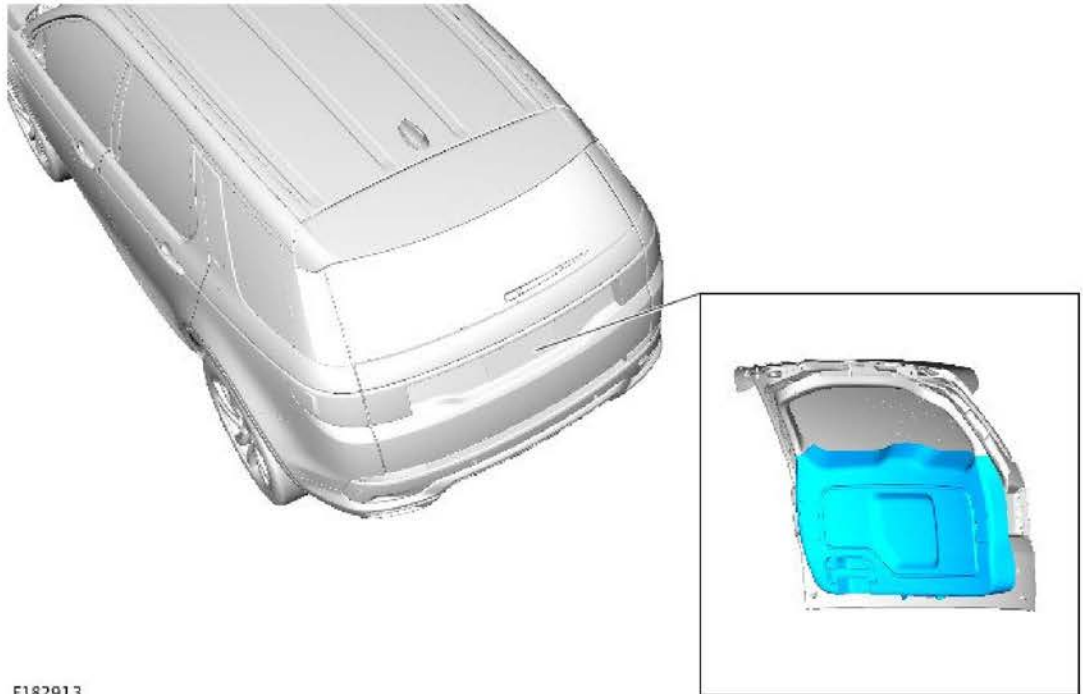
E182913

1. Component location.

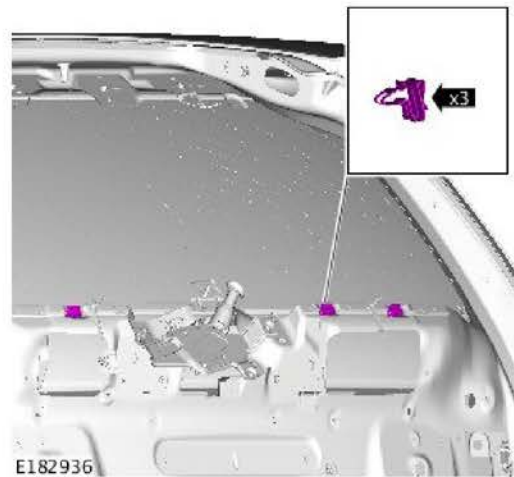
E182936

**NOTE: The three tailgate clips must be centralized and pushed fully onto the tailgate.**

Install the three new tailgate trim panel clips to the tailgate.
