September 3, 2015

02374 Version 1

## Noncompliance Recall: 2003 Odyssey Front Passenger Airbag

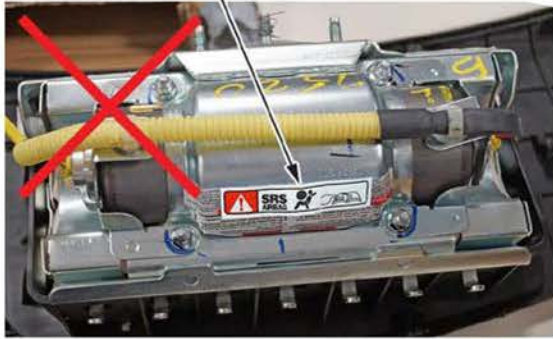
- If there is nothing unusual about the airbag or the inflator, go to step 6.
- If there are any unusual markings, like an incorrect label or a model year written in marker, the airbag and inflator may be a counterfeit part. For more information about counterfeit airbags, you can refer to [safercar.gov](http://safercar.gov), enter keywords **MANAGING COUNTERFEIT**, and select **Recommended Dealer Guidance for Managing Counterfeit Air Bags** from the list. **If you suspect that the airbag or inflator is counterfeit, do not continue this procedure.** Contact your DPSPM for assistance.

NON-STANDARD SAFETY LABEL

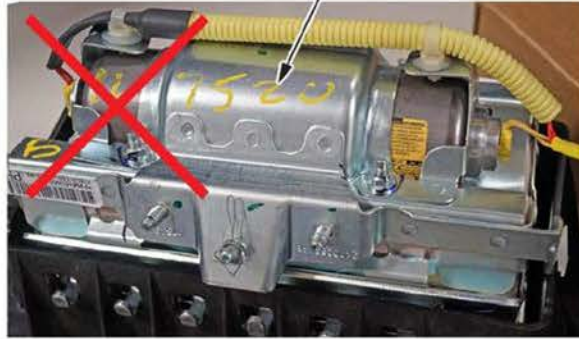
GREASE PENCIL OR PAINT MARKINGS

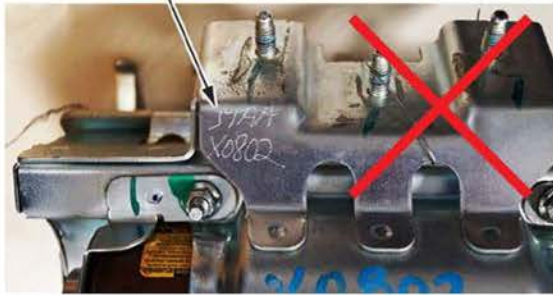
HAND ENGRAVING

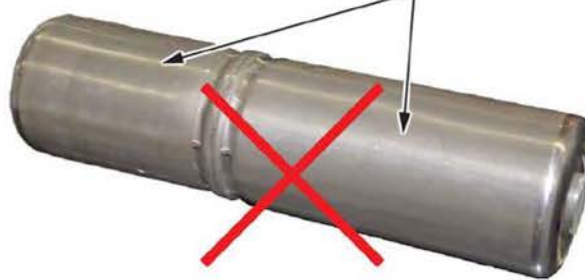
NO LABELS ON INFLATOR
