ATB 51811-01884 Version 10

Safety Recall: Front Passenger's Airbag Inflator Can Be Over-Pressurized

Supersedes 14-040, dated June 16, 2015; see Revision Summary

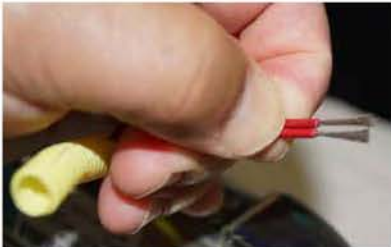
- Strip away about 1 inch of the wire insulation, then twist the wires together.

- Tape the twisted ends with electrical tape.

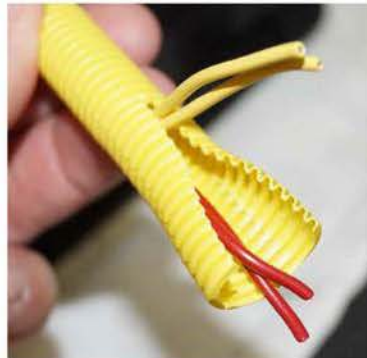
- Cut about 2 inches of the corrugated tube, then pull out the yellow wires.

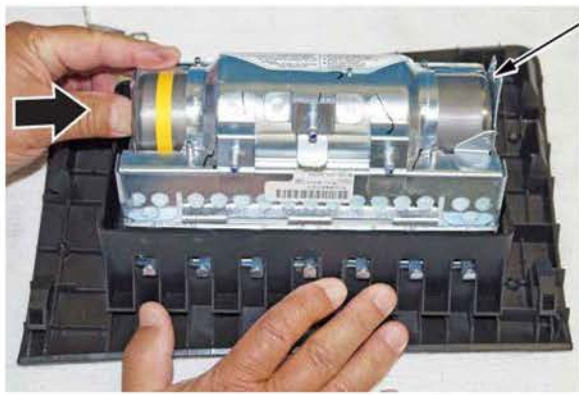
- Slide the inflator in until the “D” aligns with the tab on the inflator bracket. There should be no space or gap between the inflator and bracket.

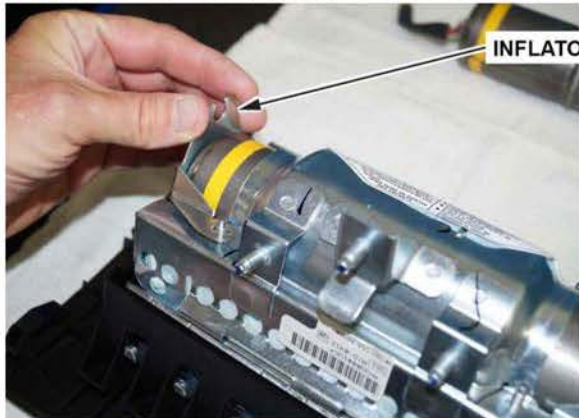
INFLATOR BRACKET

- Reinstall the inflator bracket. There should be no space or gap between the bracket and inflator.

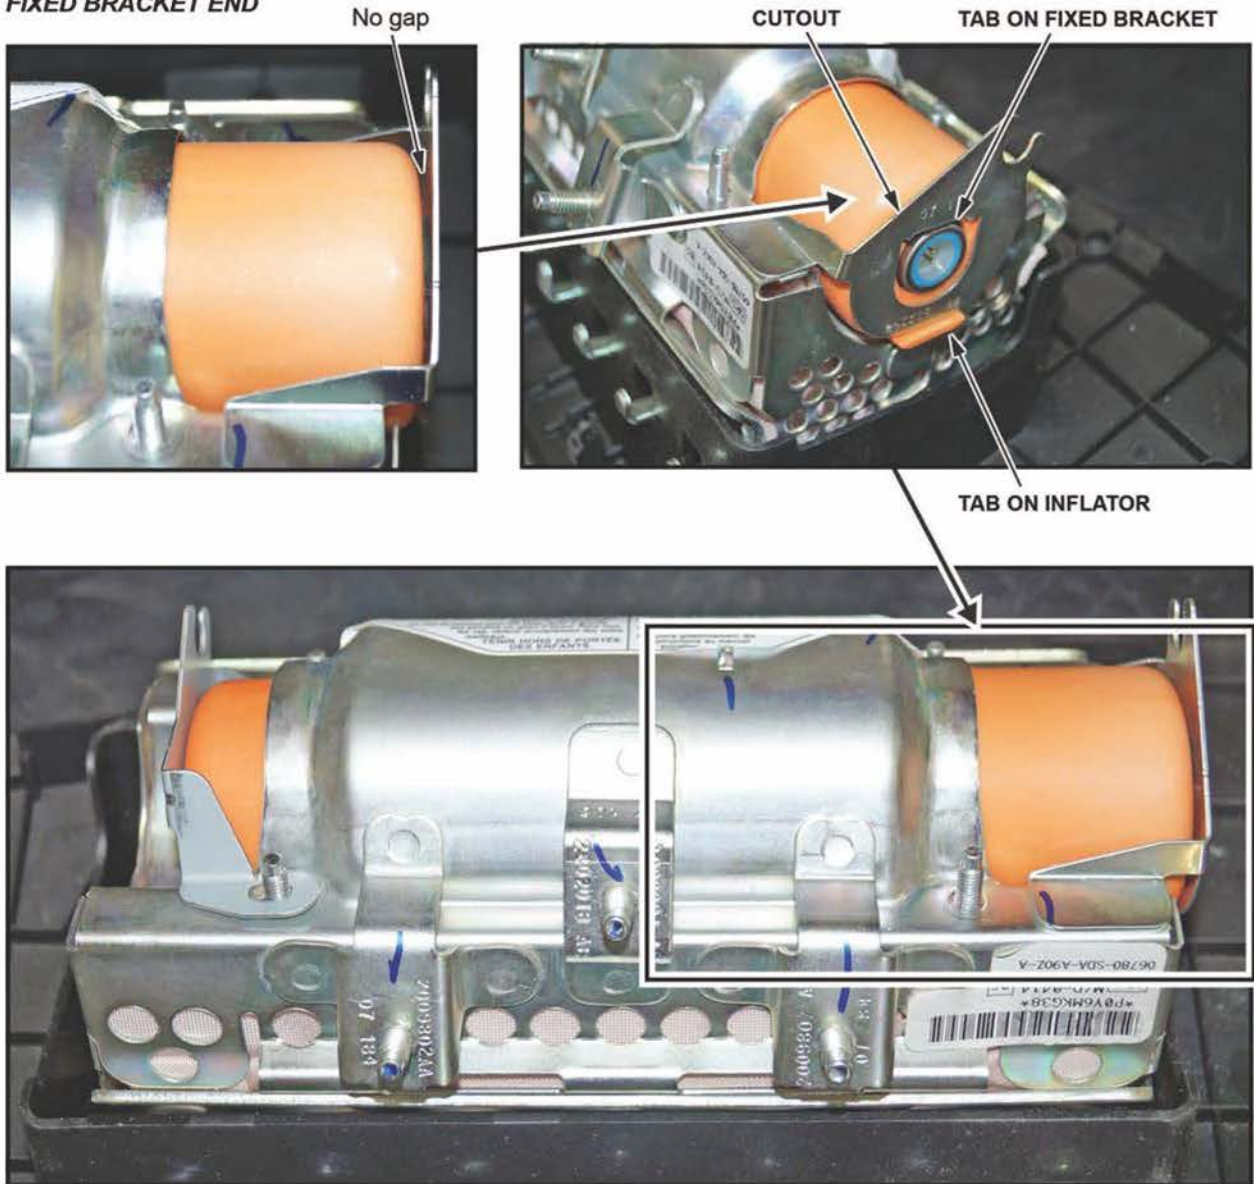
FIXED BRACKET END

- Slide the inflator in until the plastic cutout and the small flat spot align with the tab on the bracket. There should be no space or gap between the inflator and bracket.

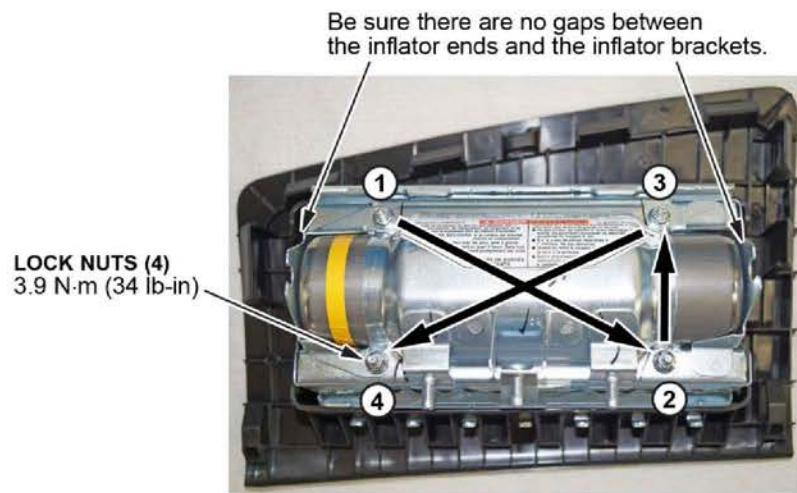
14. Install the new 5 mm locknuts and torque them in sequence to **3.9 N·m (34 lb-in)**.

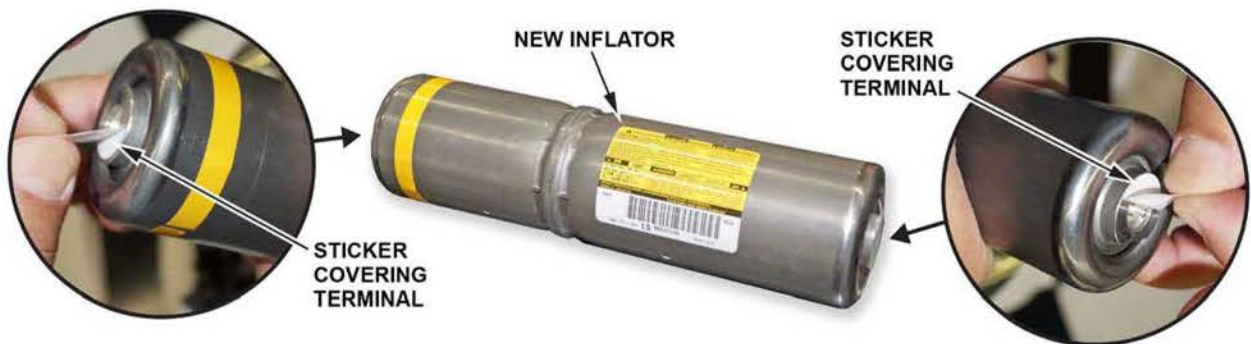
15. Remove the stickers covering the terminals on both sides of the new inflator.

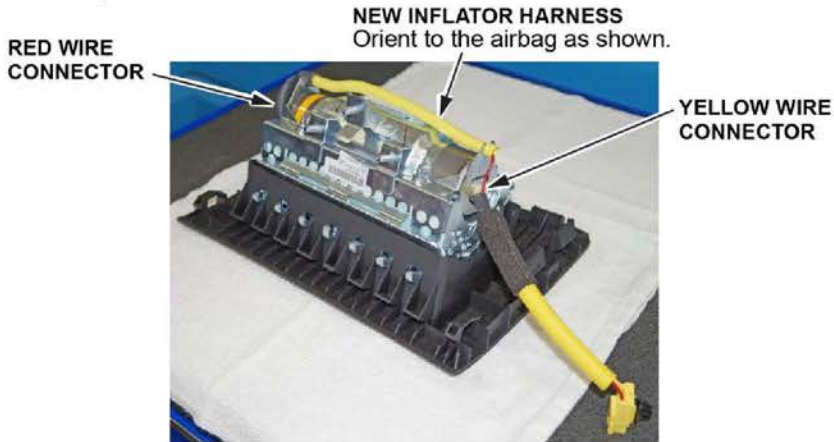
- Make sure the airbag and harness are aligned as shown.

- **Make sure you have the orientation correct as shown below.** If you connect the harness incorrectly, the harness cannot be removed, and you will not be able to reinstall the airbag because the harness will be too short.
- On the replacement inflators with plastic collars, connect the red wire connector to the connector with the red dot.
- On the replacement inflators without plastic collars, connect the red wire connector to the connector nearest the yellow band.

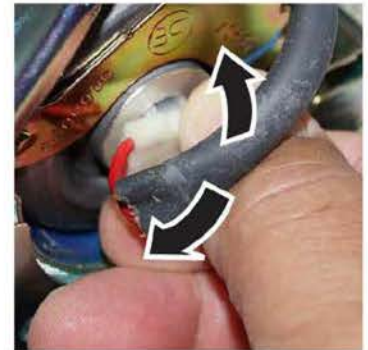
③ Wiggle the connector to make sure it's secure.

- After you hear each connector click, wiggle it to make sure it is secure.
NOTE: If the connector is not properly aligned, it will come out.
