00407-01886 Version 6

Safety Recall: Front Passenger's Airbag Inflator May Produce Excessive Pressure After Long-Term Exposure To High Absolute Humidity

Supersedes 14-070, dated June 16, 2015; see Revision Summary

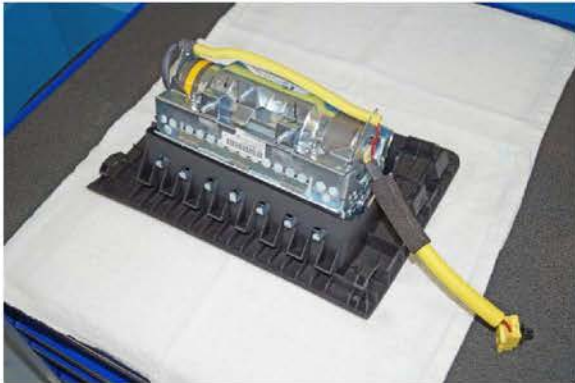
NOTE:

- The orientation of the airbag is critical because if the inflator is installed incorrectly, the harness will be too short when you reinstall the airbag.
- The brackets between the various models are similar but may differ from the example shown.

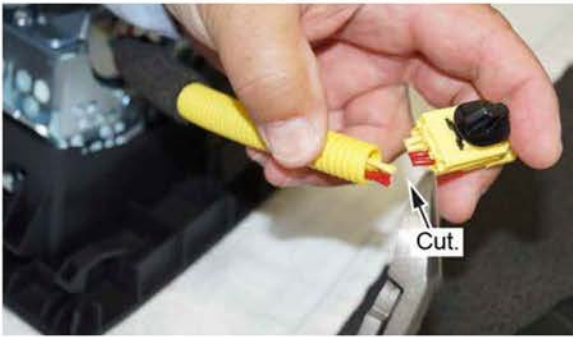
9. Cut off the connector and short the yellow wires.

You must cut and short the wires as indicated to prevent accidental deployment.

- Cut all four wires to remove the connector.

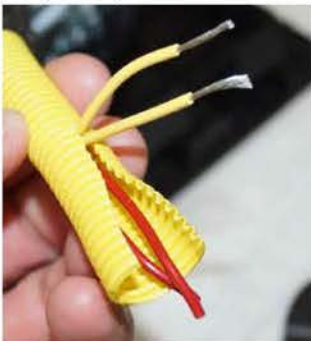
- Strip away about an inch of the wire insulation, then twist the wire ends together.

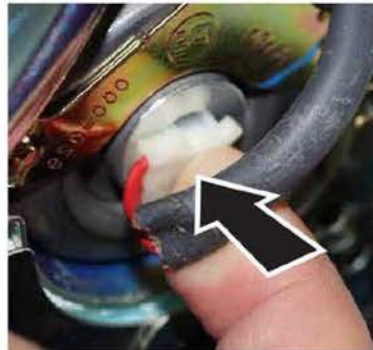
- ② Press the connector into place until it clicks.

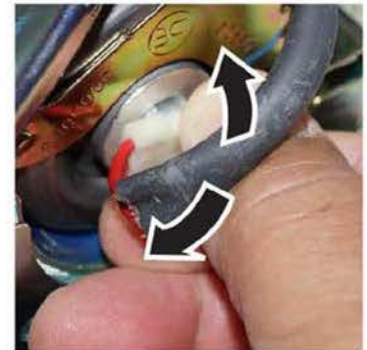
- ③ Wiggle the connector to make sure it's secure.

- After you hear each connector click, wiggle it to make sure it is secure.

NOTE: If the connector is not properly aligned, it will come out.
