06121 Version 3

Slapping or Clicking From Engine Area at Idle

Supersedes 14-030, dated June 18, 2014, to revise the information highlighted in **yellow**.

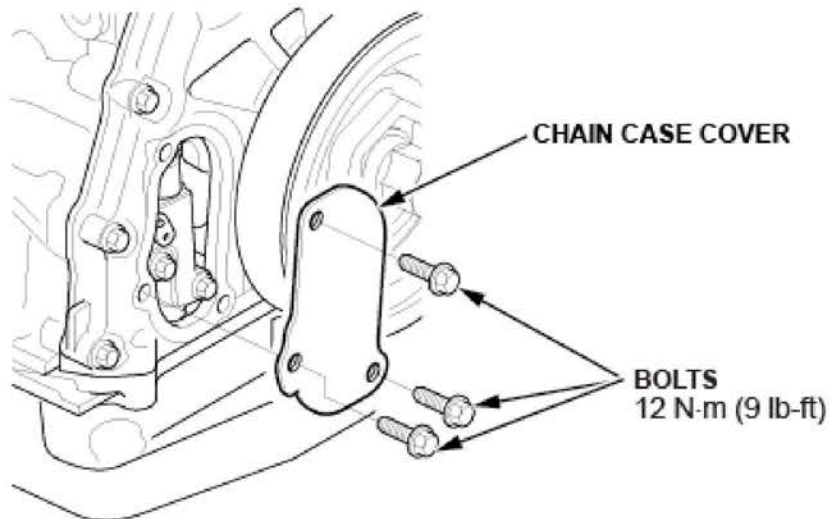
1. Remove the right front wheel.
2. Remove the engine undercover.
3. Remove the chain case cover.

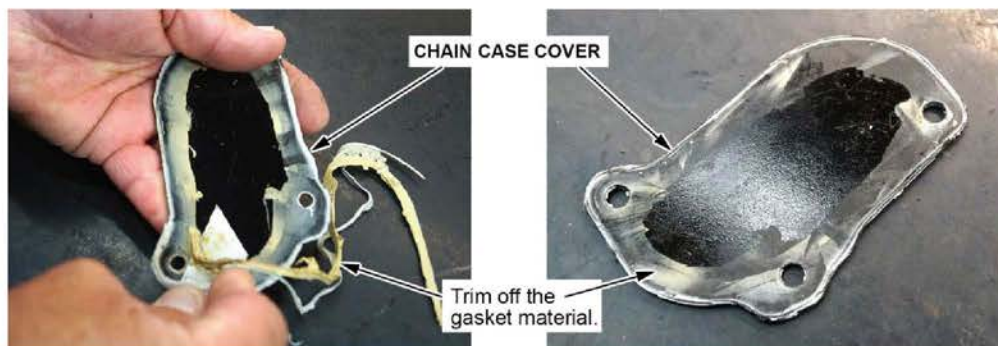
4. Clean the chain case cover and the chain case.

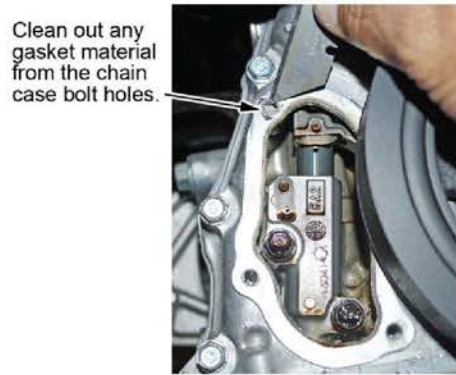
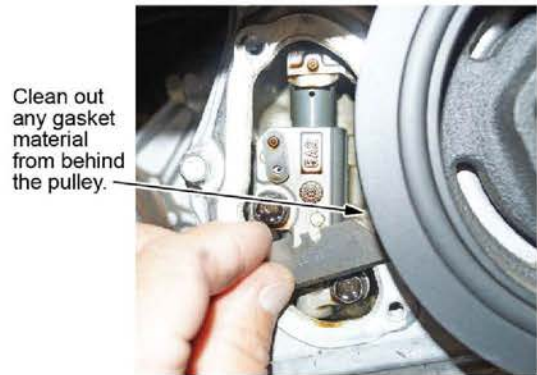
- Turn the crankshaft counterclockwise until the cam chain auto-tensioner is compressed.

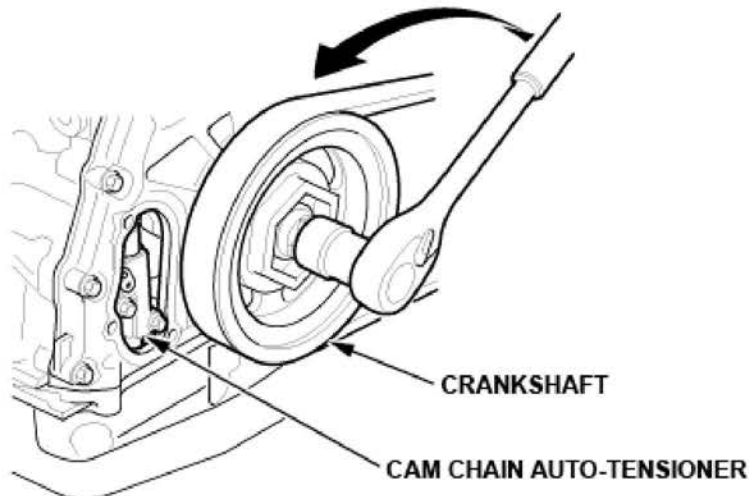
- Remove the cam chain auto-tensioner.

NOTE: Use a 1.2 mm diameter pin, a large paper clip, or similar item to hold the auto-tensioner arm in a locked position for removal.

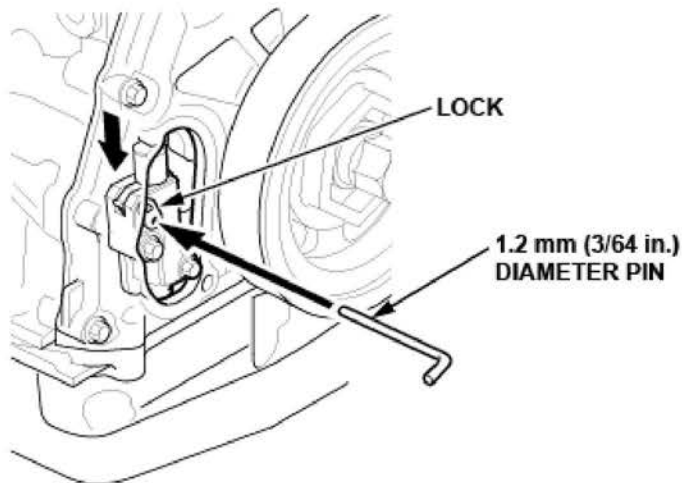
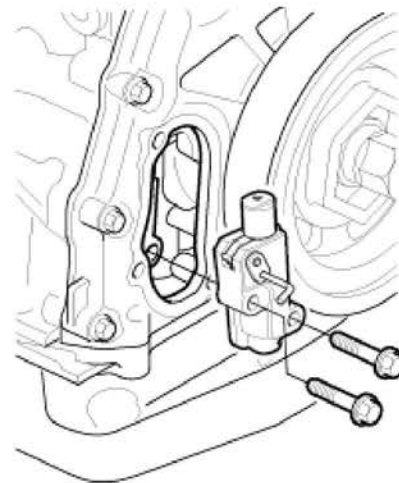
- Remove the oil filter.
- Place a shop towel over the place on the engine block where the cam chain auto-tensioner mounts.
- Using shop air, place the air nozzle into the oil filter mounting adapter.

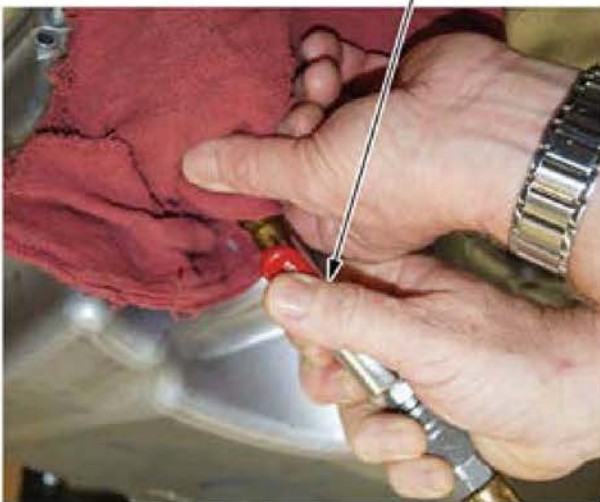
10. Blow compressed air for 5 seconds through the oil passage to clear any debris before installing the new cam chain auto-tensioner.

Blow air for 5 seconds.

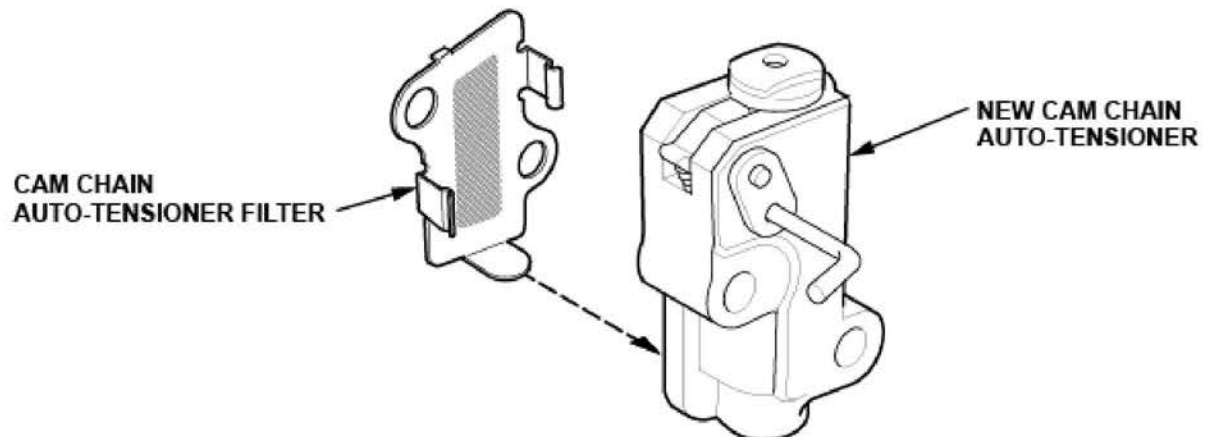
11. Install new a oil filter.
12. Install the cam chain auto-tensioner filter onto the new cam chain auto-tensioner.

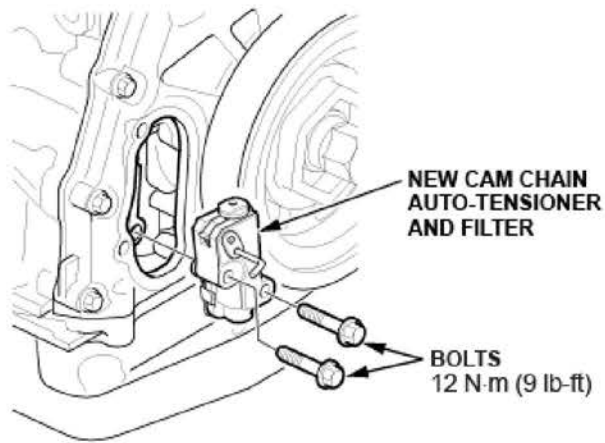
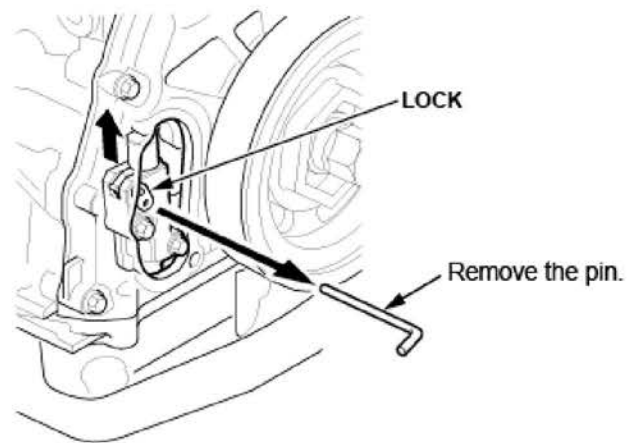
13. Install the new cam chain auto-tensioner with filter, and torque the bolts to **12 N·m (9 lb-ft)**.

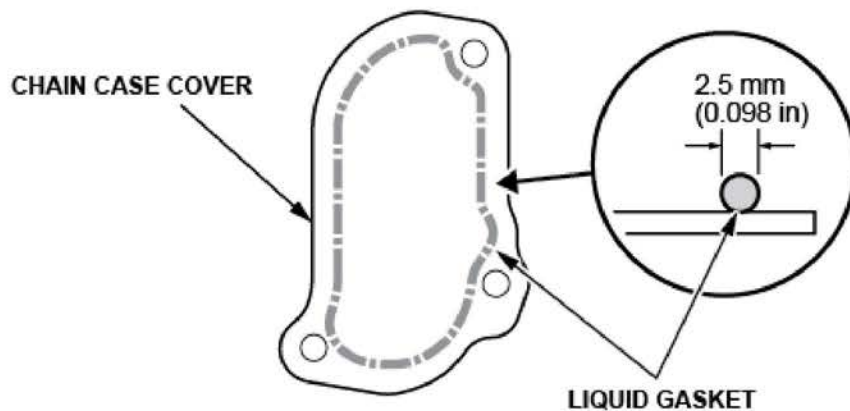
14. Apply a 2.5 mm diameter bead of hondabond 4 along the broken line.
