Subject: **Diagnostic Tip for Misfire, Malfunction Indicator Lamp (MIL) Illuminated - DTCs P0300, P0301, P0302, P0303, P0304, P0305, P0306, P0307 and/or P0308**

Brand:	Model:	Model Year:		VIN:		Engine:	Transmission:
		from	to	from	to		
Chevrolet	Silverado	2017	2018			L5D, L5P	
	Silverado 2500/3500	2019	2020				
	Silverado 4500HD, 5500HD and 6500HD	2019	2019				
GMC	Sierra	2017	2018				
	Sierra 2500/3500	2019	2020

Version	1
Modified	Released October 14, 2019

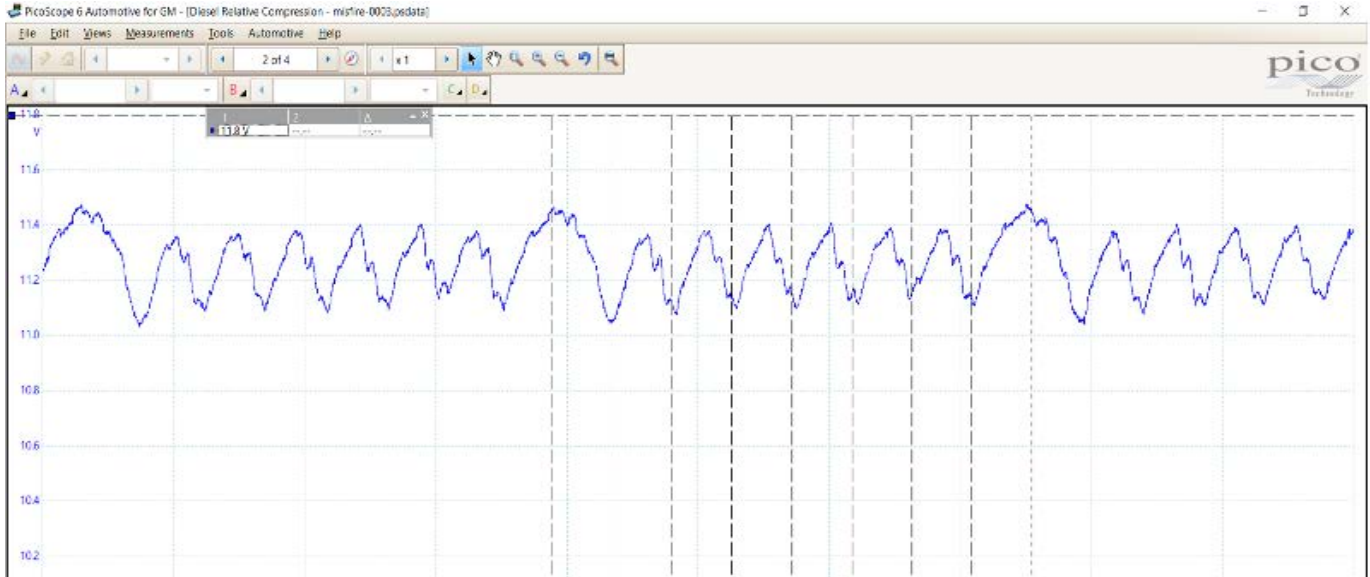
5420017

The graphic above depicts an example of an eight-cylinder engine with a cylinder that has no compression in one cylinder.

Note that one of the dips is missing and it repeats every eight dips.

– This is a clear indication that there is an issue with this engine.

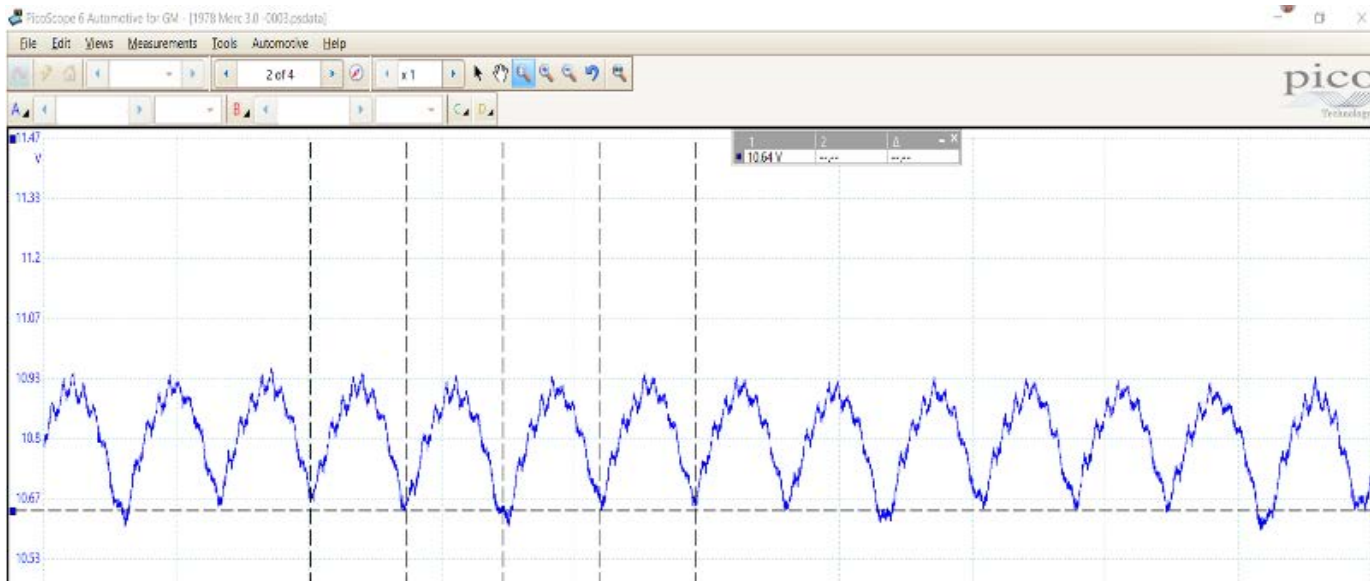
5420027

The graphic above depicts an example of a four-cylinder engine with a bad exhaust cam lobe.

Note that consistently there is one cylinder with an extra-long compression stroke.

– Examination of this engine showed that cylinder number four had a worn down cam lobe.

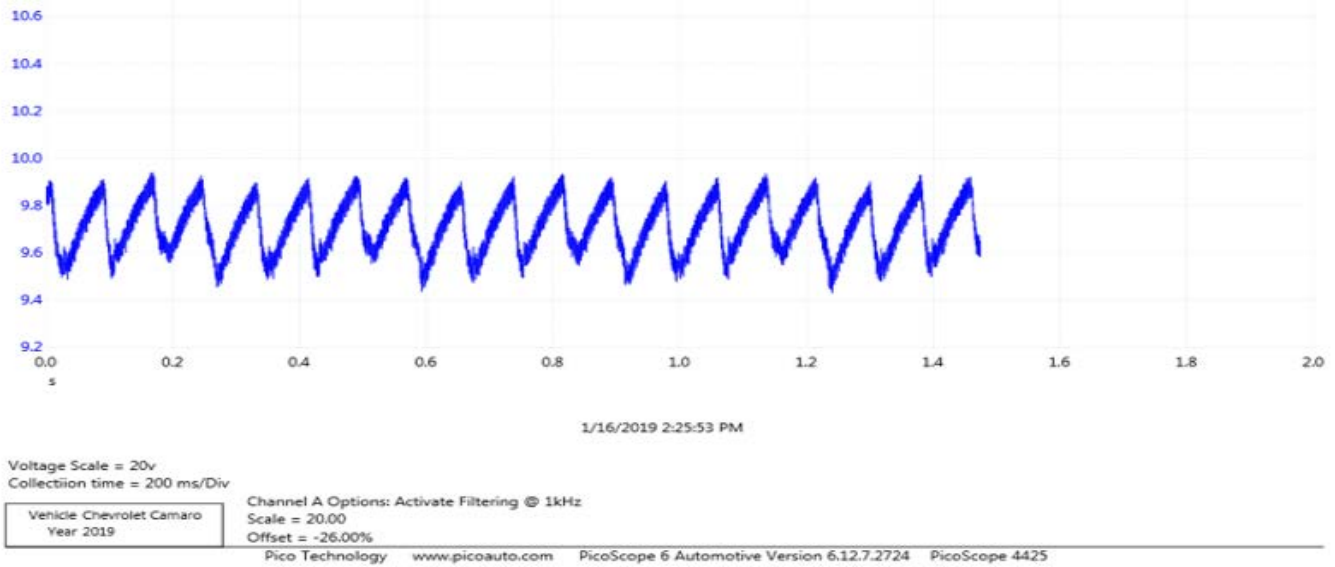
5420028

This is a four-cylinder engine with a 20 PSI loss in one cylinder

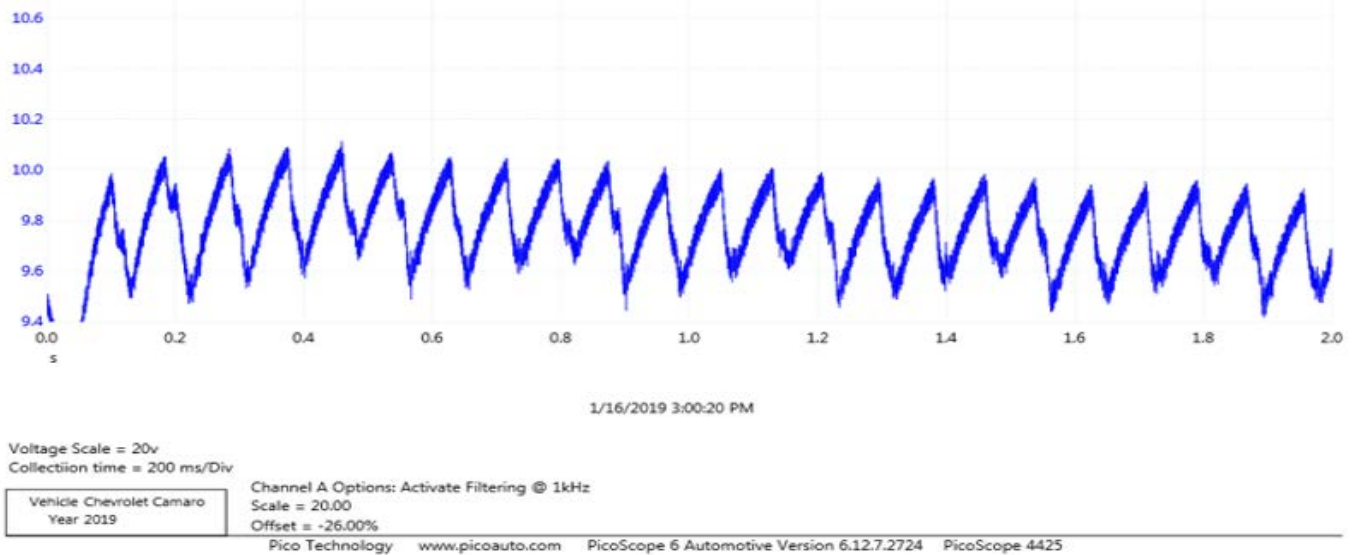
5420040

This is a four-cylinder engine with a 60 PSI loss in one cylinder.

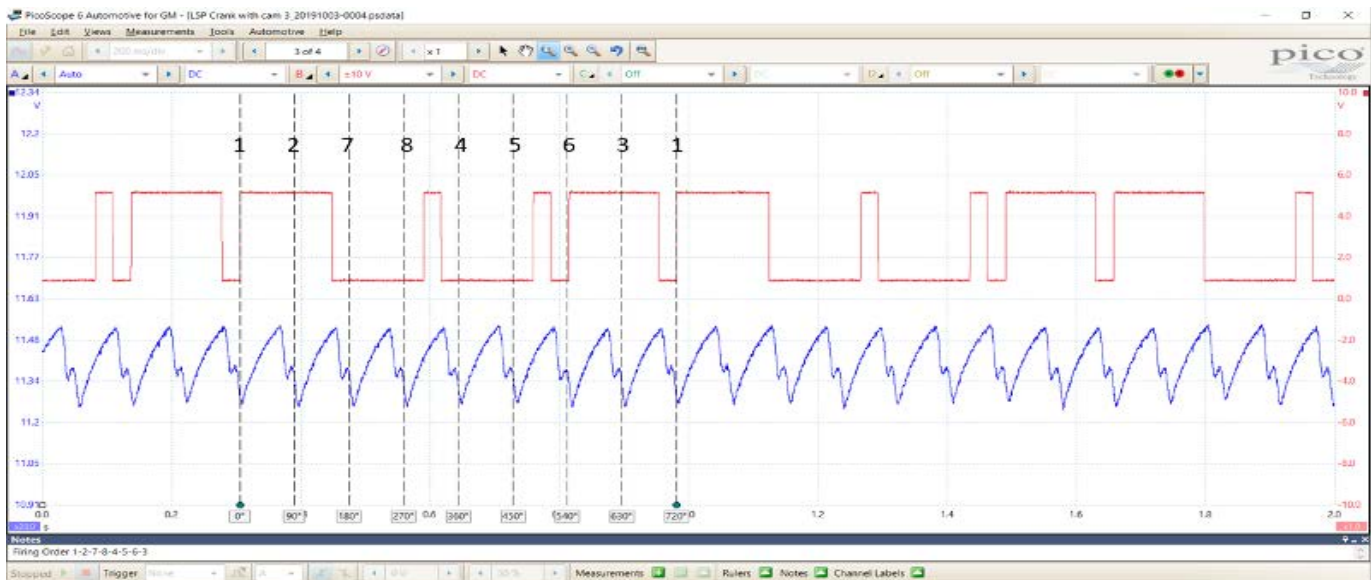
5420524

If an engine has low or high compression on one cylinder, it may be useful to add an injector pulse or a Camshaft Position Sensor to help determine which cylinder has an issue.
