Field campaign

Topic	Side glass measurement check and software update for the rear door control modules - 00BB and 00BC (SC23/23)
Market area	Australia E04 Bentley rest Asia and Australia (6E04),China 796 VW Import Comp. Ltd (Vico), Beijing (6796),Germany E02 Bentley rest Europe (6E02),Japan E03 Bentley Japan (6E03),United Arab Emirates E06 Bentley Middle East and Africa (6E06),United Kingdom E01 Bentley UK (6E01),United States E05 Bentley USA and rest America (6E05)
Brand	Bentley
Transaction No.	2071249/1
Campaign number	EC88
Note	
Type	
US code

New Continental GTC

New Continental GT

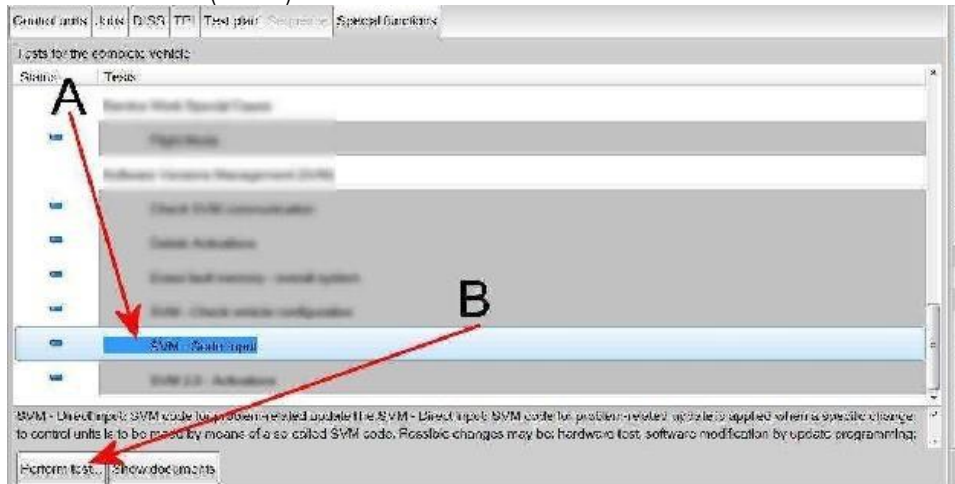
2) Referring to Figure 1 - Within the Special functions tab - Select SVM - Code Input (Point A)

• Select Perform test (Point B)

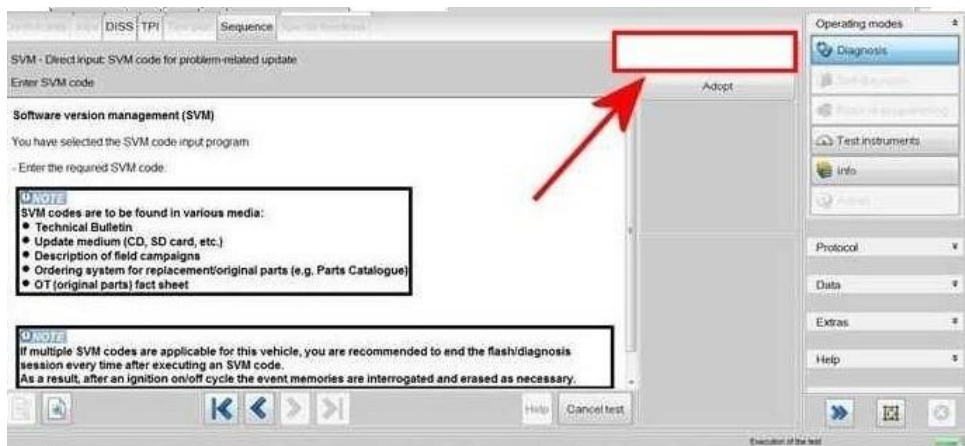
3) Referring to Figure 2 - Enter SVM code **370FTM01**

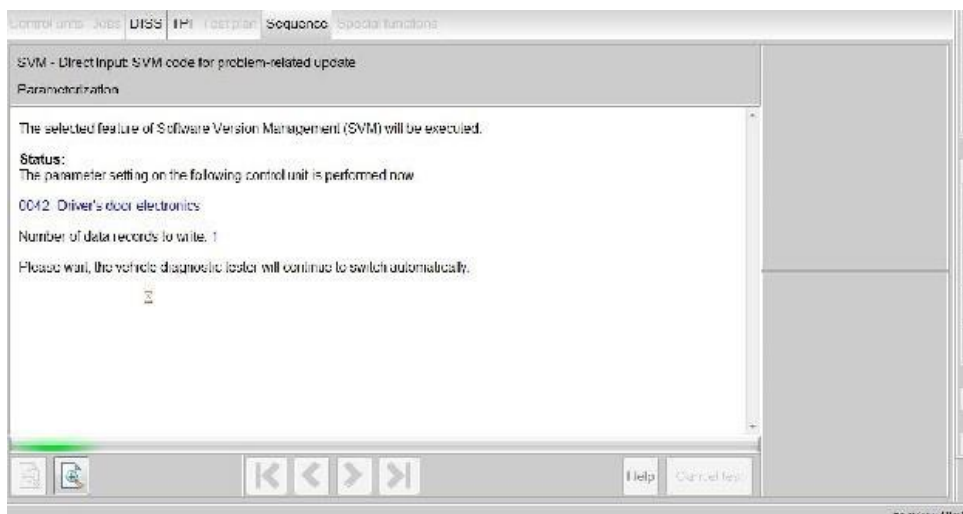
Figure 3

4) The required control modules will be automatically updated one by one, starting with 0042 - Door electronics Drivers side (Figure 3)

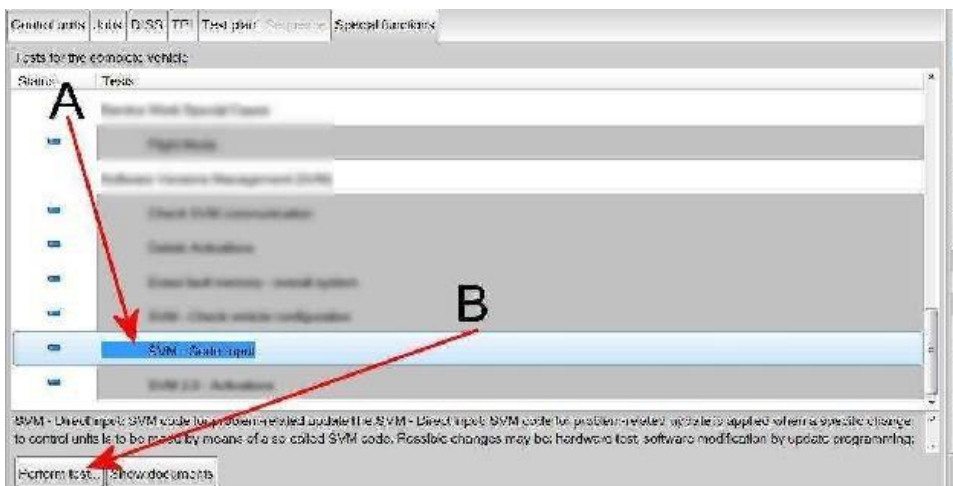
7) Referring to Figure 4 - Within the Special functions tab - Select SVM - Code Input (Point A)

• Select Perform test (Point B)

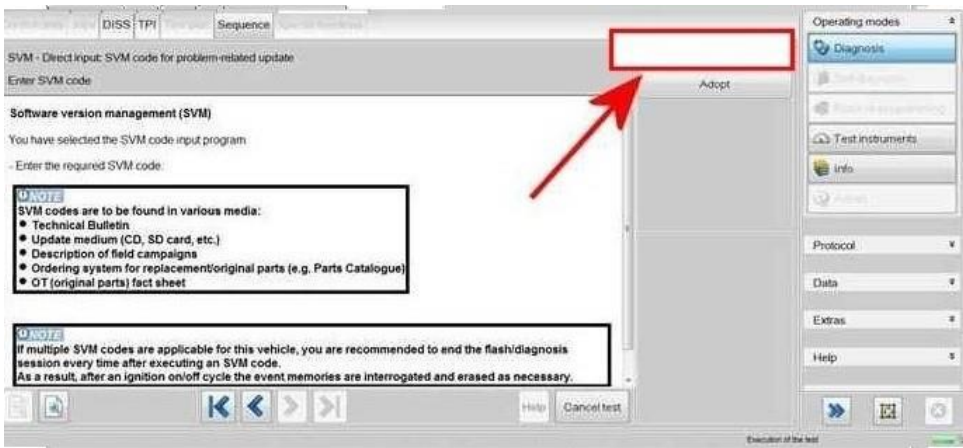
8) Referring to Figure 5 - Enter the SVM code **370WAD01**
