Preliminary Information

## PIT6142 No Cluster Graphics In Progressive Theme At Times

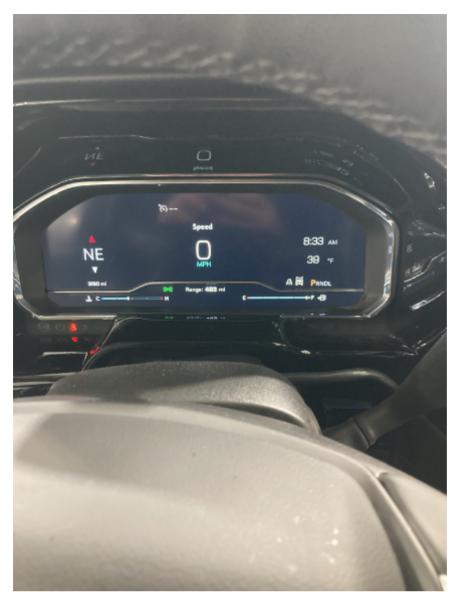
Involved Region or Country	North America
Additional Options (RPO)	UDV
Condition	A customer may comment that there are no graphics displayed in the Cluster (IPC) at times after starting vehicle while viewing the Progressive Theme. Customer may indicate they can shut the vehicle off and restart or change to a different theme and graphics will return.
Cause	The cause of the condition may be software anomalies that Engineering is aware of.

Example Picture of Cluster with no graphics:

Currently GM Engineering is working on a repair. When a repair becomes available this PI will be updated.
