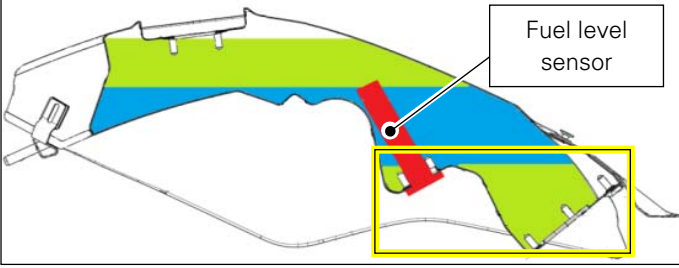
no.	Symptom	Subject	Photo	Trouble Code (Diagnostic Trouble Code)	Part no.	Notes/Indications/Corrective action
5	<p><u>Only in case of motorcycle just delivered by DMH</u></p> <p>Upon first battery connection, few fuel level marks are displayed on the instrument panel with empty tank</p>	Display of fuel level

<p>It is not necessary to replace the fuel level sensor.</p> <p>There is no error in the control unit</p>		<p>This possible mismatch is due to the fuel level management strategy <u>when the fuel is drawn from the tank</u> (at the end of the production line or during a Service operation).</p> <p>The fuel level sensor detects the level in the central part of the tank (blue area); in the upper and lower part of the tank (green areas) the fuel level is therefore calculated by the software. When fuel is drawn, the software could not recognise the level decrease and continue to display on the instrument panel a fuel quantity that is not actually inside the tank.</p>

<p>A new BBS software with relevant update for the DDS 2.0 diagnosis instrument will be made available to introduce a function that allows to reset the fuel level indication displayed on the instrument panel.</p> <p>To have a fuel level indication displayed on the instrument panel actually corresponding to the quantity of fuel inside the tank it is <u>necessary to fill in the tank with at least 8 litres of fuel</u> so that the fuel level sensor starts reading the correct level. Turn the motorcycle's key to ON and if the fuel level indication does not change, add some fuel in the tank; in fact, it could happen that the previously poured fuel quantity is not enough to allow a correct fuel level reading by the relevant sensor.</p>

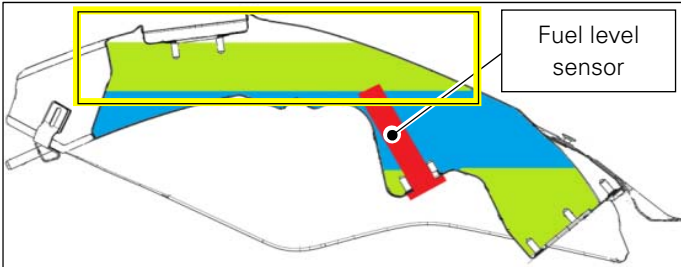
no.	Symptom	Subject	Photo	Trouble Code (Diagnostic Trouble Code)	Part no.	Notes/Indications/Corrective action
6	With fuel tank almost full, due to continuous fuel top ups, the fuel level displayed on the instrument panel continues to decrease	Display of fuel level

<p>It is not necessary to replace the fuel level sensor.</p> <p>There is no error in the control unit</p>		<p>This possible mismatch is due to the fuel level management strategy <u>in case the tank is continuously topped up with fuel (after a consumption lower than 5 litres) starting from a completely full tank condition.</u></p> <p>In this condition, the real level of the fuel stays always in the top side of the tank (top green area) and is not read by the fuel level sensor. The fuel level displayed on the instrument panel is calculated with a software strategy; in the unlikely case that the top up happens in a frequent way, the fuel reserve could also be displayed.</p>

<p>A new BBS software with relevant update for the DDS 2.0 diagnosis instrument will be made available to introduce a function that allows to reset the fuel level indication displayed on the instrument panel.</p> <p>Meanwhile, to match the fuel level indicator shown on the instrument panel with the fuel quantity inside the tank it is <u>necessary, starting from a completely full tank condition, to use at least 6.5 litres of fuel</u> so that the fuel level sensor starts reading the correct level; as soon as the level sensor will restart the reading, the indication of the fuel level displayed on the instrument panel will be instantly updated.</p>
