Summary of CM2350 Loose Bracket Issue

August 28th, 2015

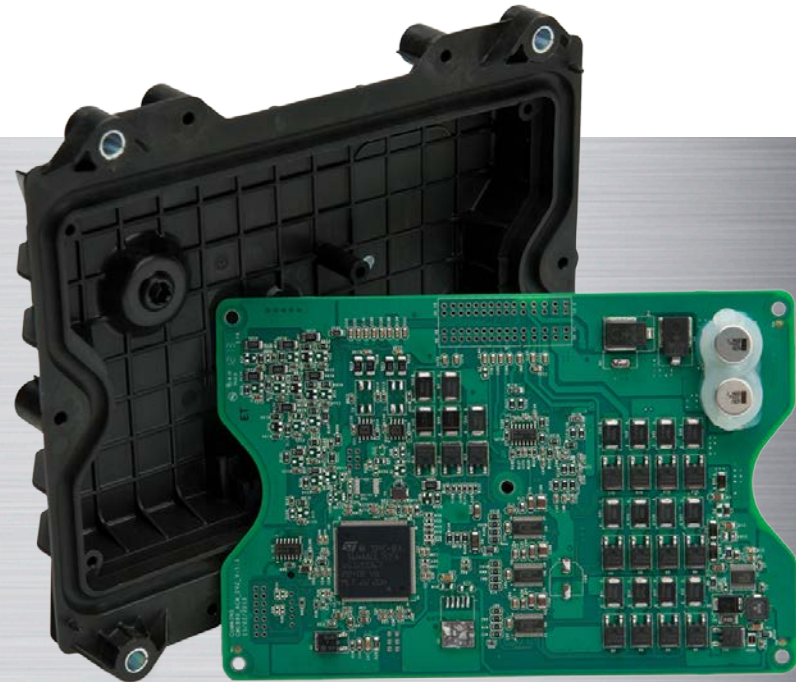
- 8 CM2350A modules with Vboost short to ground.:
 - 3 Plant returns at programming station with communication error.
 - 3 Plant returns due Engine Test Station fault codes related to ECM.
 - 2 OEM returns, failure mode is ECM blowing 30A fuse.
- These 8 ECM's are showing a short to ground damage around the area of any of 3 specific screw locations, the concentration diagram is shown below.
- The ECM's are manufactured in two final assembly lines (A and B), all 8 confirmed failures were manufactured through Screw Cell of line A.
- A screw feed error from line A caused a screw contact to the PCB during the screw insertion, which result in ECM with the Vboost short to ground failure.

- Loose bracket of Screw Cell line A was fixed by tightening the screws on the bracket and adding Loctite to the screws (Completed on 7/22/2015).
- The screw/process retry option was removed from the screw cells from operators (Completed on 7/24/2015).
