<b>GROUP</b> <b>Engine</b>	<b>MODEL</b> <b>2017MY</b> <b>Forte (YDm)</b>
	<b>NUMBER</b> <b>PS461 Rev 1, (9/13/2016)</b>	<b>DATE</b> <b>August 2016</b>

**SUBJECT:** DTC P0014 – EXHAUST CAMSHAFT POSITION TIMING OVER-ADVANCED OR SYSTEM PERFORMANCE

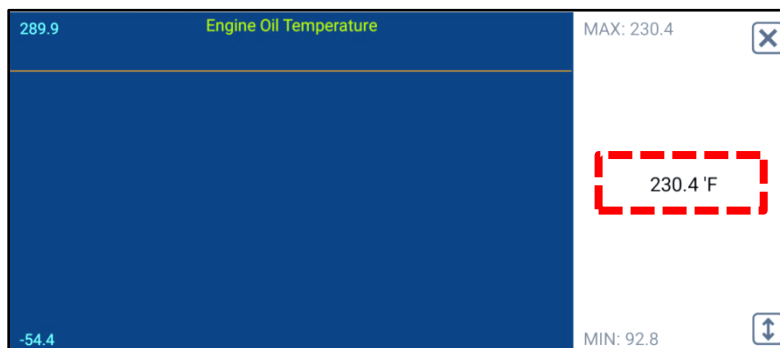
7. With the vehicle in park, slowly rev the engine from idle to 4000 RPM and back to idle in about 10 seconds. During this process, compare the current (A) and control (B) angles of the exhaust camshaft to ensure that the difference is less than 5 degrees.
