DENSO Driving Assist & Safety Eng. Div.3
Driving Assist & Safety Quality Assurance Div.

To HONDA NORTH AMERICA, INC.
Market Quality Department.

Title Filed claim investigation result for Airbag sensor (G2)

Part Name : SENSOR ASSY, SATELLITE SAFING (rep)
Part Number : 77975T6A J110M2 (rep)

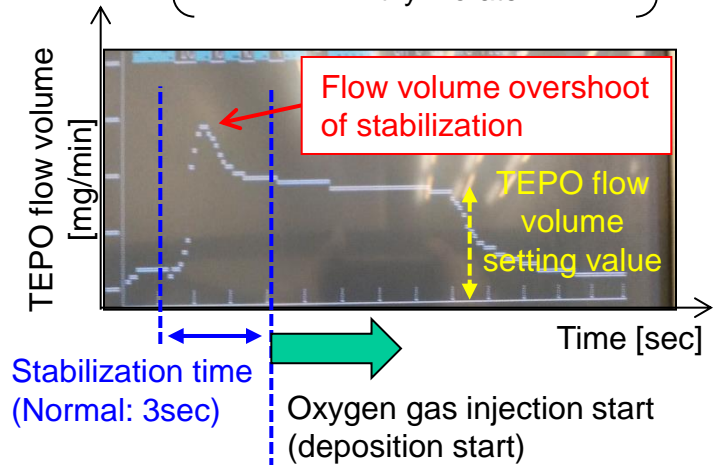
BPTEOS deposition device overview

* Machine below: FF09 (A, B, C, D) and FF10 (A, B, C, D)

Supply P by TEPO.

Confirmed that the process change of TEPO flow setting was happened. → Next page
