TECH TALK

Volume 216 - February, 2015

Vehicle Technical Info

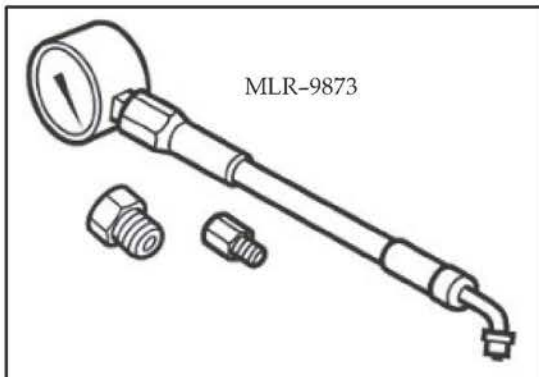
SPECIAL TOOLS SUPERSESSON:
MD998330-01 — 2008 & later Lancer, Outlander (w/CVT), 2009 & later Lancer Sportback, 2011 & later Outlander Sport. Transmission pressure gauge MD998330-01 is superseded to MLR9873. The new gauge is capable of higher pressure (2000 psi) making it usable in most transmission applications. If you do not have this tool, place an order for it through the Mitsubishi Service Solutions Website (www.mitsubishidealersolutions.com).

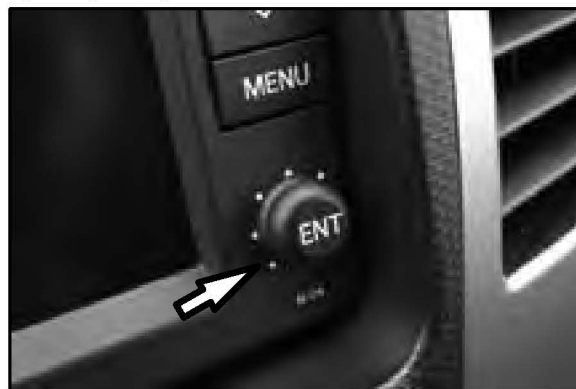
✓ “ENT” BUTTON AVAILABLE FOR MMCS NAVIGATION UNIT — 2007–13 Outlander, 2008–13 Lancer based vehicles, 2011–13 Outlander Sport. The enter button (ENT) for affected vehicles equipped with “NAVI” is available as a spare part (p/n 892L45510).
