CAMPAIGN BULLETIN

Body Seal Retailer Inventory

Reference: PG7B3

PG7B3 - 2017 Q30/QX30 (H15) BODY SEAL REPAIR

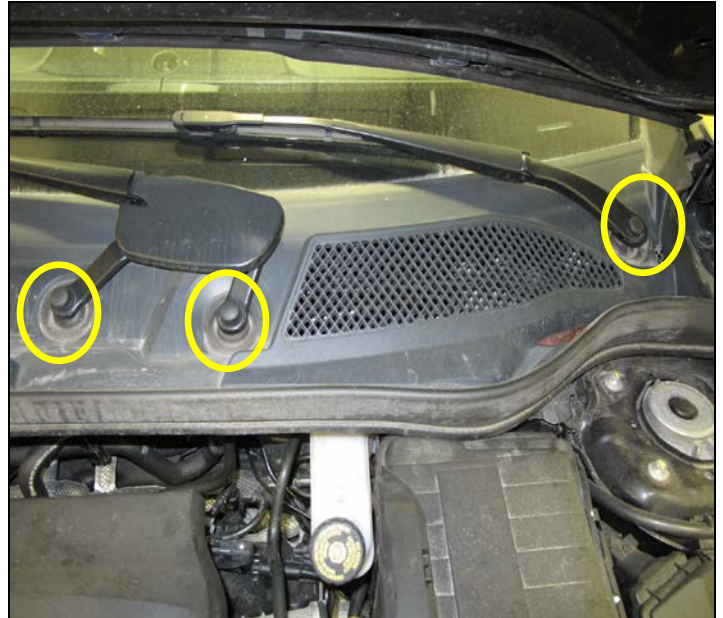
Figure 1

1. Verify the VIN of the affected.
2. Clean windshield glass and wiper blades to avoid windshield damage.
3. Switch ignition on and cycle wipers so they set to the auto stop position.
4. Open the hood and remove the three plastic caps covering the 16MM nuts holding on the windshield wiper arms. (Figure 1).

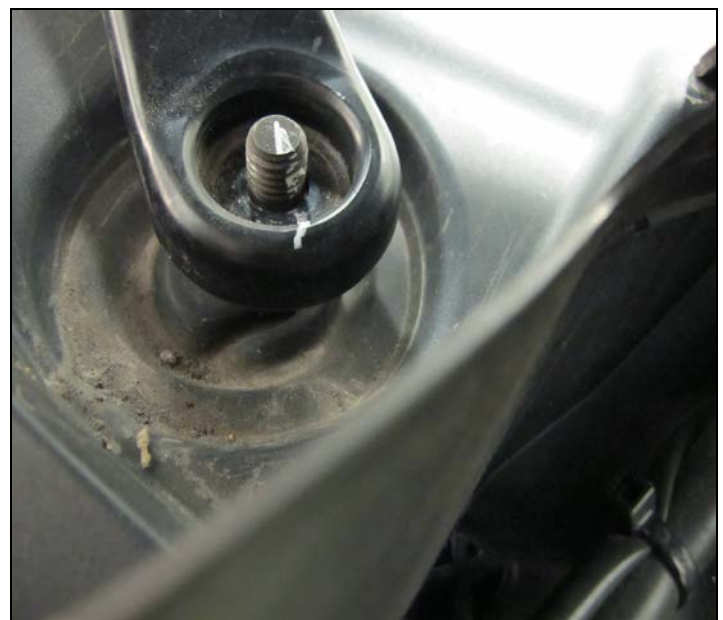
Figure 2

5. Locate the three 16MM nuts that are under the caps and remove them.
6. Using a grease pencil, mark the wiper arm in relation to the mounting point on the wiper arm stud. (Figure 2).

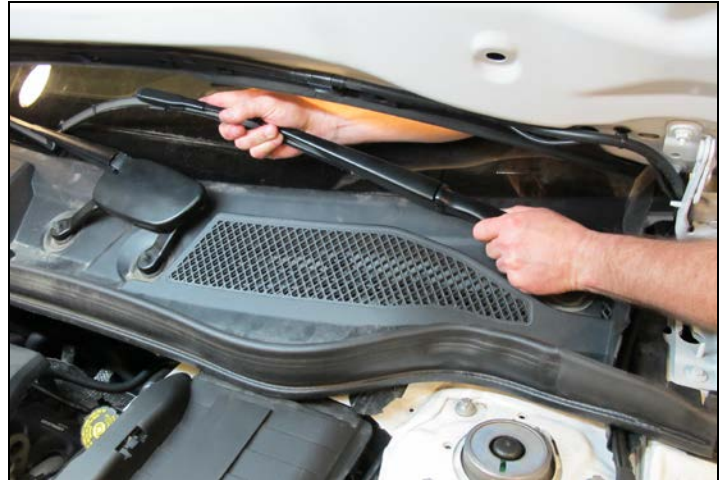
Figure 3

- Using one hand lift the wiper blade slightly off the windshield and with the other hand gently rock the arm at the mounting point to loosen the arm on the stud, and remove the wiper arms. (Figure 3).

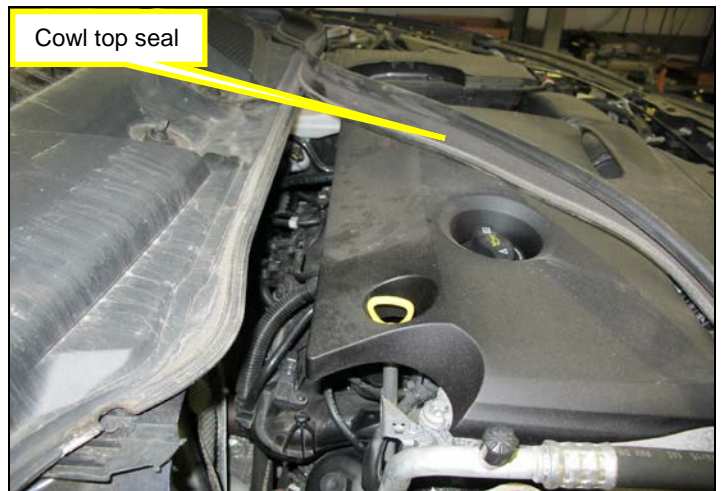
Figure 4

- Remove the cowl top seal and set aside. (Figure 4).

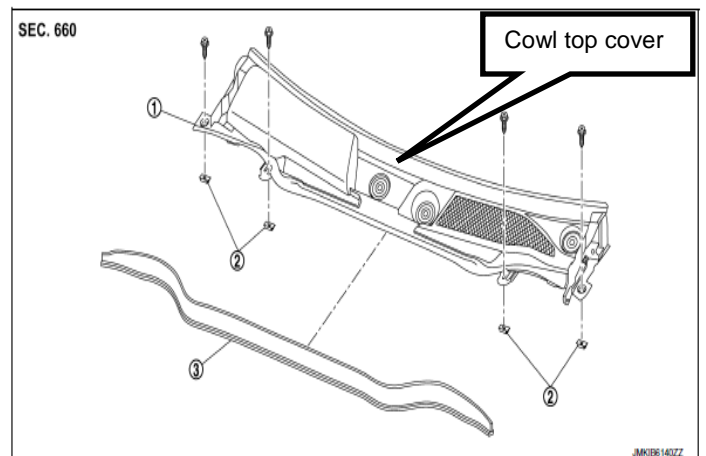
Figure 5

- Remove the (4) 8MM bolts that hold the cowl top cover in place. (Figure 5).

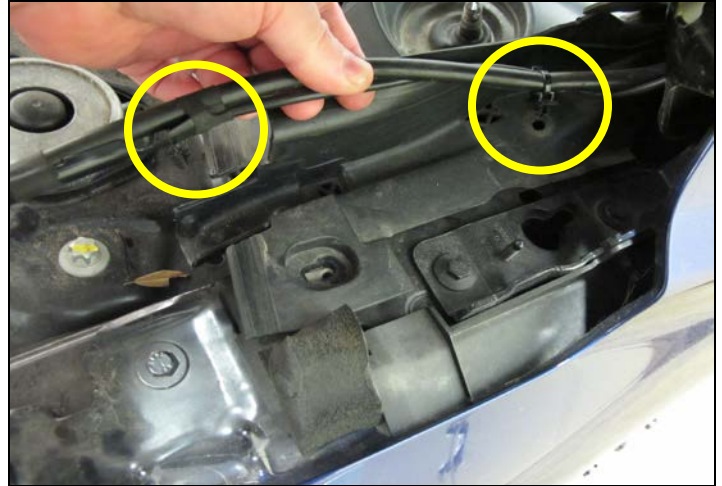
Figure 6

10. Remove the front washer tube-fixing pawls from the cowl top cover. (Figure 6).

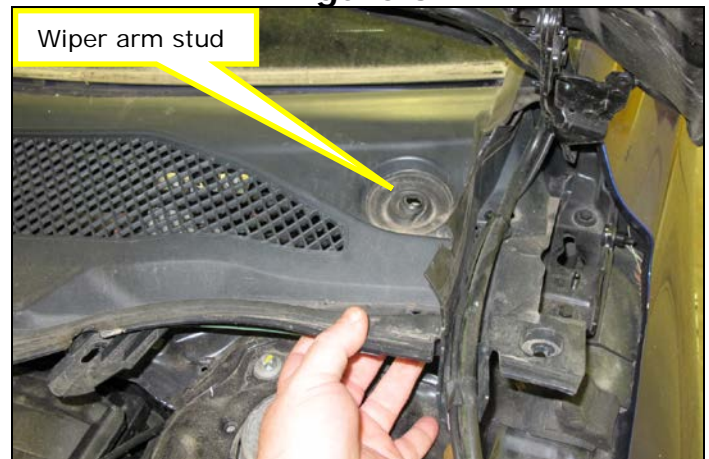
Figure 7

11. Pull cowl top cover up just enough to clear the wiper arm studs and pull gently forward starting from the driver's side. (Figure 7).

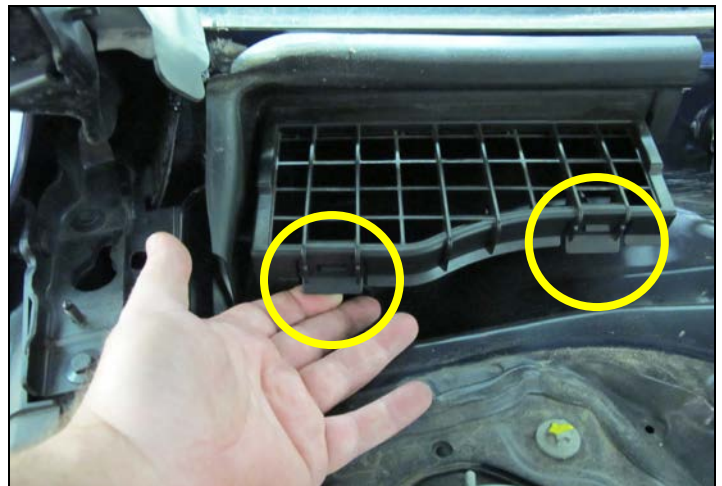
Figure 8

12. Remove the air box inlet assembly by pulling up on the release tabs. (Figure 8).

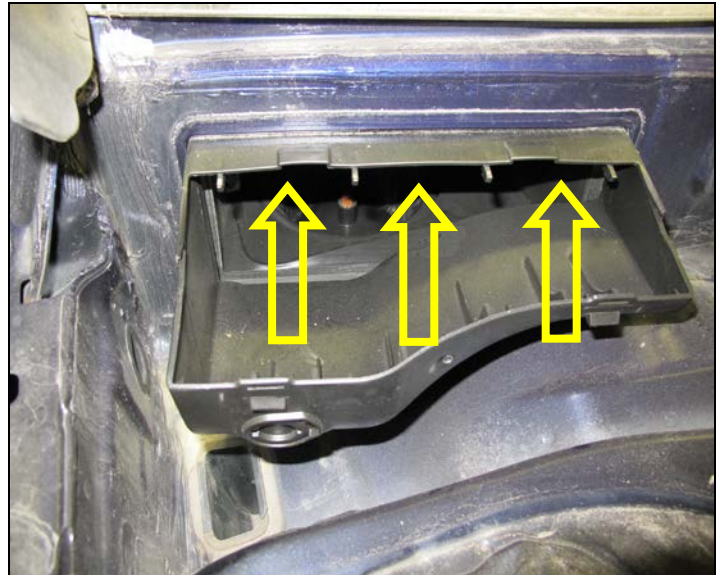
Figure 14

- **Note:** The bottom side of the air box inlet cover hooks where the yellow arrows are pointing. (Figure 14).

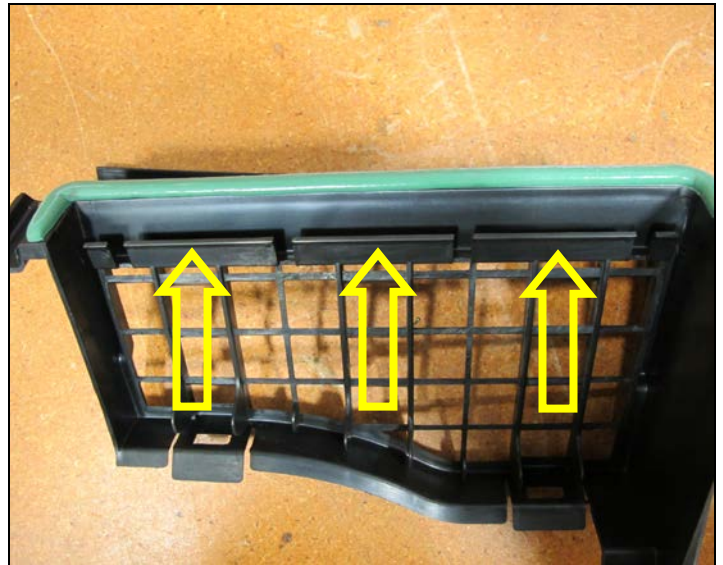
Figure 15

20. Looking at the bottom side of the air box inlet cover, make sure the three clips with the yellow arrows hook onto the back of the air box. (Figure 15).

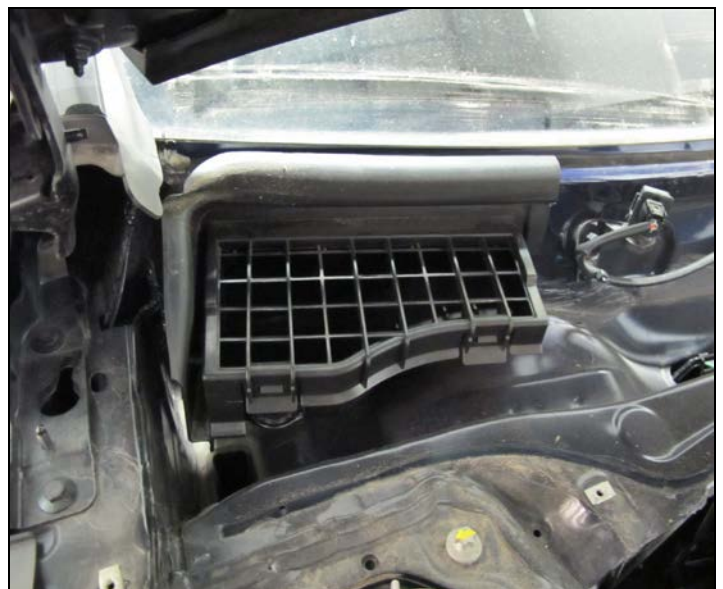
Figure 16

21. Verify the air box inlet cover is attached in the front and rear by pulling up on it gently.

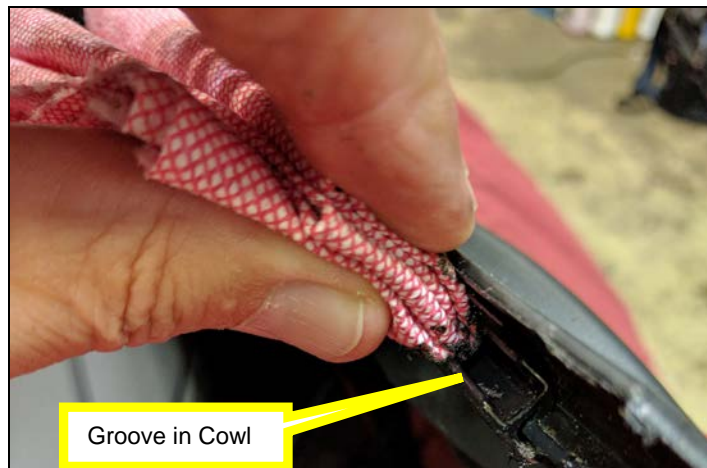
Figure 17

- 22. Clean lower portion of windshield and bottom edge. Wipe inside of groove in in cowl top cover with damp rag making sure any grit or debris is removed in order to prevent any scratches along lower edge of glass.

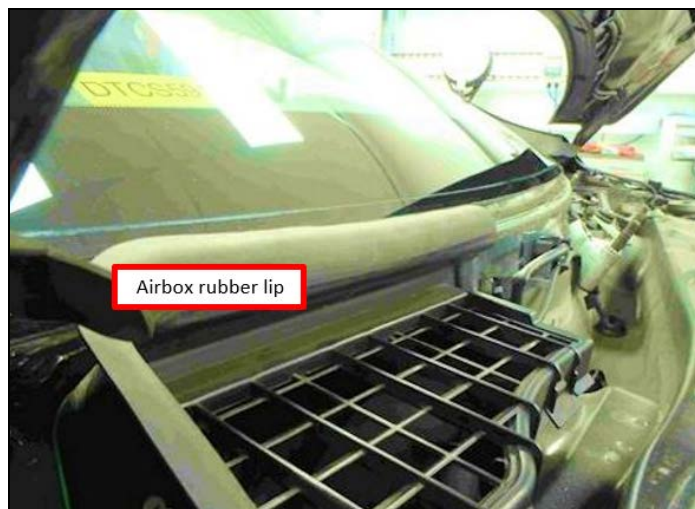
Figure 18

- 23. Installing the cowl top cover needs to be done smoothly and without application of excessive force. Special care should be taken on the Airbox side where the Airbox rubber lip sits against the cowl top. It is necessary to flex the rubber lip to allow fitment of the cowl top.

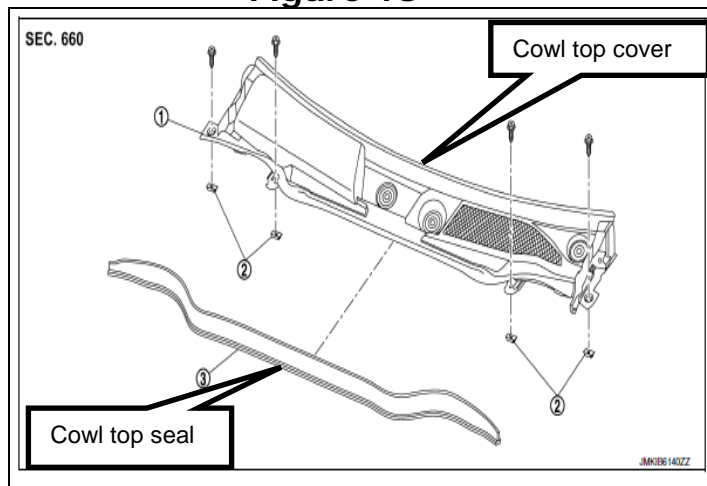
Figure 19

- 24. Reinstall the (4) 8MM bolts for the cowl top cover. (Figure 19).

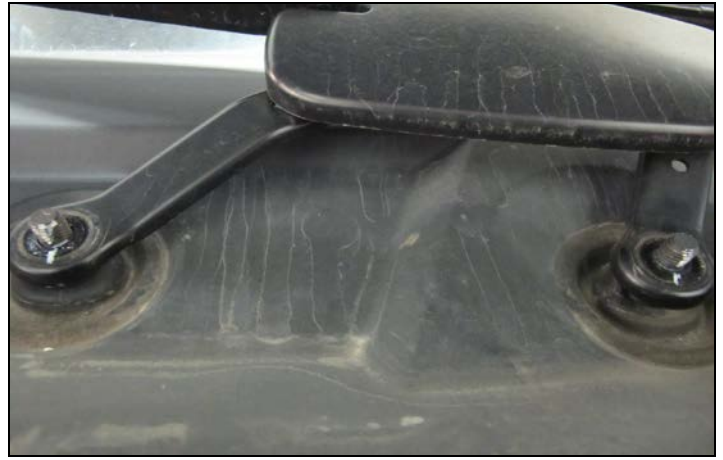
Figure 20

26. Reinstall the wiper arm assemblies, aligning the marks left from the grease pencil from step 2.

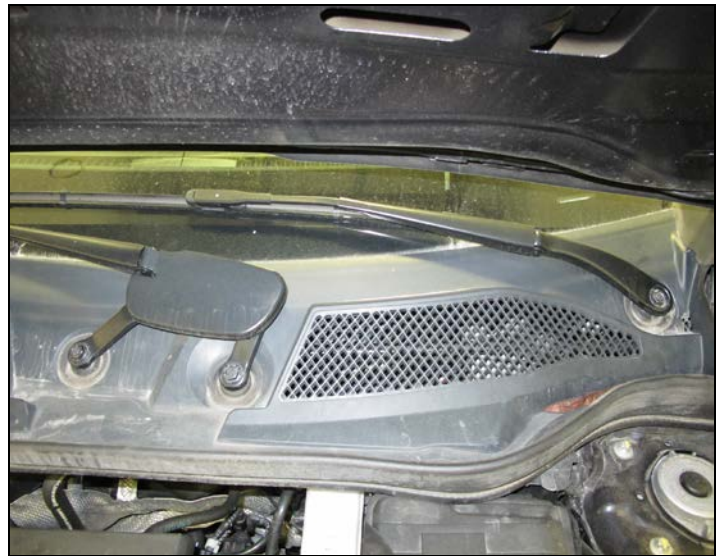
Figure 21

27. Reinstall the three 16MM nuts that hold on the wiper arms and torque to **15 (ft-LB) OR 30Nm**.

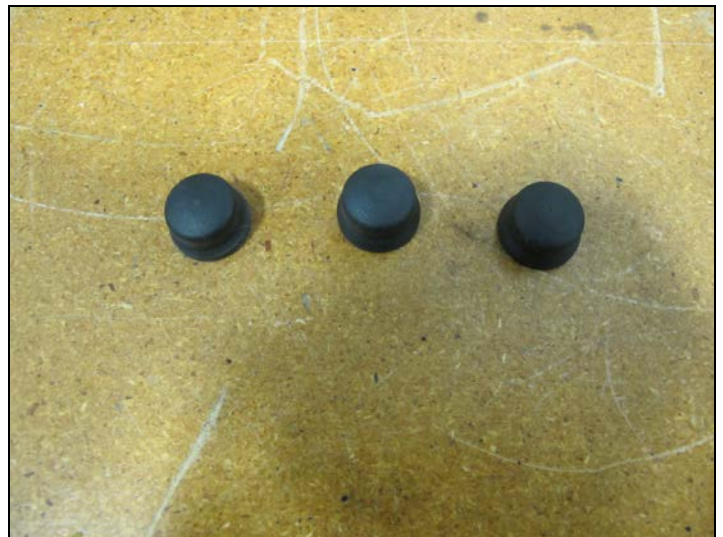
Figure 22

28. Reinstall the (3) plastic caps that cover the wiper arm 16MM nuts.

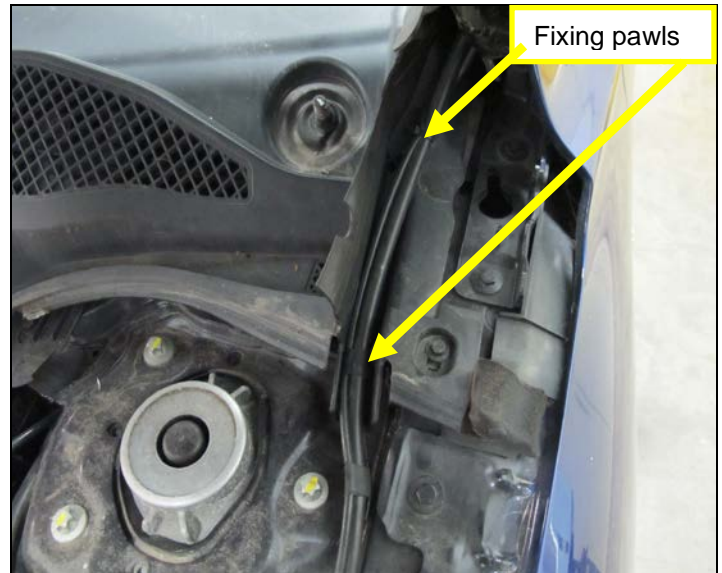
Figure 23

29. Reinstall the two-windshield washer tube fixing pawls to the cowl top cover, on the driver's side. (Figure 23).

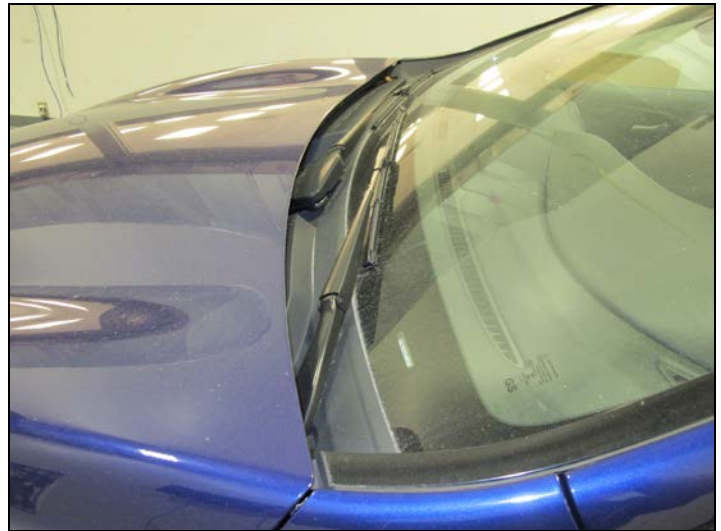
Figure 24

30. Close the hood and cycle the windshield wipers to make sure that they park properly at the bottom of the windshield.
