# LH Rocker Panel Pop/Creak Noise

YEAR(S)	MODEL(S)	ADDITIONAL INFORMATION
2014 – 2015	Avalon, Avalon HV

Some 2014 – 2015 model year Avalon and Avalon HV vehicles may exhibit a condition where there is a pop/creak type noise from the LH rocker panel/bottom of the driver's door opening area. This is caused by two body panels contacting one another within the rocker panel structure. Use the following Repair Procedure to address this condition.

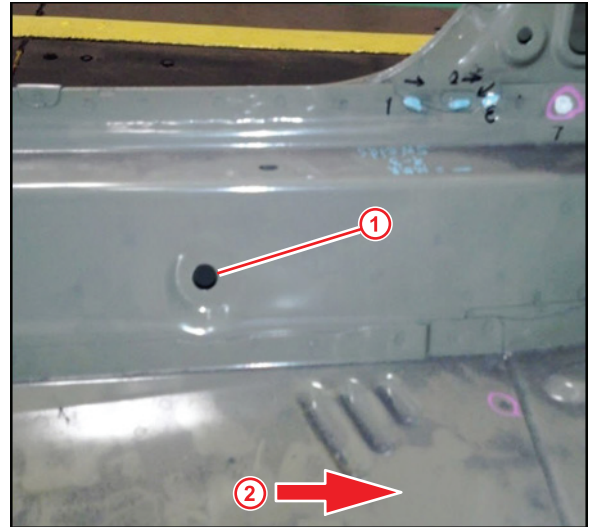
**Figure 2.**

<b>1</b>	Access Hole
<b>2</b>	Front of Vehicle

2. Confirm and repair contact point No. 1.

- A. Using a borescope, navigate into the rocker panel through the access hole (from step 1E) towards the contact point No. 1.

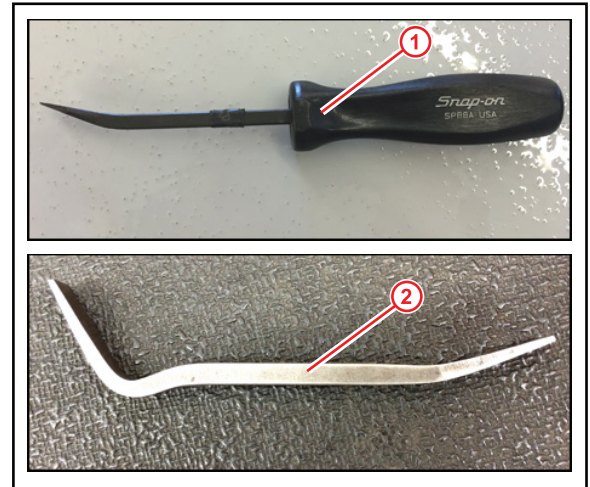
**Figure 5. Sample Tools**

<b>1</b>	<b>Prybar</b>
<b>2</b>	<b>Drum Brake Shoe Adjustment Tool</b>

- C. If contact is found in step 2B, insert a prybar through the access hole to the position of contact between the A-pillar reinforcement and the step panel reinforcement.

- D. Using a hammer, tap the end of the pry bar until separation is created at the contact point.
- E. Lift the weather strip to access rocker panel flange.
- F. Confirm separation by shining a flashlight through the rocker panel flange towards the bulkhead and confirm with the borescope that light is coming in between the A-Pillar reinforcement and the step panel reinforcement.
