Service Bulletin

Subject: Headliner Wet, Water Leak from Front or Rear Sunroof Glass or Rear Compartment Carpet Wet

Models: 2008-2016 Buick Enclave
2009-2016 Chevrolet Traverse
2007-2016 GMC Acadia
2007-2010 Saturn OUTLOOK

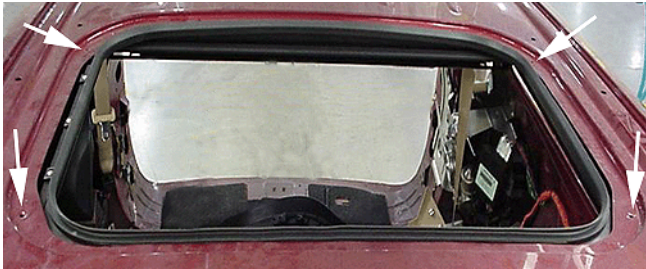
The primary cause of the leaks in this area could be a result of the rear stationary glass to body weather-strip, front glass weather-strip, or rear roof drains allowing too much water for the sunroof drain system to manage. When exceeding this threshold, the water overflows onto the headliner and into the vehicle. If water overflows on the headliner, it can travel to the front of the vehicle and down the inside of the A-pillar. Therefore, water may be present in the front floor foot-well area, on either the driver or passenger side.

Whether two or four holes are present, plug the stationary glass drain holes in the roof sheet metal using the following steps:

1. Lower the headliner following the procedure in SI.

2. Loosen the front sunroof module bolts half way. Remove the sunroof drains. Remove the remaining sunroof module bolts and lower the rear of the sunroof module assembly following procedures in SI.
