SERVICE BULLETIN

Classification: EC16-033a	Reference: NTB16-095a	Date: June 7, 2017
------------------------------	--------------------------	-----------------------

2016 TITAN XD; MIL ON WITH DTC P226C OR P0471 WHEN OPERATED AT OR BELOW 32°F (0°C)

APPLIED VEHICLES: 2016 Titan XD (A61)
APPLIED ENGINE: Cummins 5.0L V8 Diesel

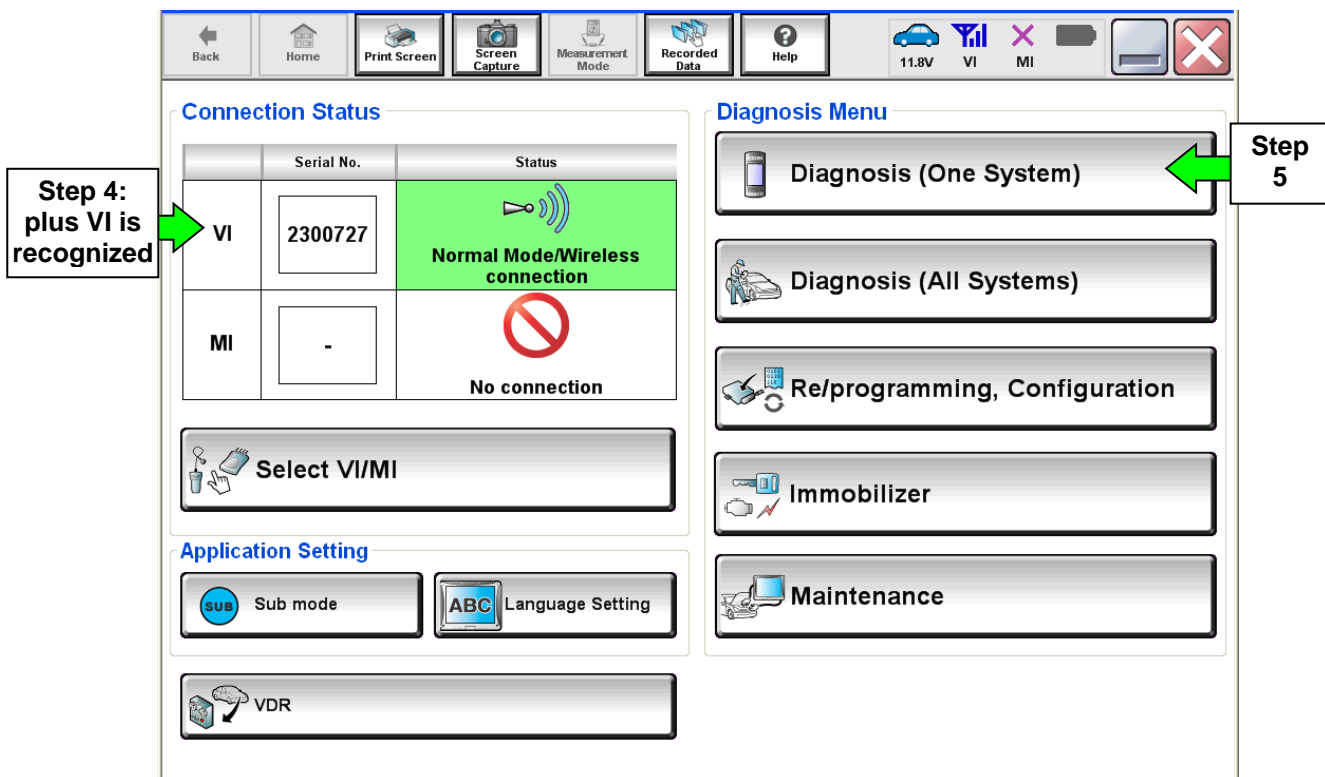
Figure A

1. Connect the CONSULT PC to the vehicle.
2. Open / start C-III plus.
3. Turn the ignition ON, with engine OFF (engine not running).
4. Wait for the plus VI to be recognized.
 - The **Serial No.** will display when the plus VI is recognized.
5. Select **Diagnosis (One System)**.

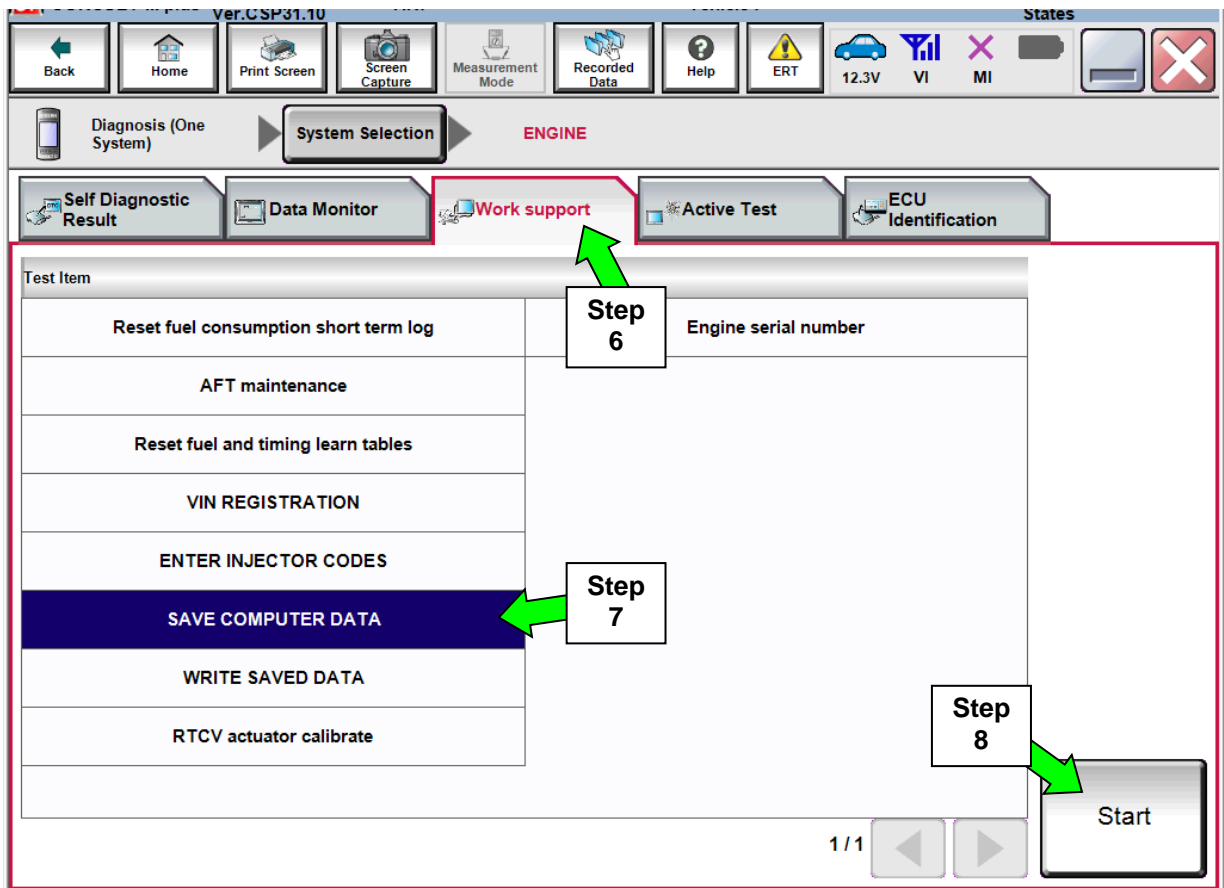
Figure B

6. Navigate C-III plus to **Engine > Work Support** (see Figure B).
7. Select **SAVE COMPUTER DATA**.
8. Select **Start**.

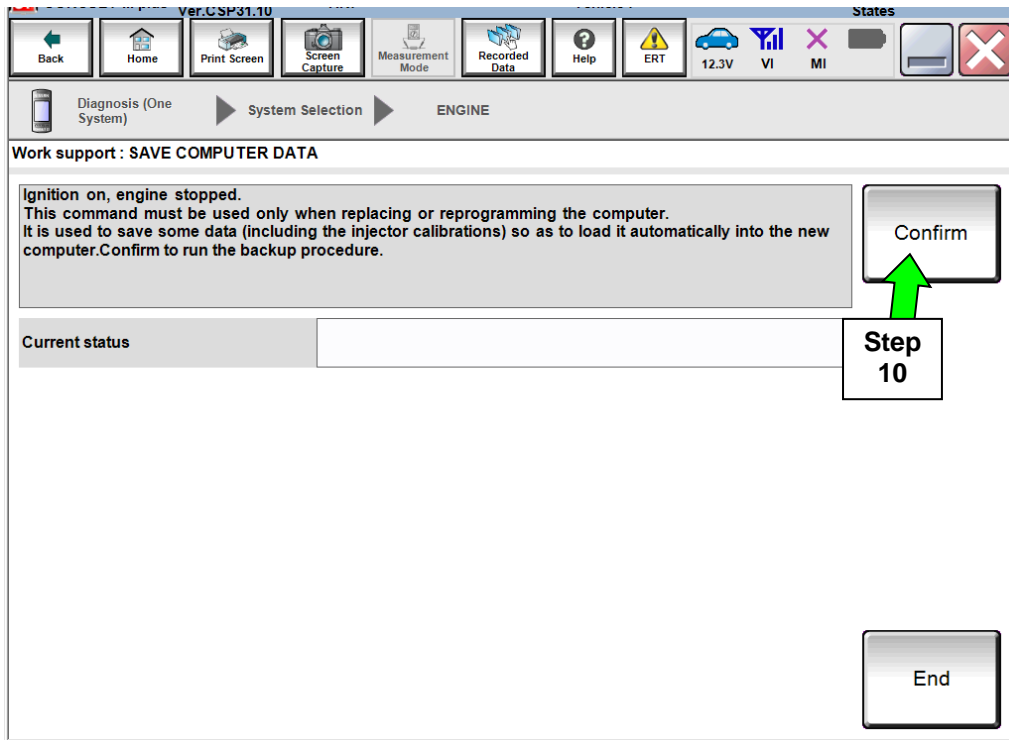
Figure C

9. Make sure the ignition is ON and the engine is OFF (engine not running).

10. Select **Confirm**.

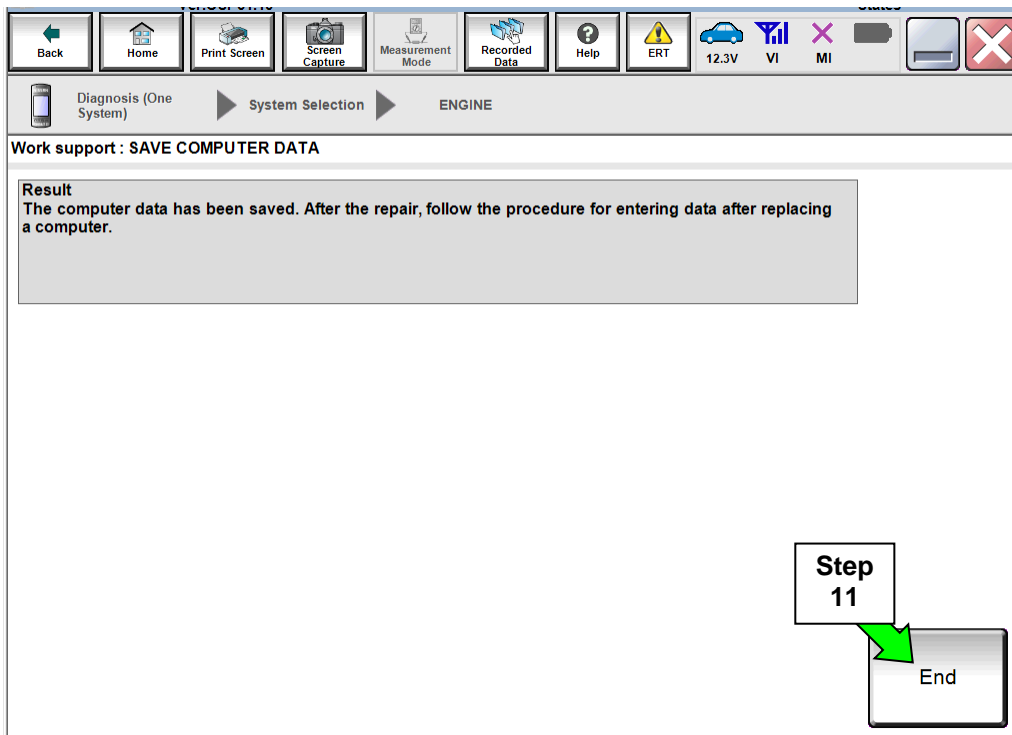
Figure D

11. Select **End**.

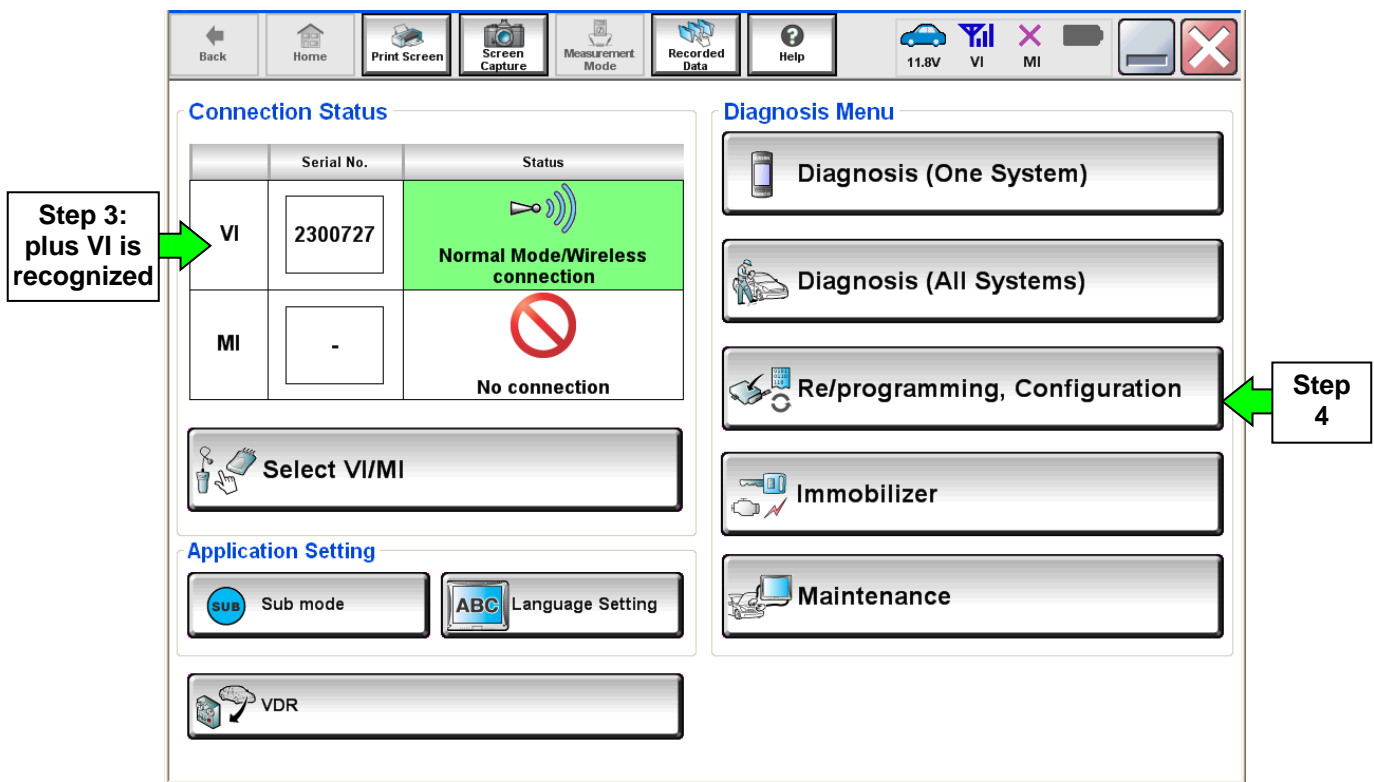
Figure 1

1. Return to the C-III- plus Home screen (see Figure 1).
2. Confirm the ignition is ON, with engine OFF.
3. Confirm the plus VI is recognized.
 - The **Serial No.** will display when the plus VI is recognized.
4. Select **Re/programming, Configuration.**

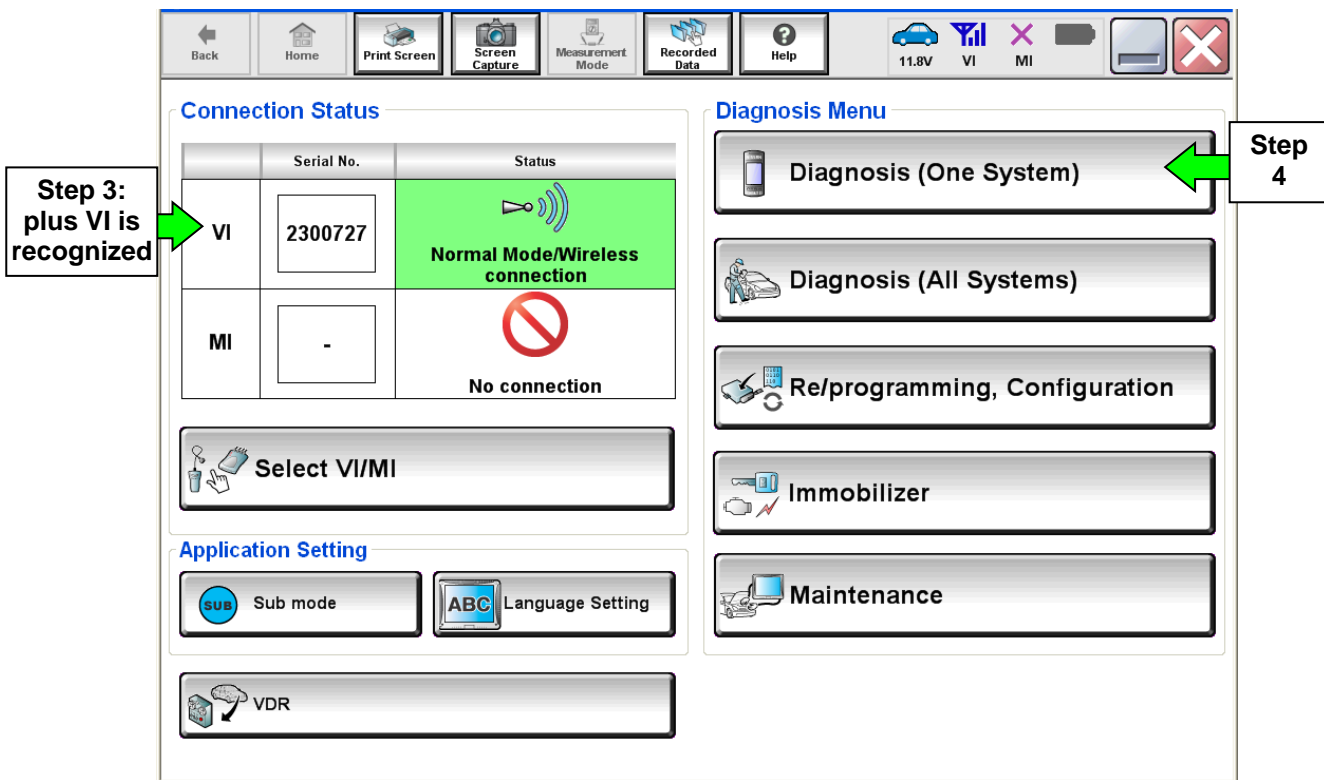
Figure 1A

1. Return to the C-III- plus Home screen (see Figure 1A).
2. Confirm the ignition is ON, with engine OFF.
3. Confirm the plus VI is recognized.
 - The **Serial No.** will display when the plus VI is recognized.
4. Select **Diagnosis (One System)**.

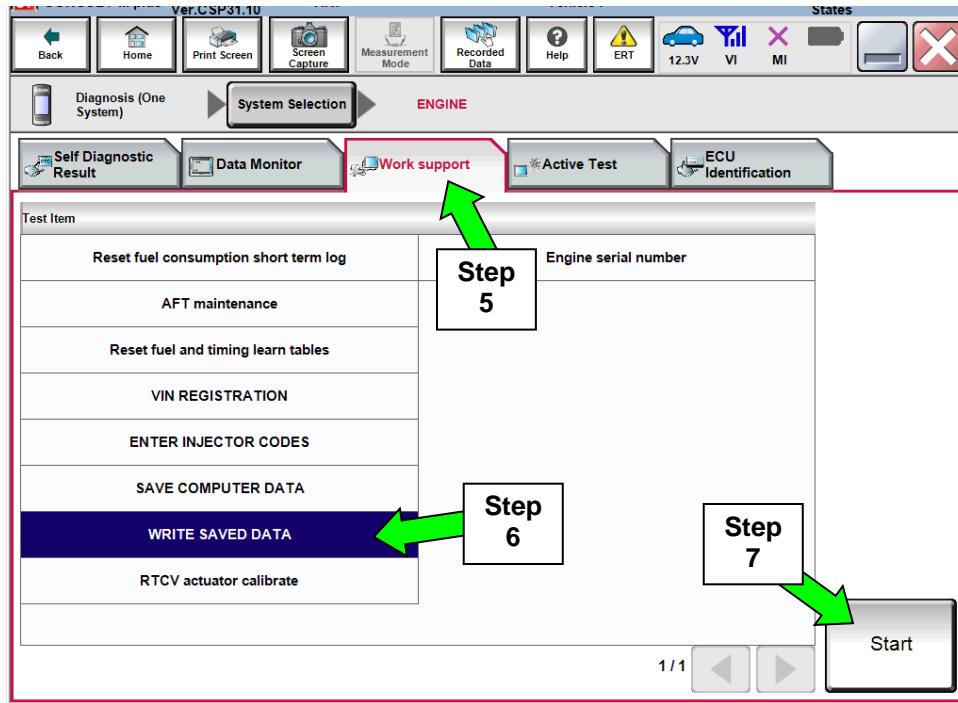
Figure 2A

5. Navigate C-III plus to **ENGINE > Work support** (see Figure 2A).
6. Select **WRITE SAVED DATA**.
7. Select **Start**.

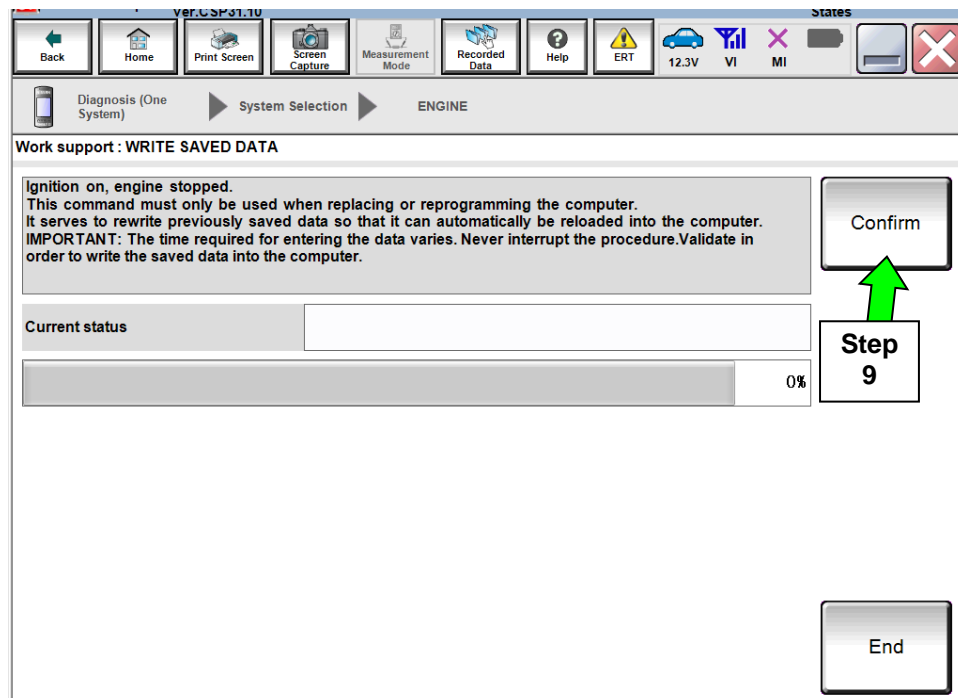
Figure 3A

8. Make sure the ignition is ON and the engine is OFF (engine not running).
9. Select **Confirm**.

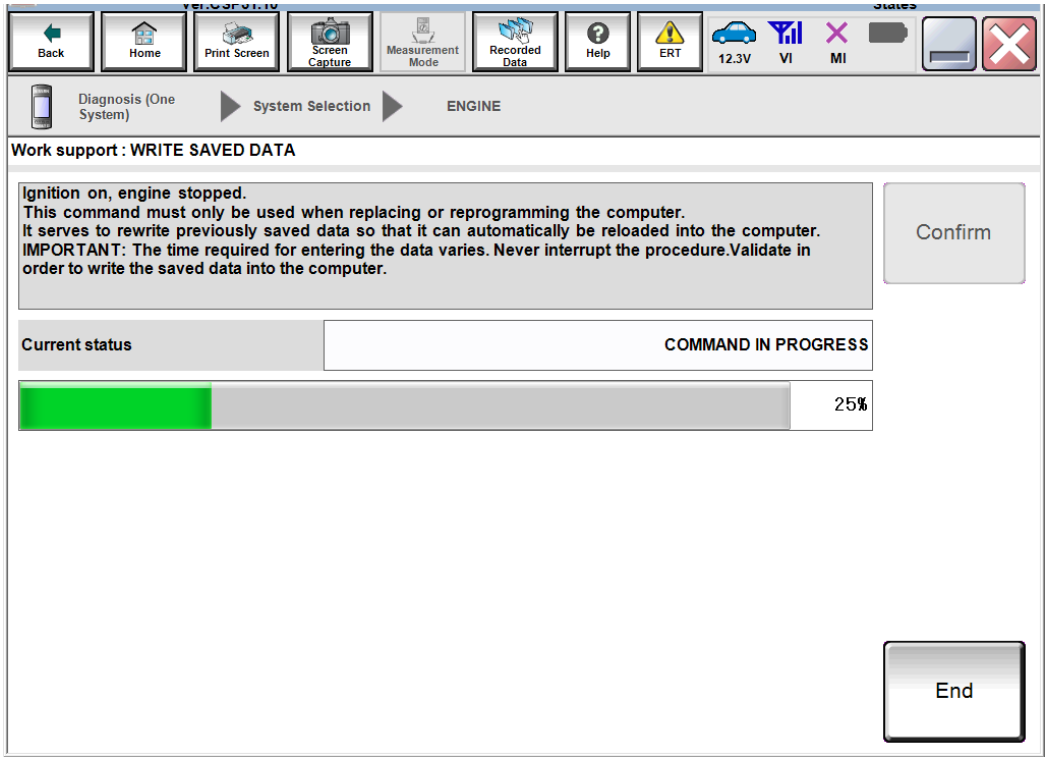
Figure 4A

10. Wait for the procedure to complete.

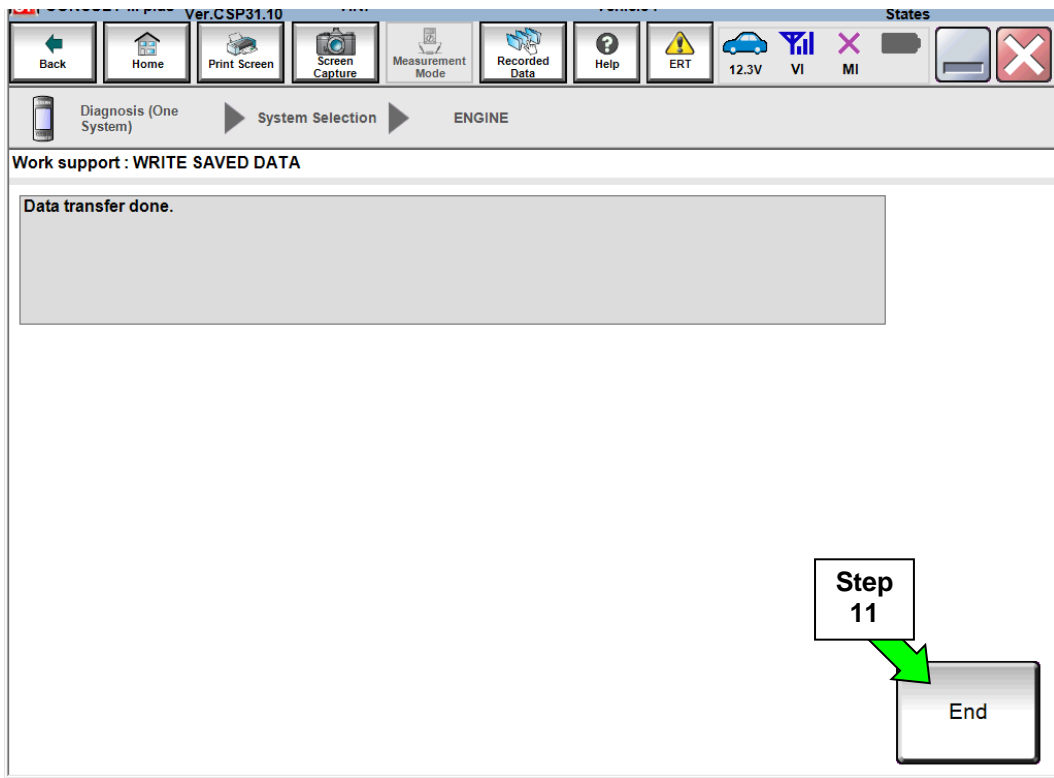
Figure 5A

11. Select **End**.
