# Service Bulletin

**Subject:** EBCM Wheel Speed Sensor Diagnostic Aid for ABS Message - Click or Ratchet Noise - Service Traction Message - Service Stabilitrak Message - Service Steering Message

*This Bulletin replaces PIC5428G. Please discard PIC5428G.*

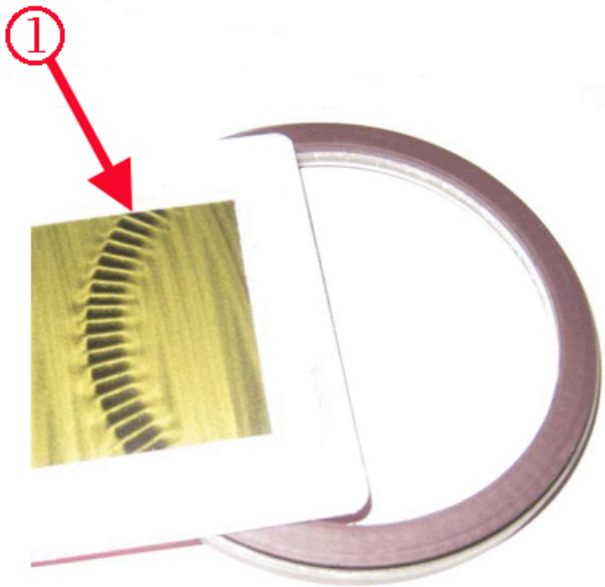
(1.) Wheel Speed Sensor

Magnetic Encoder Ring - North and South Poles are shown

New Bearing Design.

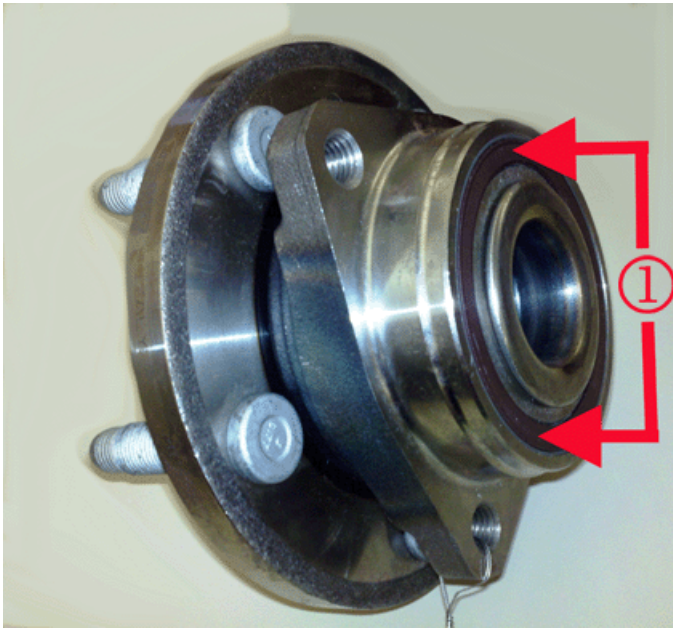
(1.) Magnetic Encoder Ring

Some new model vehicles today have begun to use a different type of wheel speed sensor encoder ring or tone wheel. Instead of a traditional mechanical type tooth tone wheel, the wheel speed sensor tone wheel is now made of a magnetized nitrile rubber ring, typically brown in color. This magnetic encoder consists of multiple North and South pole pairs surrounding the outer circumference. When this magnetic encoder ring rotates and passes by the wheel speed sensor head; it generates a sign wave in the wheel speed sensor. The wheel speed sensor converts an analog signal to a digital square wave, and typical digital signal values switch between 7mA (Low) and 14mA (High) DC current.
