Service Bulletin No. 445

MODEL J4500	TYPE Field Change Program	SECTION/GROUP 7-Electrical	DATE Mar. 24, 2017
SUBJECT TRANSMISSION HARNESS ROUTING			
CONDITIONS

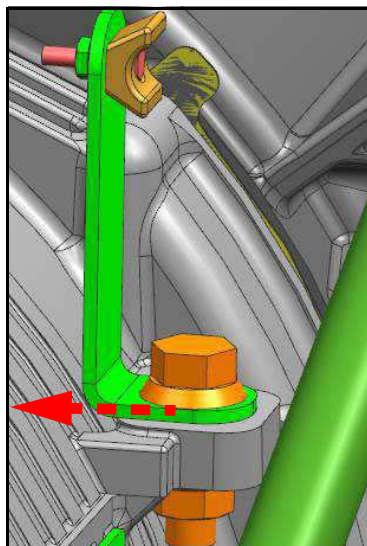
Figure 16. Push the bracket assembly as far inboard as possible to achieve clearance.

The bracket assembly must be pushed as far inboard towards the transmission as possible to achieve a 0.50 inch clearance between the transmission harness routing and the dipstick.

24. Apply Loctite 242 to the threads of screw, p/n 19-01-1536. Orient the bracket assembly with screw, p/n 19-01-1536 and nut, 19-03-0755 as shown in Figure 16. Push the bracket assembly as far inboard as the hole will allow and tighten to secure.
