Group:	SERVICE MANUAL UPDATE
Bulletin No:	SB-15-032
Issue Date:	10-21-2015

**Subject: CORRECTION OF WORKSHOP MANUAL FOR 2011~2014 MY**  
Troubleshooting information and inspection procedure of the DTC/P2030 were revised

**RELEVANT MODEL:** 11MY-14MY Conventional Trucks (238, 258, 268, or 338)

**DTC: P2030 Burner abnormal combustion (Burner misfire, Lost flame, Burner outlet temperature too high, Unable to achieve target temperature)**  
INFORMATION

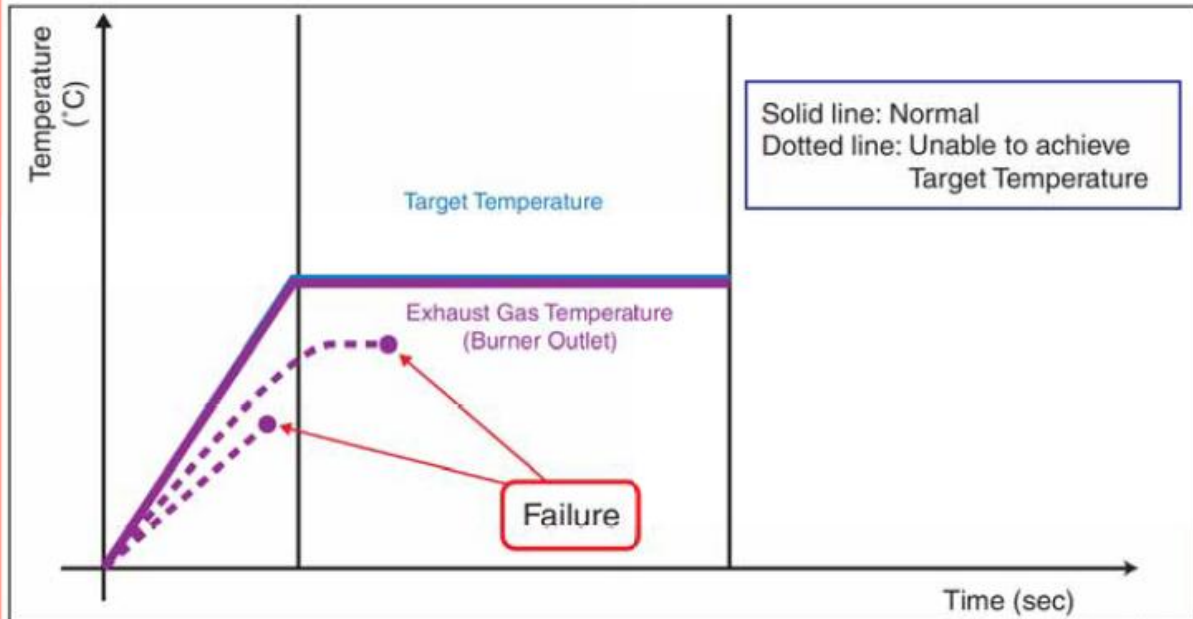
SAPH16F030500106

- (1) Check condition  
During raising/maintaining the exhaust gas temperature. (See [Reference 2])
- (2) <Judgment criteria>
  - Unable to achieve target temperature  
The exhaust gas temperature sensor (Burner outlet) value is lower than a target temperature value.

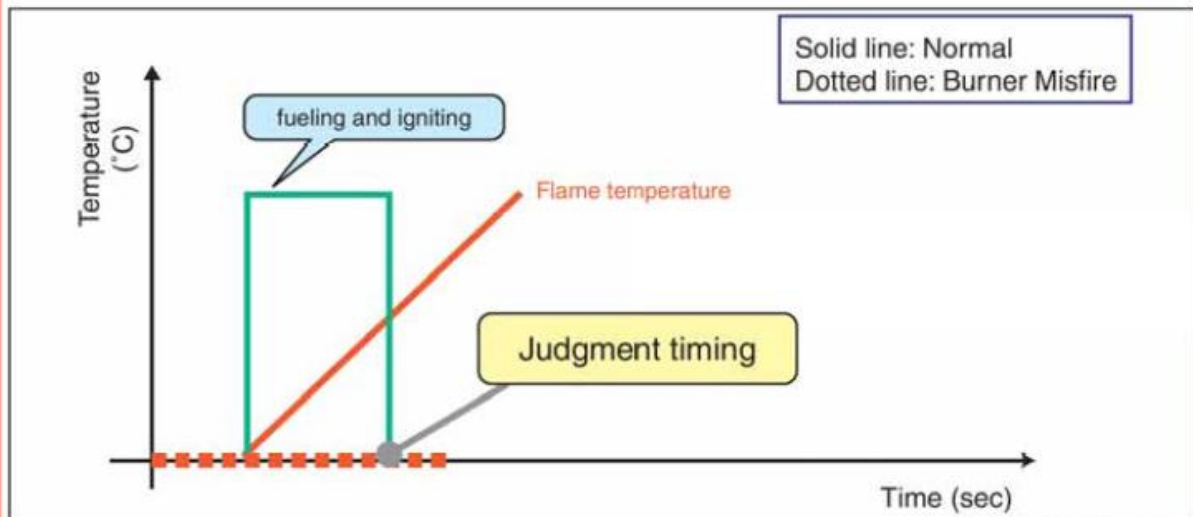
SAPH16F030500107

- Misfire  
After fuel injection, the flame temperature sensor value does not rise within 10 seconds.

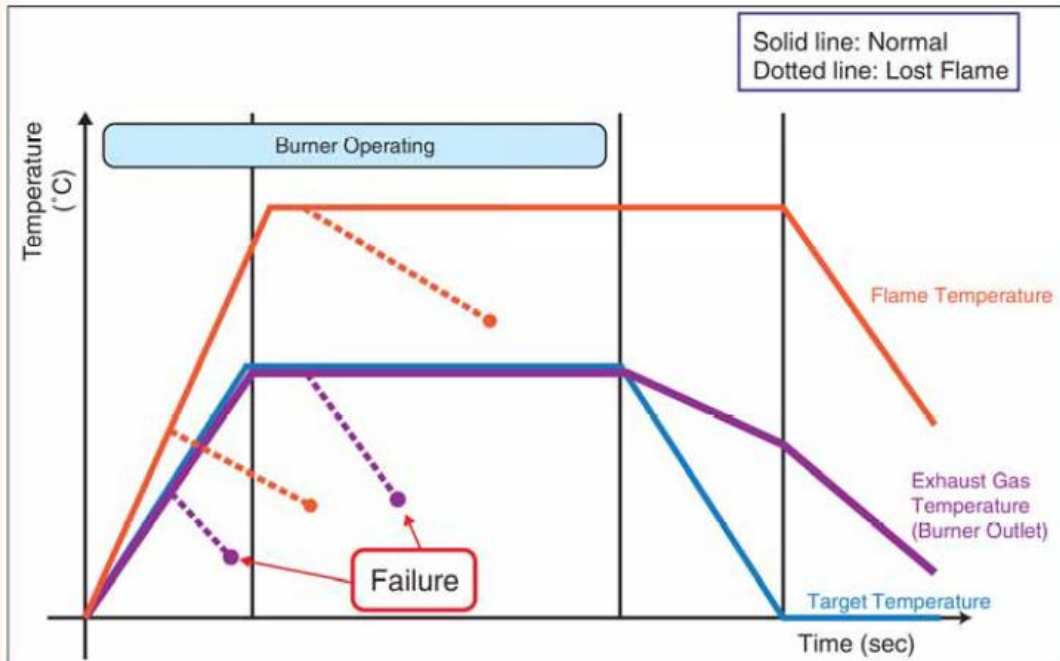
SAPH116F030500108

- Lost flame**  
 The purpose of the burner system is to raise exhaust gas temperature at burner outlet. It means the exhaust gas temperature sensor (Burner outlet) value reduces immediately when lost flame occur. The exhaust gas temperature sensor (Burner outlet) value reduces.

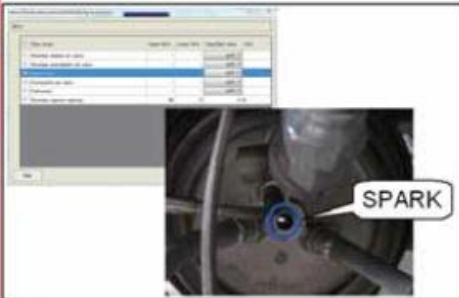
SAPH16F030500115

### 3 Inspect the ignition coil condition [HINO DX II ]

Remove both blue ceramic igniter plugs from the combustor. And carefully cleaned up by break cleaner and wire brush.  
Switch igniter positions side to side. Reinstall both igniter plugs and torque to the specified torque.  
Specified Torque: 22.0 lb-ft (29.8 N-m). Check the gap again. If the gap is still out of spec, remove one (1) igniter from the combustor and exchange it with another new one. Due to manufacturing variability of igniters it may be necessary to replace one of the two igniters to bring the gap within specification and then go to step 5.

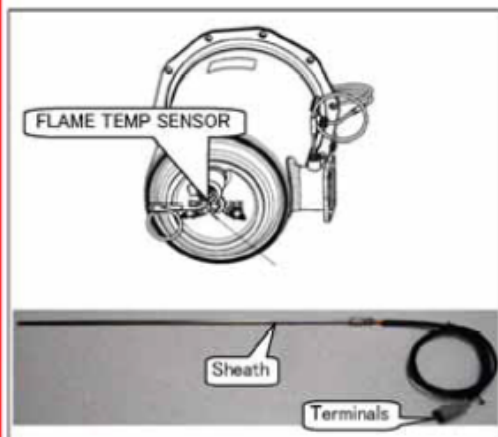
### 9 Inspect the flame temperature sensor insulation resistance

Flame temperature sensor must be periodically replaced every 150,000 miles.

Replace the flame temperature sensor.  
And then go to step 10.
