Technical Service Bulletin

69 Replaced airbag control unit cannot be coded

69 13 26 2023323/11 October 21, 2013. Supersedes Technical Service Bulletin Group 69 number 12-25 dated April 25, 2012 for reasons listed below.

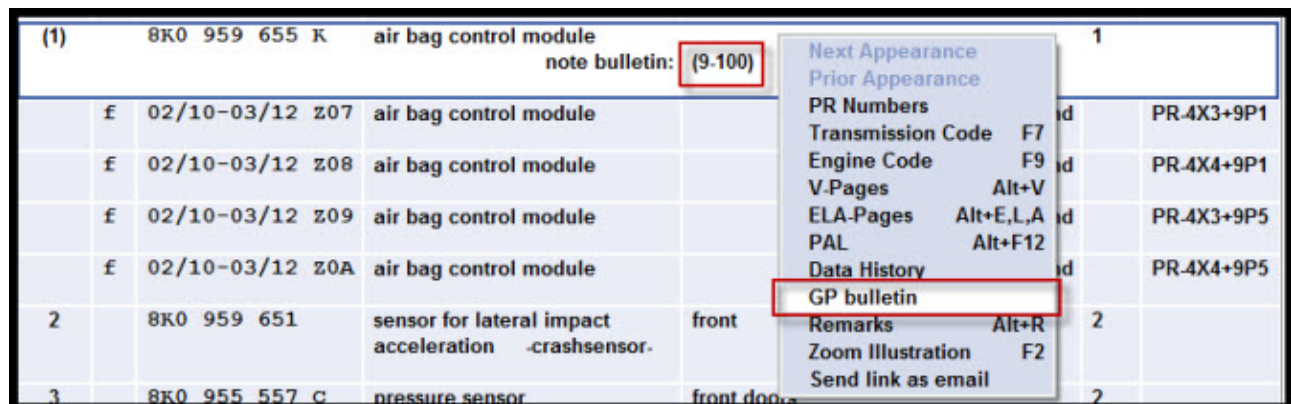
Figure 1. Selecting GP bulletin in ETKA.

1. Locate the part in ETKA. Use the FI search function (VIN filter) to determine if the correct control module (including color code) was ordered for the vehicle.
2. To open the GP bulletin, right-click the part number and select **GP Bulletin** from the drop-down menu (Figure 1).
