Technical Service Bulletin

91 Bluetooth call quality issues for caller on other end of call (A5 Cabriolet, TT Roadster)

91 14 33 2036865/1 April 8, 2014.

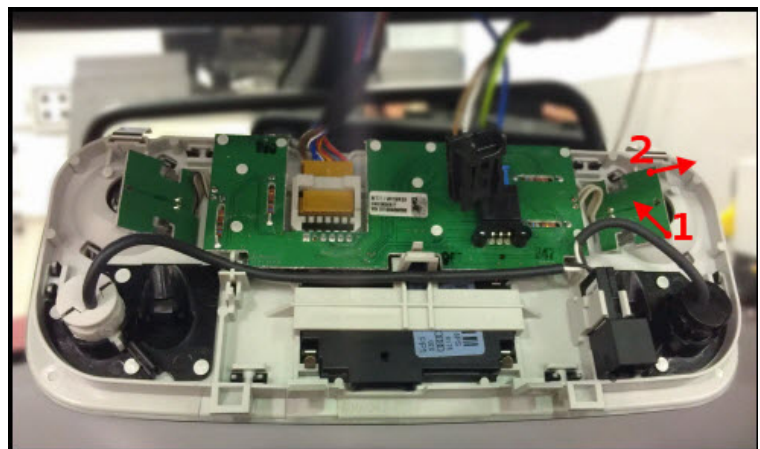
Figure 2. Prying the LED circuit-board of the jewel.

- To remove the LED circuit boards, first pry the top of the small circuit board away from the LED jewel, in the direction indicated by arrow 1 (Figure 2). It will only need to be lifted 1-2mm. Then, pull up on the circuit board in the direction indicated by arrow 2 (Figure 2) to release the circuit board from the LED jewel. There are three different attachment points of the LED circuit board and LED jewel (Figure 3).

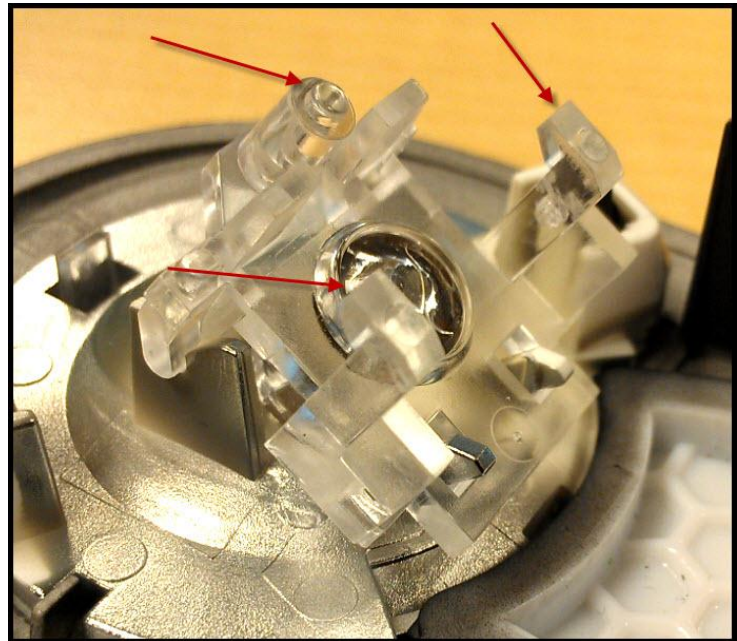
Figure 3. LED jewel attachment points.

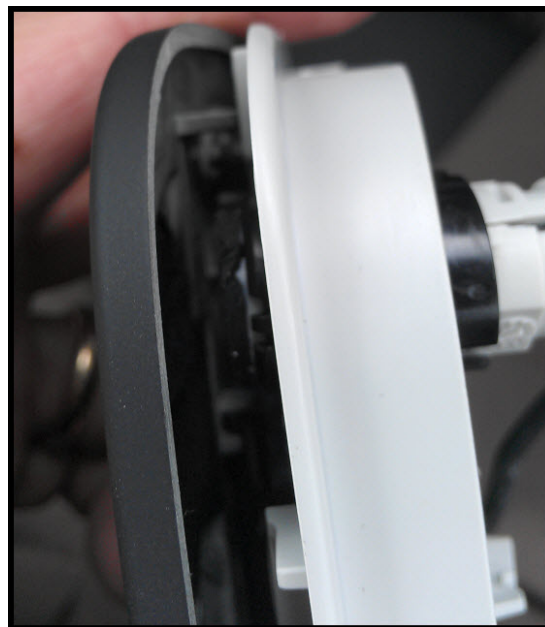
Figure 4. Prying the trim plate from the base plate.

- There are many clip points holding the two pieces together. Sliding your finger slowly around the perimeter is the most effective way to separate the two parts without damaging them (Figure 4).
