Technical Service Bulletin

91 Bluetooth call quality issues for caller on other end of call

91 13 86 2027718/4 June 11, 2013. Supersedes Technical Service Bulletin Group 91 number 12-68 dated November 12, 2012 for reasons listed below.

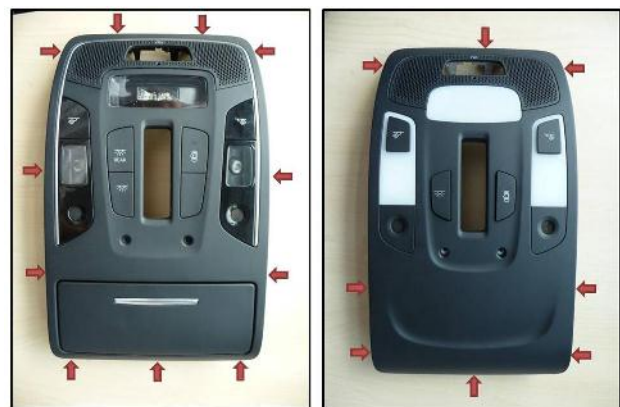
- Remove the decorative trim from the base plate with your fingers. If necessary, gently pry the trim with a trim stick or bone tool, then finish removing it with your fingers.
- There are a number of different clips holding the trim plate to the base plate depending on the trim level of the vehicle (Figure 1).

Figure 1. Clip location for A6/A7 high-line roof module (left) and for mid-line roof module (right)

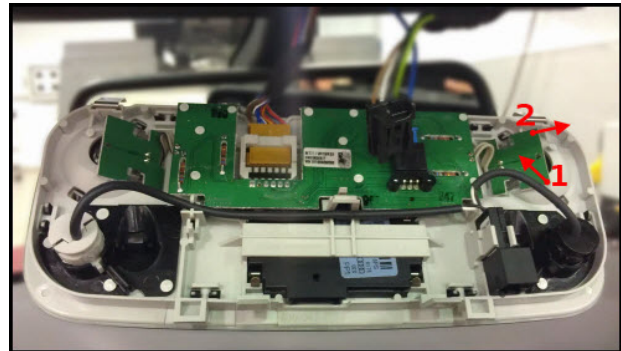
- To remove the LED circuit boards, first pry the top of the small circuit board away from the LED jewel, in the direction indicated by arrow 1 (Figure 2). It will only need to be lifted 1-2mm. Then, pull up on the circuit board in the direction indicated by arrow 2 (Figure 2) to release the circuit board from the LED jewel. There are three different attachment points of the LED circuit board and LED jewel (Figure 3).

Figure 2. Prying the LED circuit-board of the jewel.

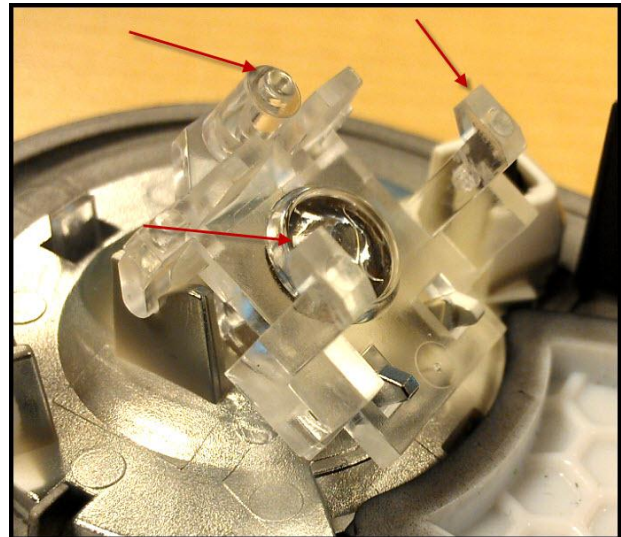
Figure 3. LED jewel attachment points.

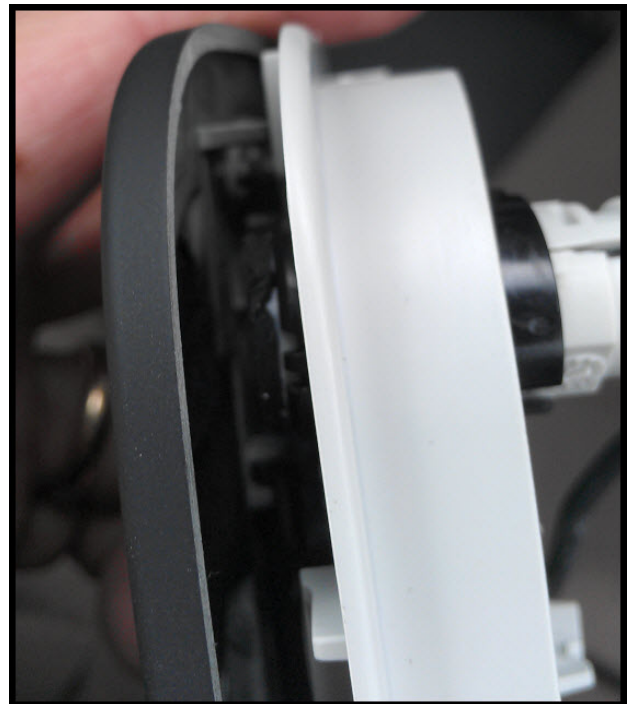
- Repeat for the other side.
- Once the LED jewels are free from the circuit boards, the decorative trim plate can be detached from the base plate. Use your fingers to pry the two pieces apart. There are many clip points holding the two pieces together. Sliding your finger slowly around the perimeter is the most effective way to separate the two parts without damaging them (Figure 4).

Figure 4. Prying the trim plate from the base plate.

The use of a bone tool or screw driver is not recommended for this roof module assembly because it can damage the soft touch paint on the edge of the trim, which can be visible once the part is reinstalled in the headliner.

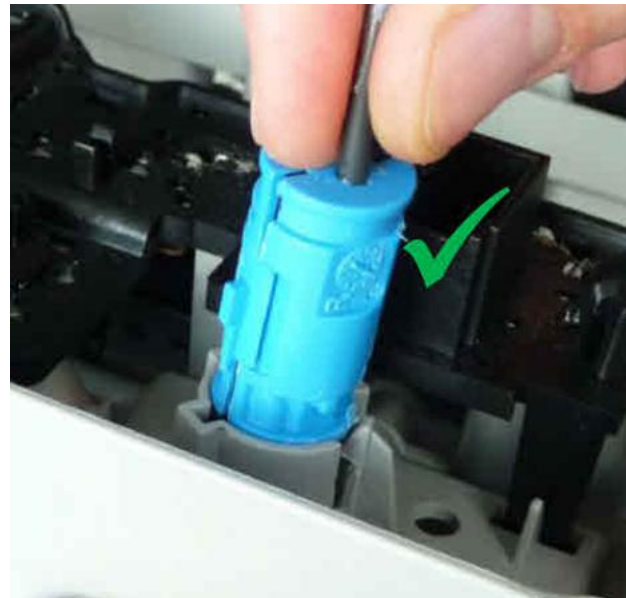
Figure 7. Proper installation.

- Replace the microphone set by installing the replacement microphone while the decorative trim is removed from the base plate. Take care when doing so to prevent damaging the new microphone's seal by slowly installing it perpendicular to the base plate (Figure 7). Do not install the microphone at an angle, as this may pinch the seal (Figures 8 and 9)

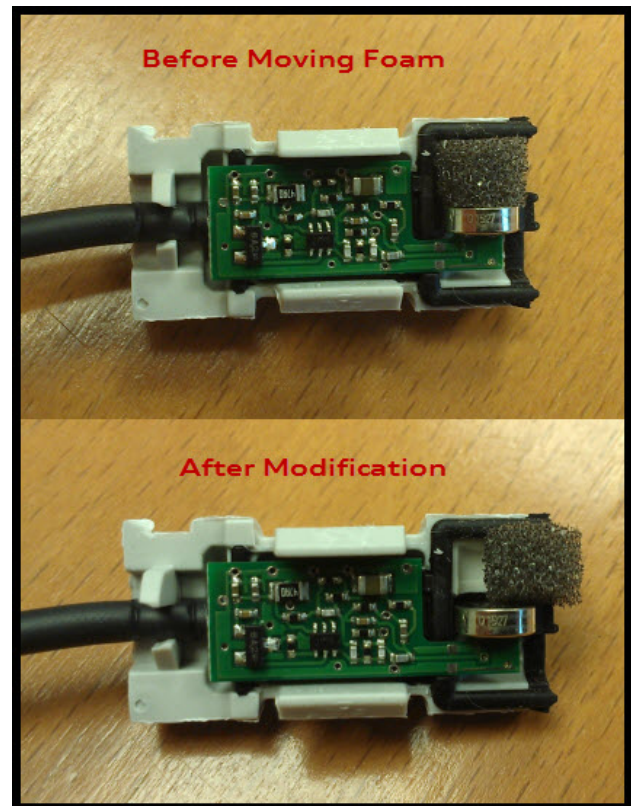
Figure 11. Foam is partially pulled out of the microphone.

- Before installing the new microphone, partially pull out the foam that is inserted in the microphone to allow for a better seal against the felt material (Figures 11 and 12).

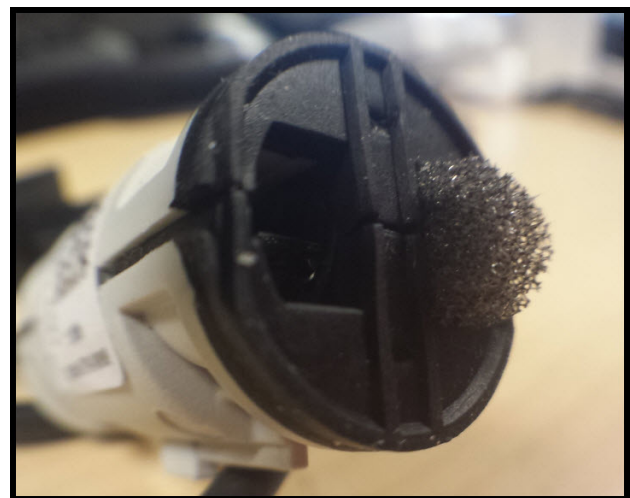
Figure 12. Foam is partially pulled out of the microphone.
