Technical Service Bulletin

91 Parking assistance provides false warnings

91 14 72 2024323/4 December 19, 2014. Supersedes Technical Service Bulletin Group 91 number 13-74 dated February 5, 2013 for reasons listed below.

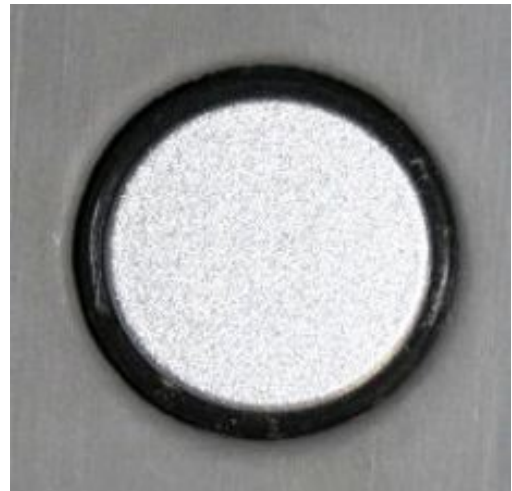
Figure 3. A correctly seated decoupling ring.

7. Check that the decoupling ring is correctly seated (Figure 3, Figure 4, Figure 5). If the ring is folded or bulging, remove the bumper and reinstall the sensor.

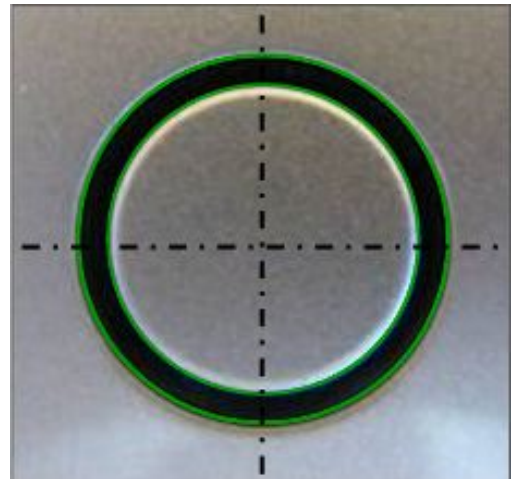
Figure 6. A correctly centered parking aid sensor.

8. Verify that the sensor is centered inside of the mounting hole (Figure 6, Figure 7). If the sensor is mounted off-center, remove the bumper and reinstall the sensor.

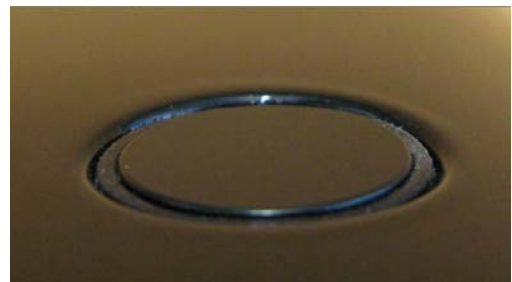
Figure 8. A correctly installed parking aid sensor.

9. Ensure the sensor sits flush with the bumper (Figure 8, Figure 9). If the sensor is recessed or bulging, remove the bumper and reinstall the sensor.

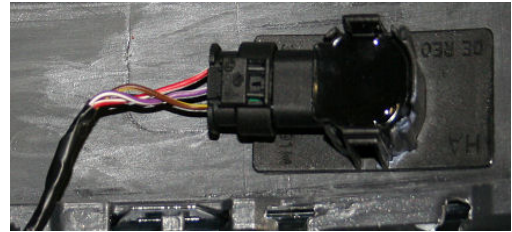
Figure 10. A correctly installed cable with sufficient length.

12. Check the cables in the bumper for damage and sufficient length (Figure 10, Figure 11). Cables that are too short can cause damage to the harness.
 - If the cable is damaged, repair the cable using VAS Repair Kit 1978.
 - If the cable is too tight, correct the routing by moving the support clip so the cable is no longer under tension.

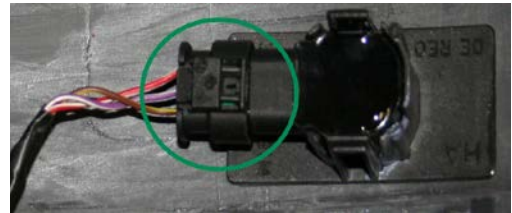
Figure 12. A correctly installed parking aid sensor connector.

13. Check the connectors on the parking sensors and the socket box for correct installation (Figure 12, Figure 13). If the connectors are not installed properly, reinstall.
