IK0800284

Title: Ambient Air Temperature (AAT) Sensor Faults/Location/Diagnostics

Applies To: Navistar N13 Engines and Cummins ISX Engines Cummins ISB, N9 and N10

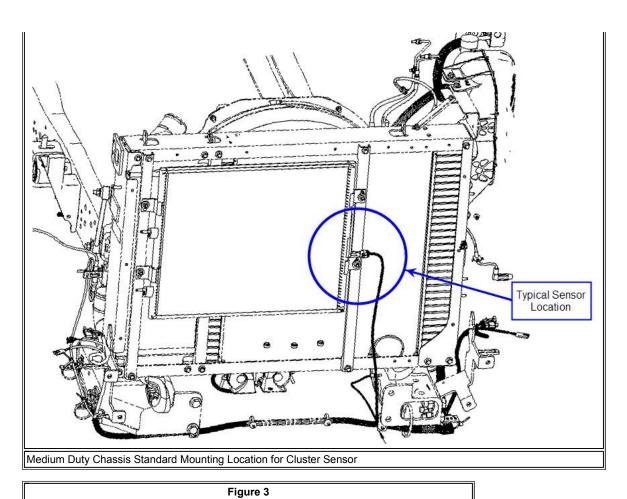
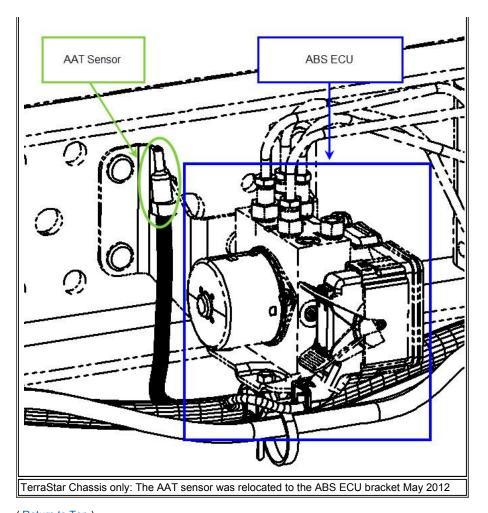
The Cab Temperature Sensor is typically mounted near the front bumper or on the cooling package. If the sensor cannot be found verify the wiring to the gauge cluster is present or that the outside air temp monitor feature as ordered on the truck.
