# PREVOST

## WARRANTY BULLETIN

**WB17-02**

DATE :	April 2017	SECTION :	23 ACCESSORIES
EXPIRATION:	April 2019		
SUBJECT :	ADDITION OF AN EXTENSION TO THE LINEAR THERMAL DETECTOR (LTD)

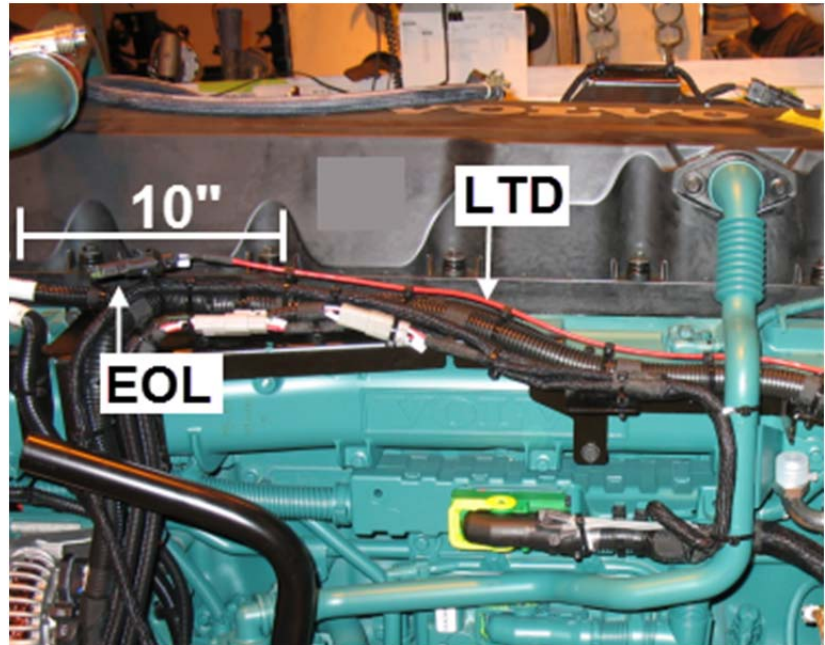
*NOTE: position of the EOL resistance may vary from about 10 inches from one vehicle to another. This position will determine the final position of the EOL resistor once connected at the end of the extension.*

- 1) On the cold side of the engine, remove the End of Line (EOL) resistor from the existing LTD connector. **Keep the EOL resistor for reuse.**
