<b>Subject:</b> NAVIGATION SD CARD ERROR MESSAGE "Invalid SD Card"	<b>M-Tips No.:</b> MT-001/18
	<b>Last Issued:</b> 01/02/2018

## DESCRIPTION

When installing a navigation SD card, the center display may show error message "Invalid SD Card".

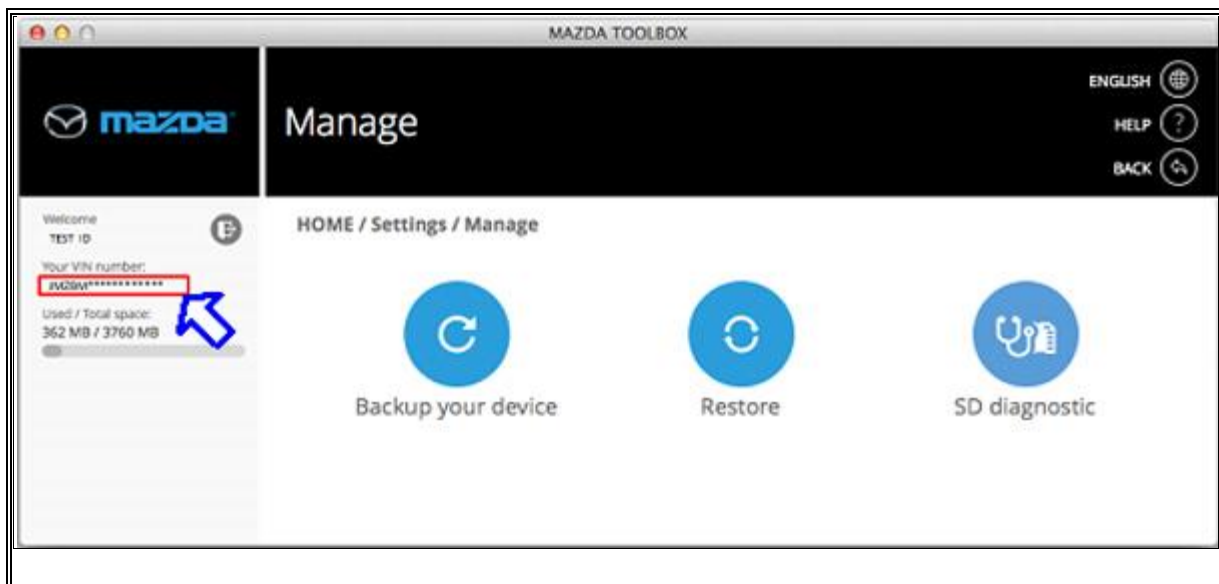
If VIN matches with the concerned vehicle, proceed to next step.

Go to Setting, select “SD diagnostic”.

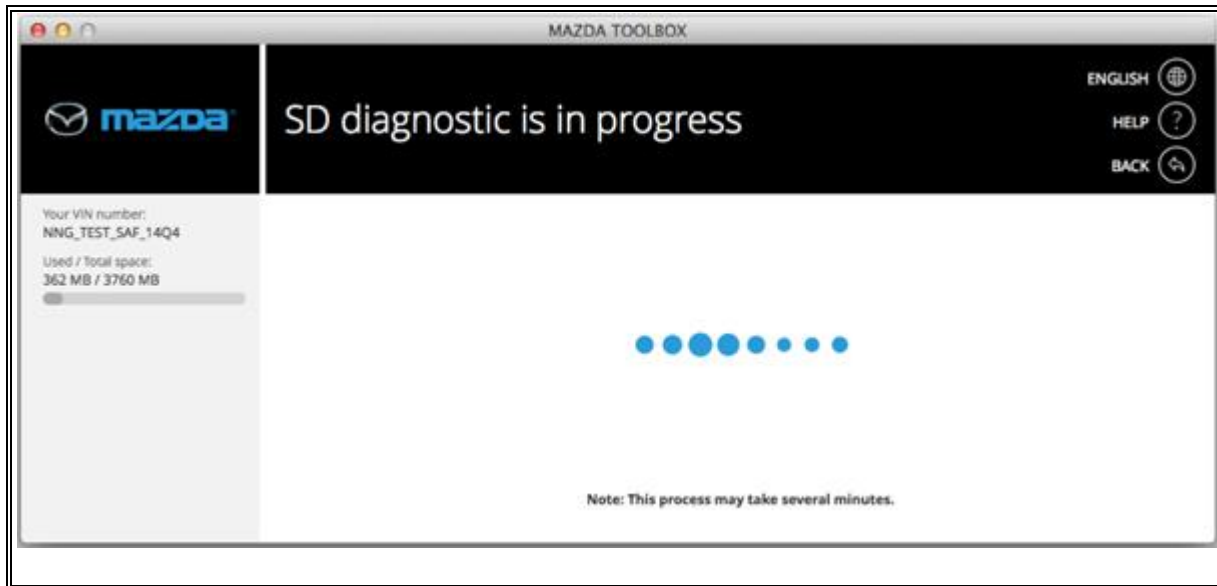
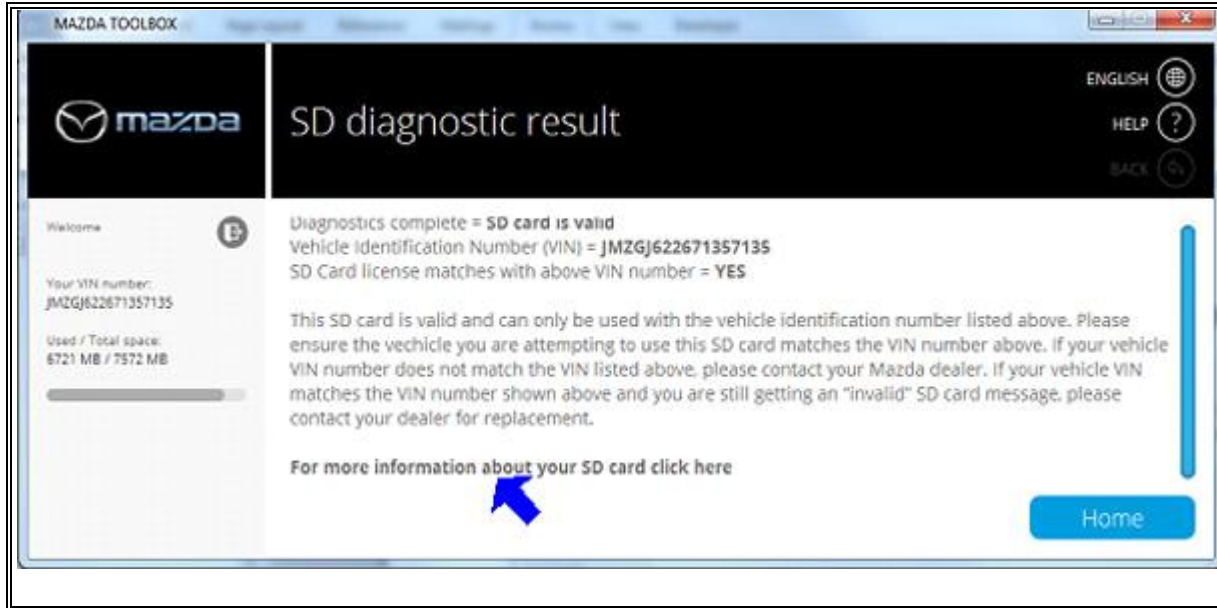
Wait while the card is being analyzed, note this may take several minutes.

MAZDA CONNECT Error Message	SD Card diagnostic	VIN Information	Dealer Action
Invalid SD Card	SD Card is valid	VIN matches the customer's vehicle	Update the SD card for the customer
Invalid SD Card	SD Card is valid	VIN does not match the customer's vehicle	Replace the SD card with a new one***

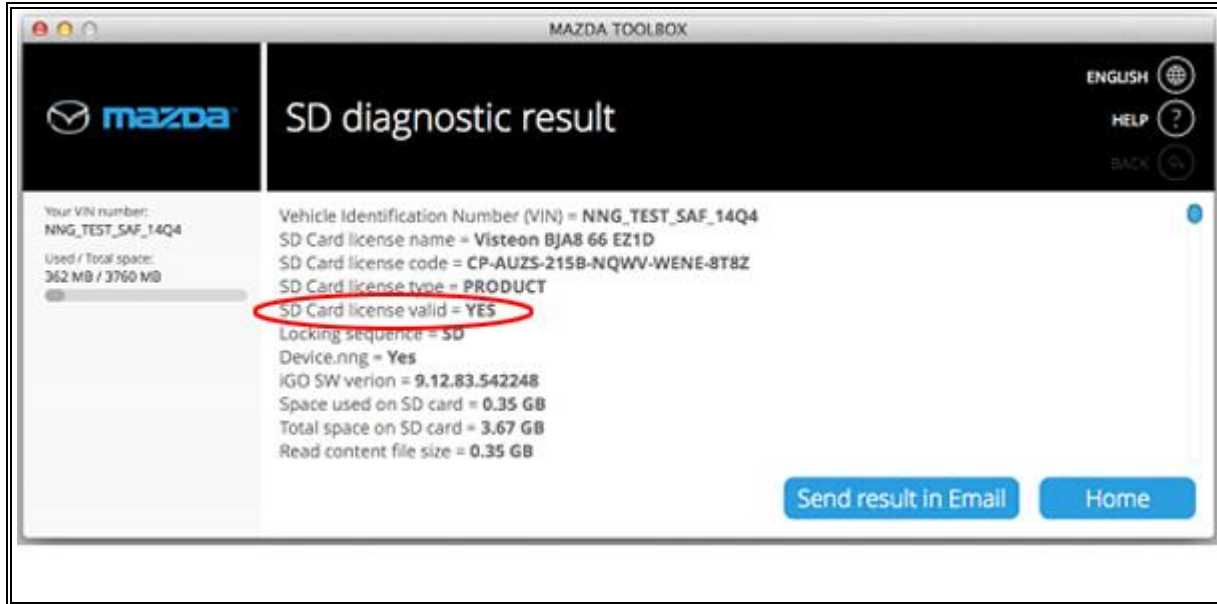
For additional SD diagnostic result information, click "For more information about your SD card click here."

SD Card license valid =	Dealer Action
Yes	Update the SD card for the customer
No	Replace the SD card with a new one*
