TECH TALK

Volume 236 - January 2018

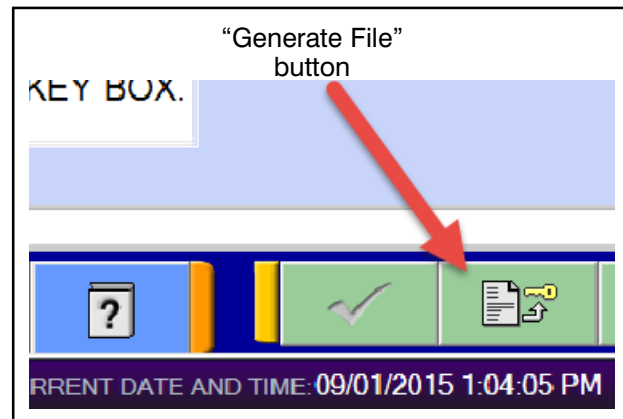
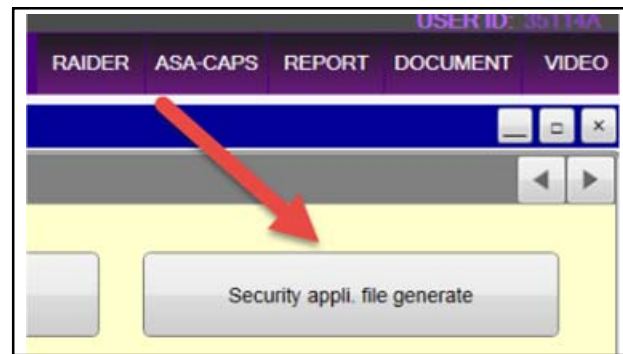
1. Download the security permission file again and attempt to use it again to confirm the file is not working correctly.
2. Confirm you are seeing the error screen shown above.
3. Once the error screen is confirmed, generate a *Security application file* from the vehicle. This file will be used to obtain a new security permission file.

Depending on the vehicle, this is done by either clicking on the “generate file” button at the bottom of the screen, or by returning to a previous screen and clicking on the “Security appli. File generate” button. The file generated will automatically go into a folder in the scan tool.

4. Once the Security Application file has been generated, open a new Techline case for this vehicle.
5. Contact the MEDIC hotline (1-800-846-7575) to retrieve the file from the scan tool. Have MEDIC hotline attach the file to the Techline case and email it to: mmnatechline@mmsa.com.

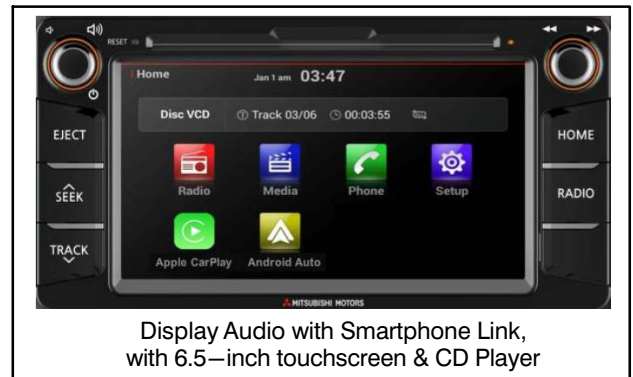
“The issues described in TIN-17-54-002 (unresponsive audio system buttons after making a phone call using an iPhone® with iOS 11.0 or 11.0.1 and Apple CarPlay™) have now been resolved with iOS 11.1, released by Apple on November 1, 2017.

If a customer has experienced any of these concerns, please have them update their iPhone with iOS 11.1.”

NOTE: MMNA has verified that the issue is resolved with iOS 11.1 and later versions.
