# Entune/Navigation Software Update Process for Display Audio (Non-HDD Type)

**Market** USA

The information contained in this bulletin supersedes SB No. T-SB-0026-12.

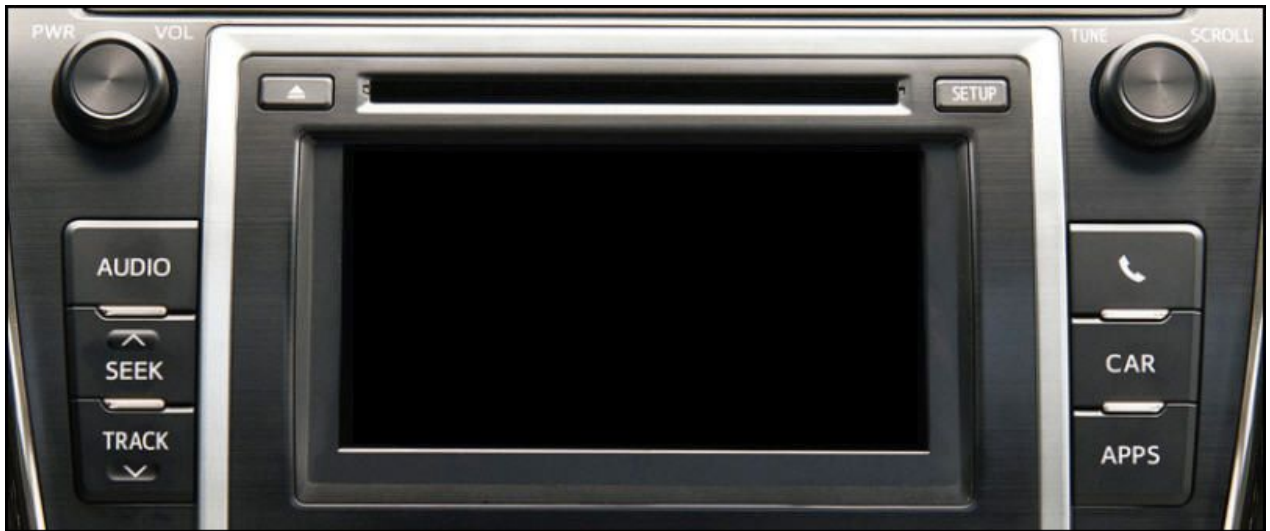
**NOTE**

- Non-HDD Type Navigation units have a CD slot visible on the front of the radio.
- HDD Type Navigation units have a tilt-open navigation screen and CD slot behind the screen.
