Technical Service Bulletin

Mazda North American Operations
Irvine, CA 92618-2922

Subject: CONDENSATION / FOG IN FRONT AND REAR COMBINATION LAMPS (HEADLAMP AND TAILLAMP ASSEMBLIES)	Bulletin No.: 09-011/18
	Last Issued: 03/22/2018

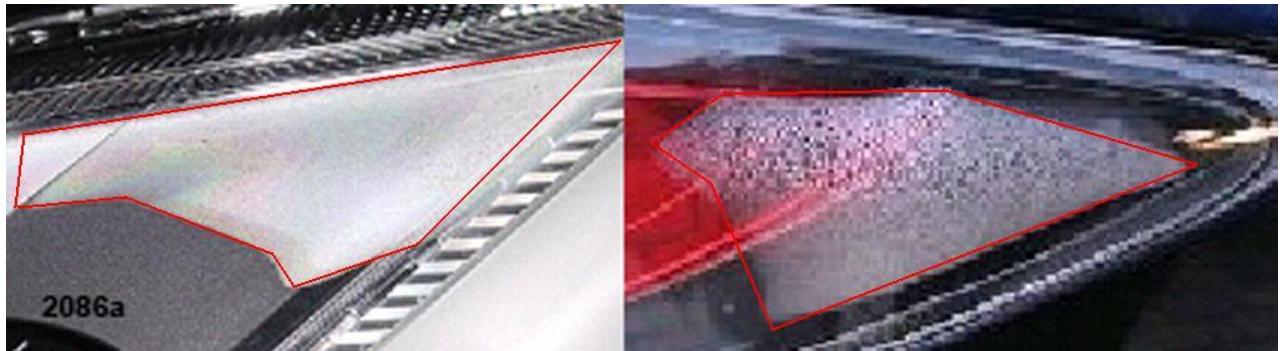
Some customers may complain of condensation/fog inside the front (headlamp/headlight) or rear (taillamp/taillight) combination lights. The recent new models have been fitted with a clear lens which can cause the symptom to be more noticeable, however, it does not affect the performance of the light. This condensation/fog is a natural phenomenon that occurs when there is a fairly large temperature difference between the inside and the outside of the light housing. It is normal for very small water drops to appear in certain locations on the light units where the air is stagnant (condensation), making the lens look whitish (fog). This happens mostly in the corners and narrow spaces, and will typically clear during warmer ambient temperatures, or when the lights have been on for some time.
