Service Bulletin

Bulletin No.: 08-08-57-007D

Subject: Excessive Midgate Closing Effort and/or Water Leak, and/or Tonneau Cover, Cargo to Midgate Water Leak

Models: 2006-2013 Cadillac Escalade EXT
2006-2013 Chevrolet Avalanche

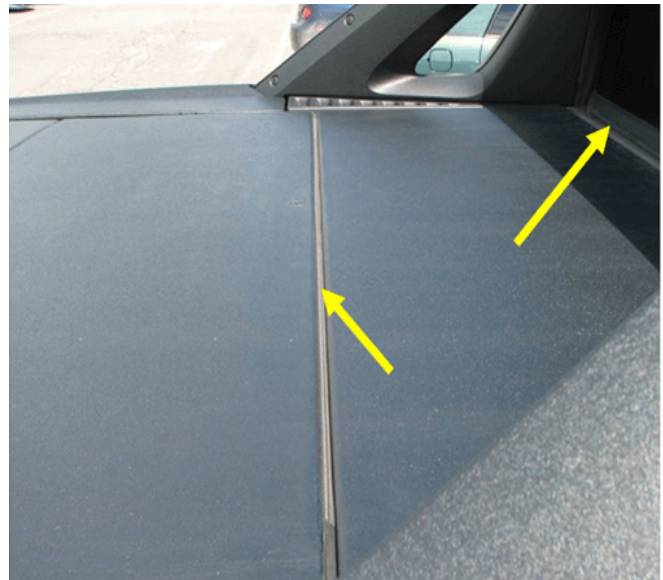
3807030

12. The remaining strikers on the same side of the vehicle may need to be repositioned to maintain proper cover to cover seal clearance and compression.

13. Once the strikers are readjusted, install the tonneau or cargo covers. To ensure proper location, install each cover in order, securing the LH side latch first, then the RH latch.
14. Verify that the cover to cover seal interfaces are correct by sighting each joint from cross vehicle position to ensure that the interfaces are parallel and uniform. Refer to the image above.
15. If the covers are not properly aligned, remove the covers and adjust the striker positions opposite the repair side to align the seal interfaces. Once the adjustment is complete, reinstall the covers in order, securing the LH side latch first, then the RH latch.
16. Thoroughly test the entire tonneau or cargo cover sealing system, including the side opposite the repair, for water leaks to ensure a complete repair. Repeat the adjustment process if water leaks are still observed.
