# Technical Service Bulletin

SUBJECT:		No: <b>TSB-18-42A-001</b>	
<b>RUST ON QUARTER PANEL</b>		DATE: <b>April 2018</b>	
		MODEL: <b>2011-14 Outlander Sport/RVR</b>	
CIRCULATE TO:	<input type="checkbox"/> GENERAL MANAGER	<input checked="" type="checkbox"/> PARTS MANAGER	<input checked="" type="checkbox"/> TECHNICIAN
<input checked="" type="checkbox"/> SERVICE ADVISOR	<input checked="" type="checkbox"/> SERVICE MANAGER	<input checked="" type="checkbox"/> WARRANTY PROCESSOR	<input type="checkbox"/> SALES MANAGER

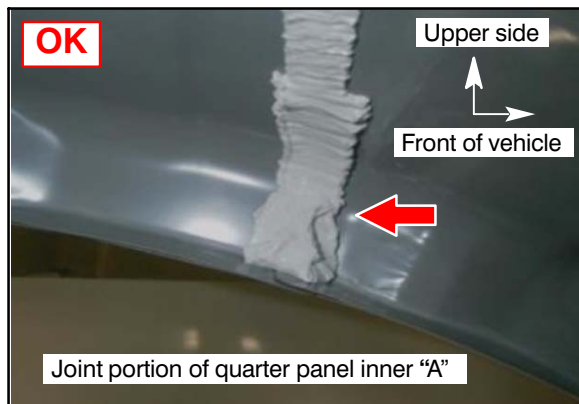
**NOTE:** The photos for steps 6 and 7 are taken from a vehicle in production for easier identification. Customer vehicles have an under body protection coating in the inner wheel arches covering the sealant.

- 5. Repair all rusted areas according to the applicable Service Manual as necessary.
- 6. Apply sealant to fully cover the edge of the joint portion of the inner quarter panel, inner quarter panel extension, and outer side panel.
