SERVICE BULLETIN

APPLICABILITY: 2013-14MY Legacy and Outback Models with 2.5L FB Engines
 2011-14MY Forester Models with 2.5L FB Engines
 2015 MY Forester (Manual Transmissions Only) with 2.5L FB Engines
 2012-13 MY Impreza and XV Crosstrek Models with 2.0 FB Engines
 2014-15 MY Impreza and XV Crosstrek Models (Manual Transmissions Only) with 2.0 FB Engines

NUMBER: 02-157-14R
DATE: 08/28/14
REVISED: 04/13/16

SUBJECT: Engine Oil Consumption

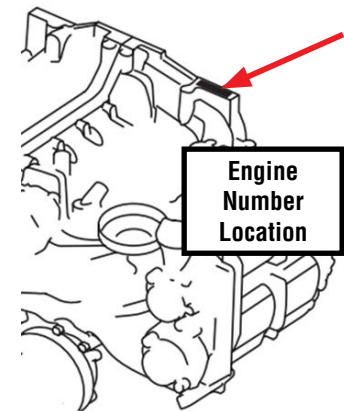
* **NOTE:** When determining the engine number, use the **LAST 8** characters of the number stamped into the boss on top of the block adjacent to the starter and shown in the illustration. The engine number range for the FA1 assembly line is 800000 to 930025 and the FB2 range is 000000 to 652640.

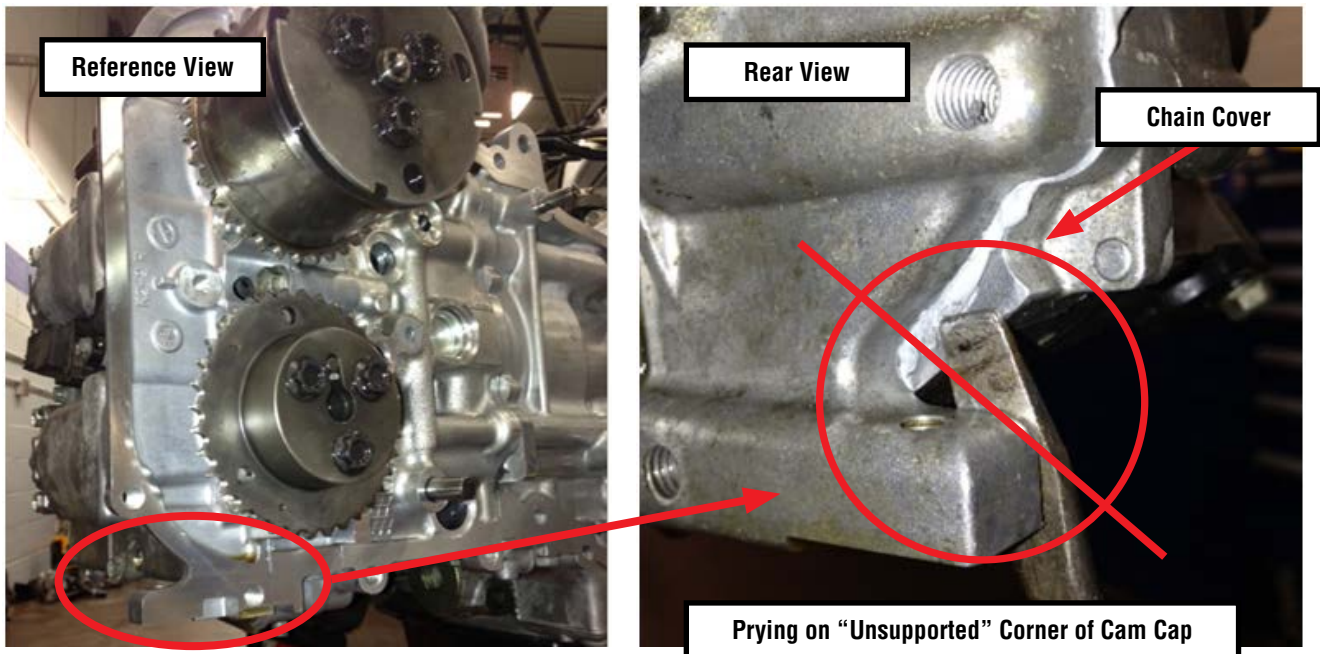
- IMPORTANT:** After all 32 bolts securing the chain cover are removed, be **EXTREMELY** careful where you pry and what you pry on to break the silicone sealant's bond. The photos below show an example of where **NOT** to pry. In this case, the cam cap became cracked requiring a complete cam carrier replacement. *Patience is the key!*
