JTB00457NAS1

TECHNICAL BULLETIN

303-04E: Fuel Charging and Controls - Turbocharger

Whine/Whistle Noise From The Turbocharger

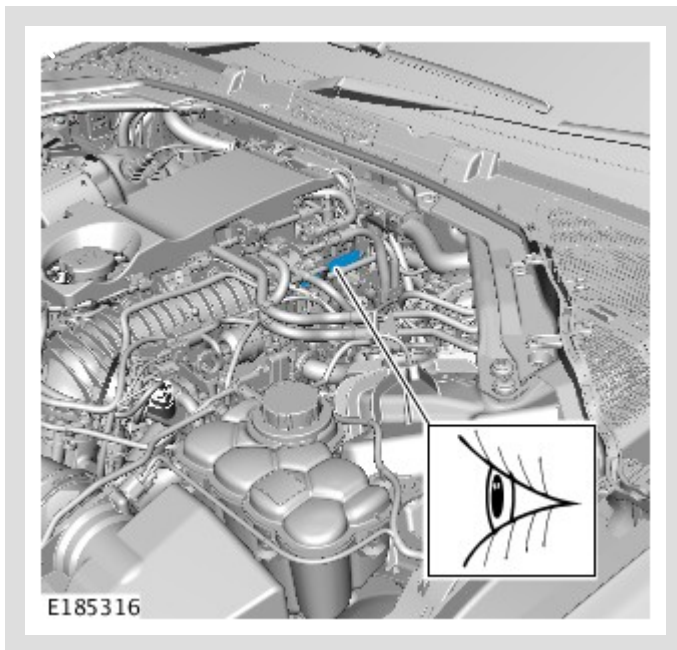
Locate and record the engine serial number.

- If the engine serial number is higher than **151002W0302**, do not continue with this Technical Bulletin.
- If the engine serial number is **151001W0302** or lower, go to the Workshop Procedure below.
