SERVICE BULLETIN

APPLICABILITY: All 2015-17MY Vehicles with Fujitsu TEN (F10) 7in. Multimedia Navigation (AVN) & Display Audio Units
NUMBER: 15-177-14R
DATE: 10/16/14
SUBJECT: “Gen 2” & “Gen 2.1” Operating Tips
REVISED: 06/11/18

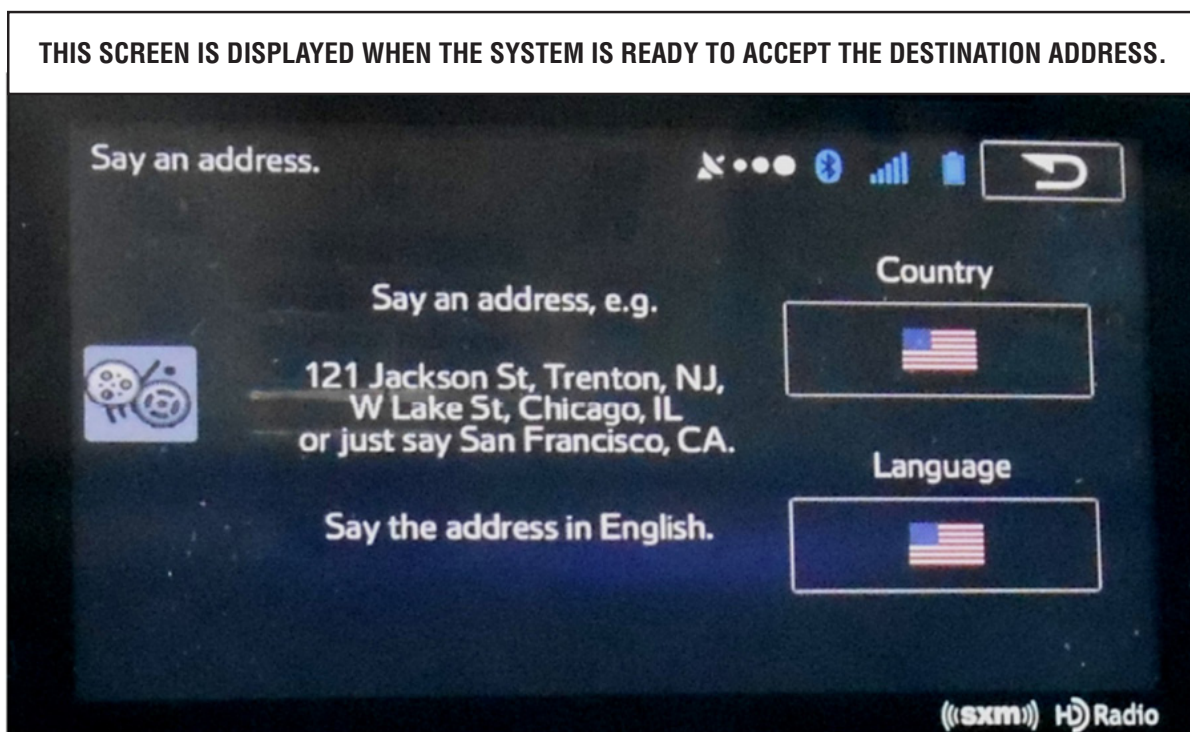
CONDITION #3: Unable to set up the “Destination Address” using voice command.

Incorrect command: 121[pause] Jackson [pause] Street [pause] Trenton [pause] NJ

Correct command: 121JacksonStreetTrentonNJ

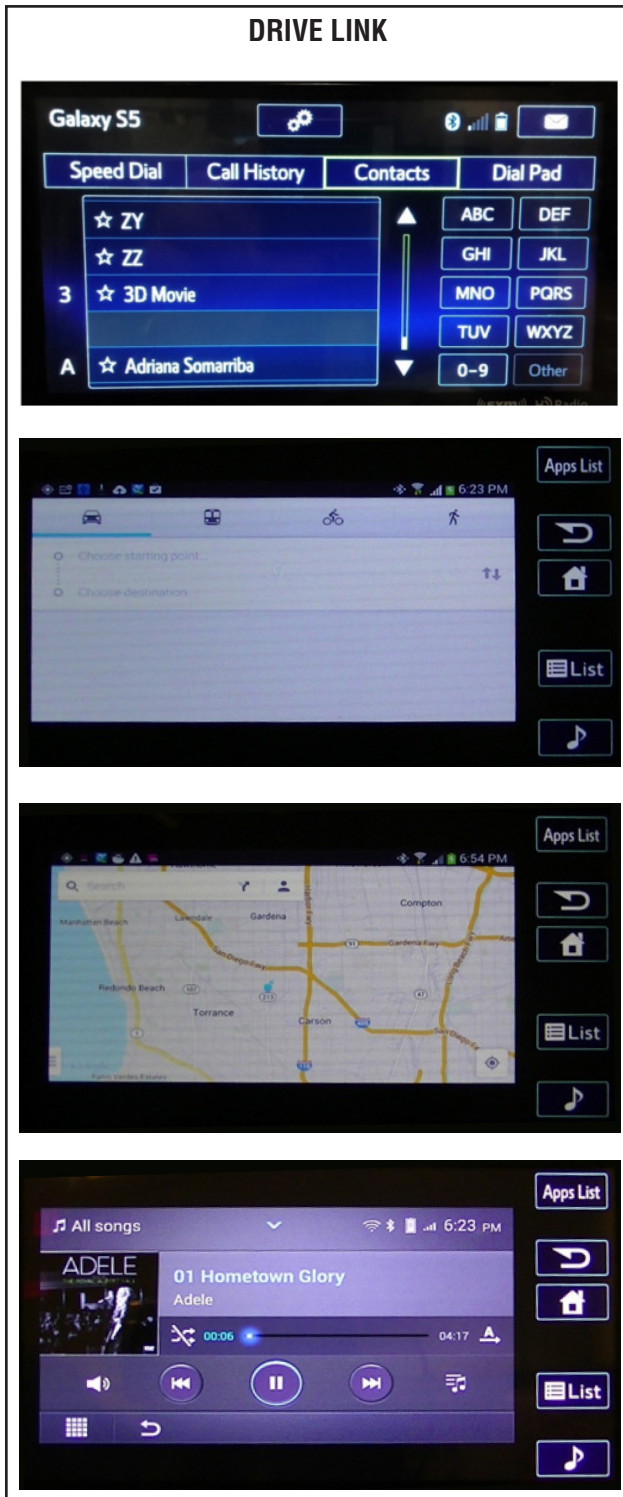
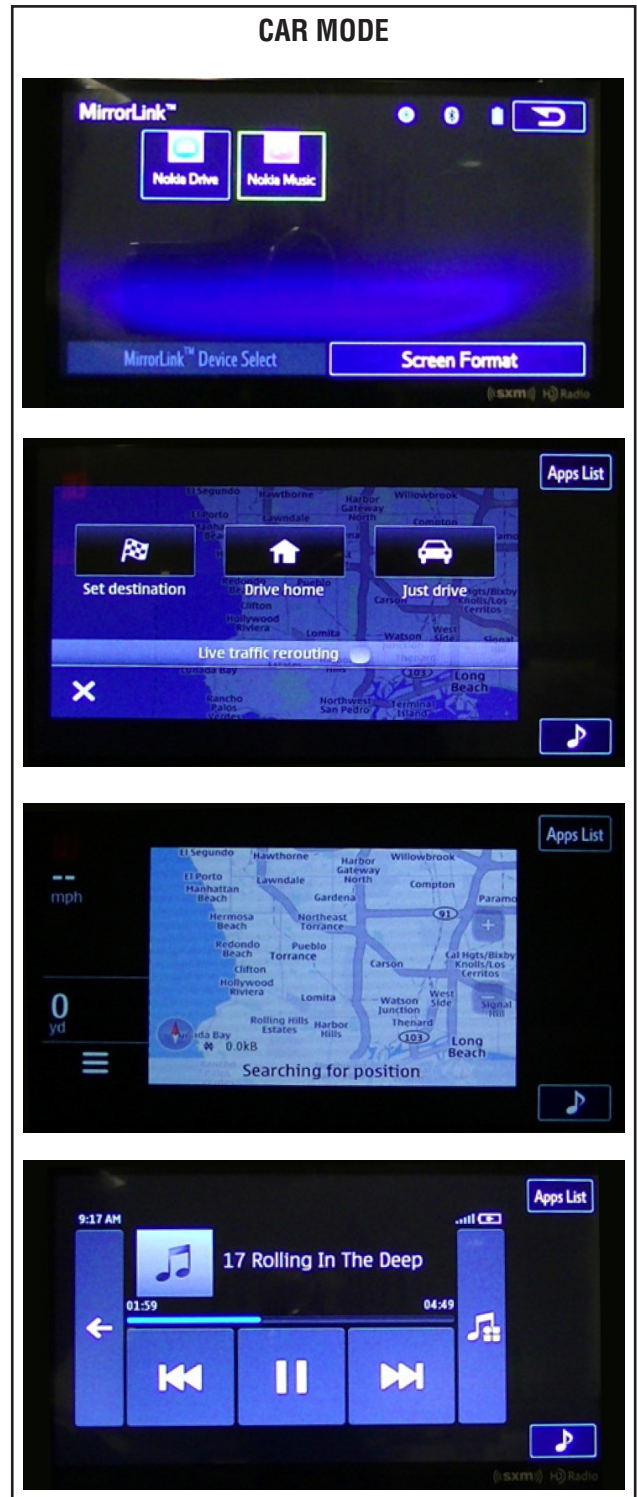
CONDITION #6: MirrorLink screen does not look the same when using “Drive Link” and “Car” mode.

Explain to the customer, Drive Link and Car modes will display information differently when accessing the MirrorLink feature of the head unit. Examples of each are shown in the screen shot photos below.

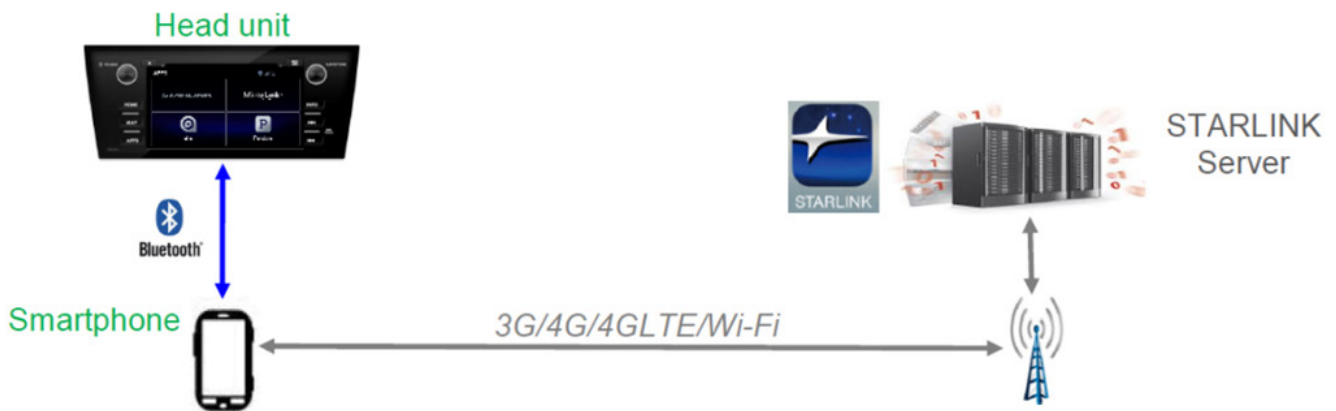
CONDITION #8: When selecting the STARLINK function on the head unit, an error message appears on the screen as shown below.

- STARLINK application on the Smartphone was not loaded and/or launched on the Smartphone prior to selecting the STARLINK function on the head unit. Therefore, Smartphone cannot communicate with STARLINK Server.
- Smartphone has not been paired with the head unit for Bluetooth connection

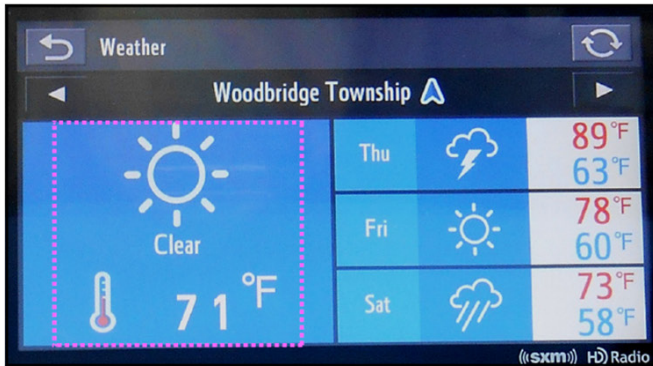
Weather information via STARLINK

CONDITION #11: Weather information from the “STARLINK” and “INFO” function appears to be different even when the time of day and location are exactly the same.

In the examples shown below, the temperature displayed is different even though the time of day and location are the same.

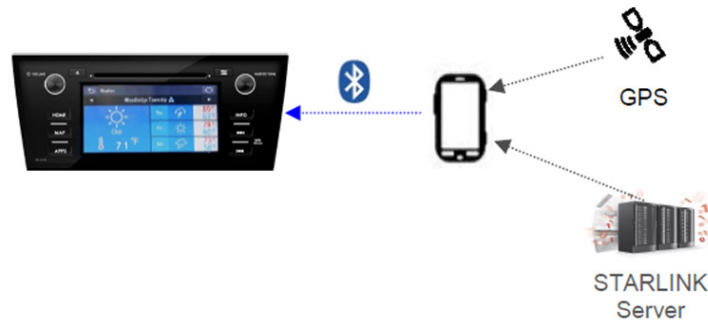
- **Weather via STARLINK:** Current location is determined by GPS signals received by the Smartphone paired to the head unit. The actual weather information is sent from the STARLINK server.

Explain to the customer that the STARLINK and INFO functions utilize different sources to provide the displayed weather information as shown in the illustrations below.

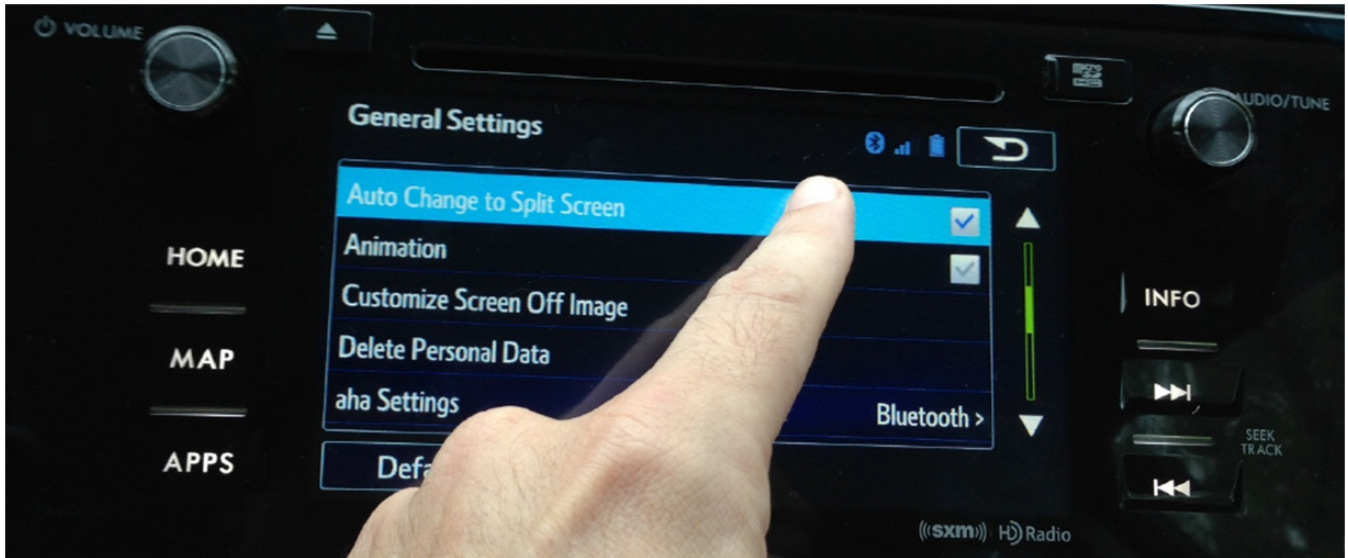
CONDITION #16: After 30 seconds of not pressing any buttons, the screen automatically displays a split screen view

- Follow the procedure below to turn off the “Auto Change to Split Screen” setting:
 1. Select “Home”
 2. Select “Settings”
 3. Select “General”
 4. Scroll down to “Auto Change to Split Screen” and uncheck the setting.

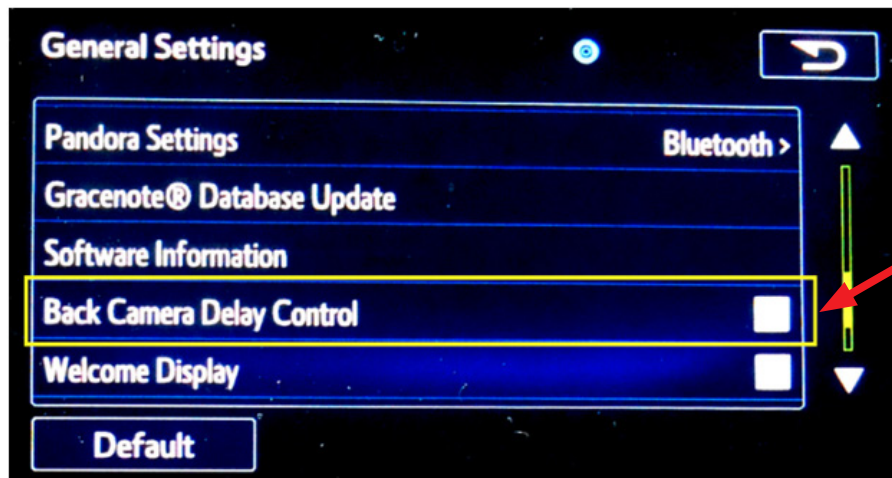
CONDITION #17: Back-up camera image remains displayed after shifting out of Reverse

Disable “Back Camera Delay Control” setting by following the steps below:

1. Touch “HOME” button.
2. Touch “SETTINGS” button.
3. Touch “General”.
4. Unselect the “Back Camera Delay Control”.

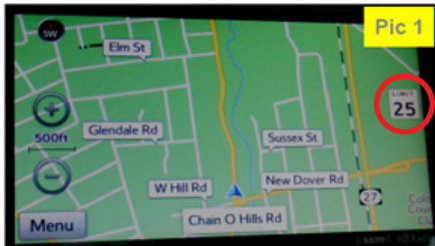
Speed Limit Displayed

Display of the Speed Limit takes priority over Warning Sign Alerts and Alert Point Warnings. If the Speed Limit is being displayed as shown in Pic 1 below, the other warnings will not be displayed.

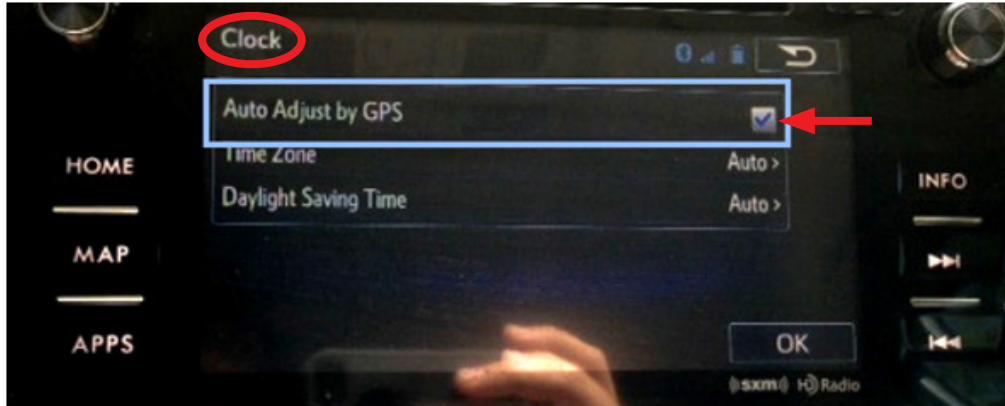
CONDITION #23: The clock display on HVAC panel is incorrect even when “Auto Adjust by GPS” is selected on the Clock settings menu.

The correct time is 4:59 pm but HVAC display shows 8:59 pm.

When a map SD card is removed from the AVN unit or the map SD card cannot be read properly by the AVN unit, the time displayed on the HVAC panel will automatically default to Greenwich Mean Time (GMT). In this case, the GMT is 4 hours “ahead” of local time.

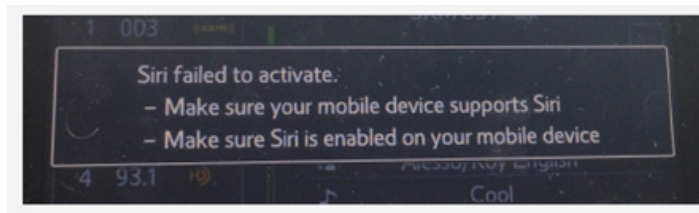
Pic 3

3. The message shown in (Pic 3) will display when a Siri-compatible phone is paired but “Siri” has not been enabled on the phone.

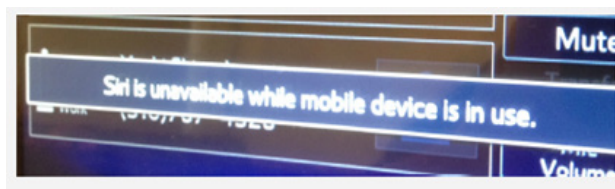
Pic 4

4. The message shown in (Pic 4) will display when Siri is initiated during a call. Siri will not operate while a call is in progress.

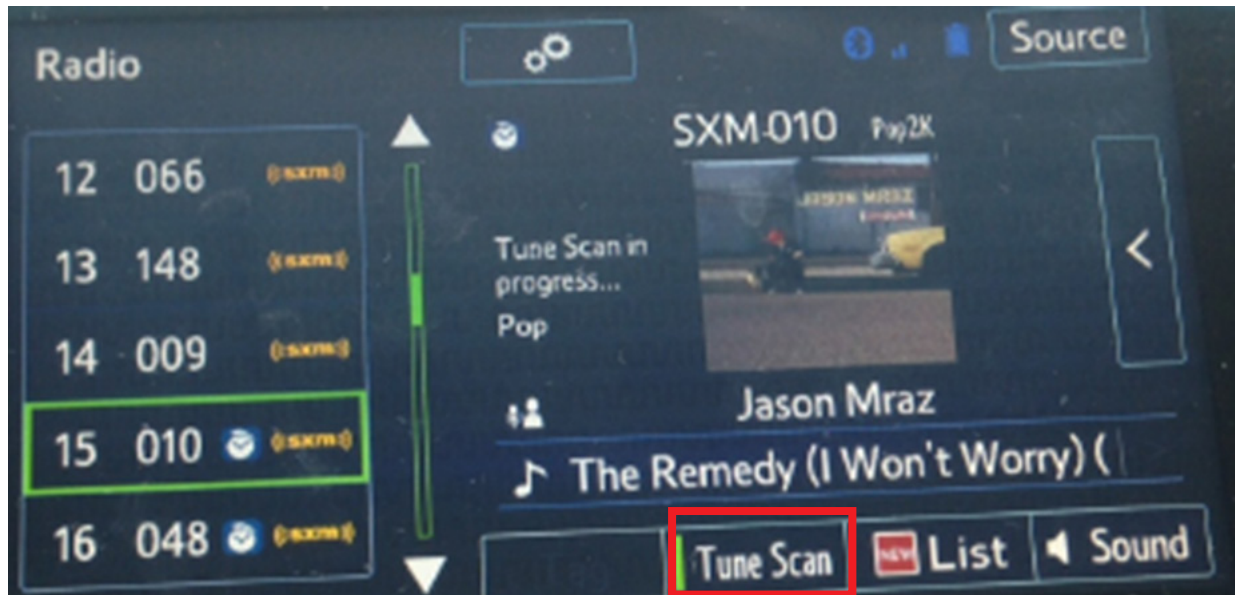
Are SXM preset channels stored as “Smart Favorites”?

YES: Wait for several minutes after the unit has received SXM signal for the “Tune Scan” button to become available.

NO: Store SXM preset channels as “Smart Favorites” then wait for several minutes after the unit has received SXM signal for the “Tune Scan” button to become available.

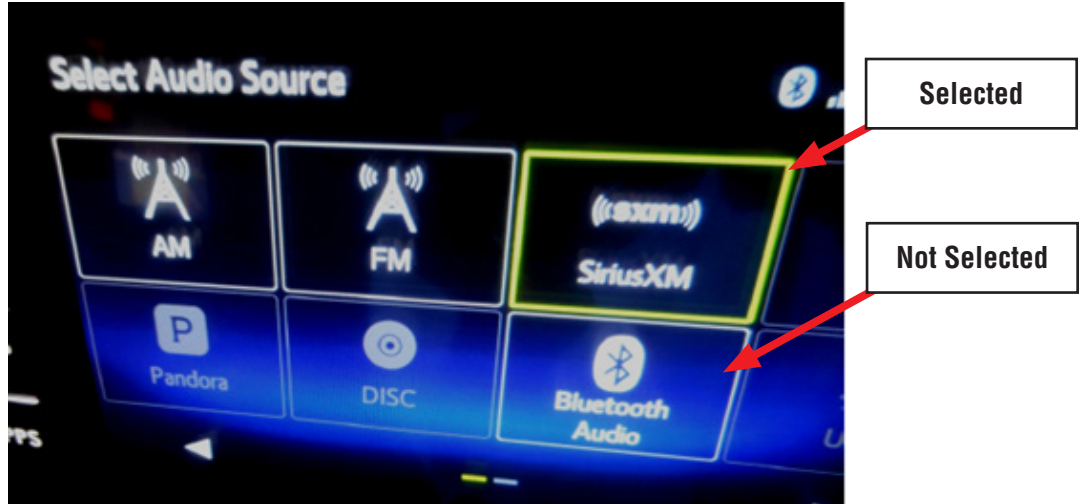
CONDITION #27: Navigation voice guidance cannot be heard from the vehicle speakers when the destination was requested by Siri (iPhone App) (2016 MY vehicles equipped with Gen 2.1 Navigation / Display Audio system)

Bluetooth Audio is not selected as an Audio Source.

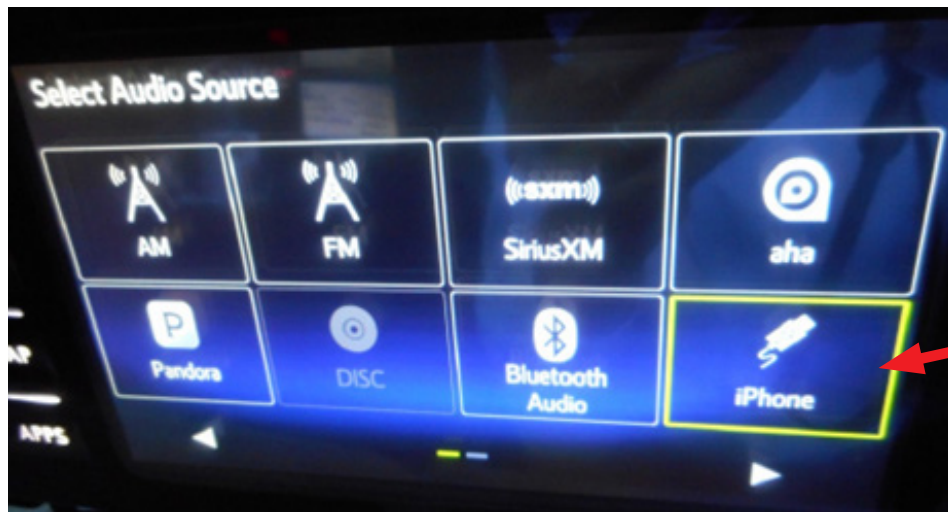
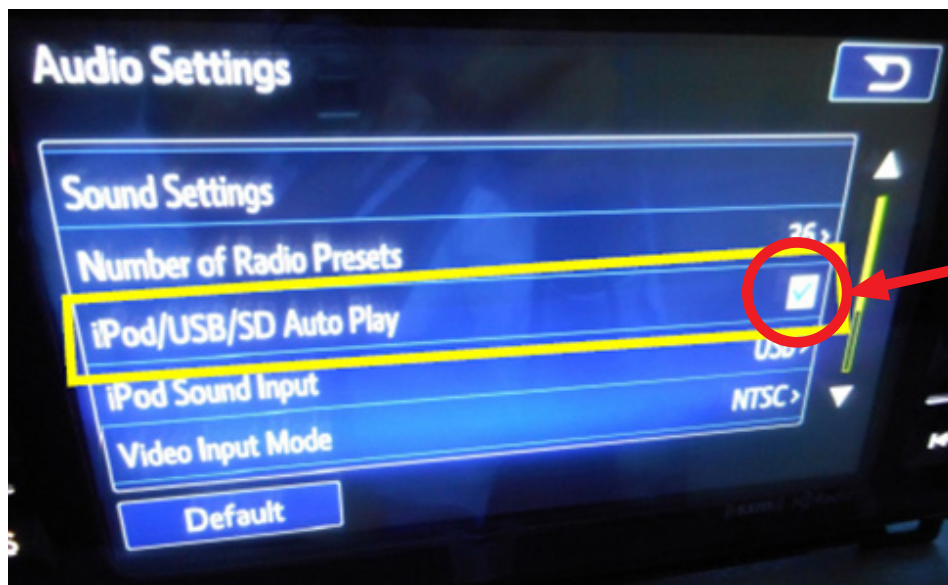
CONDITION #28: When connecting an iPhone to the USB port to charge it, the Audio Source automatically switches to iPhone.

If the unit automatically “defaults” to iPhone mode, the “iPod/USB/SD AutoPlay” setting is selected (activated / checked) on the Audio Settings screen.

If the user does not want the unit to switch to an “iPhone” mode automatically when an iPhone is connected to the USB, disable the “iPod/USB/SD Auto Play” setting by following the steps below:

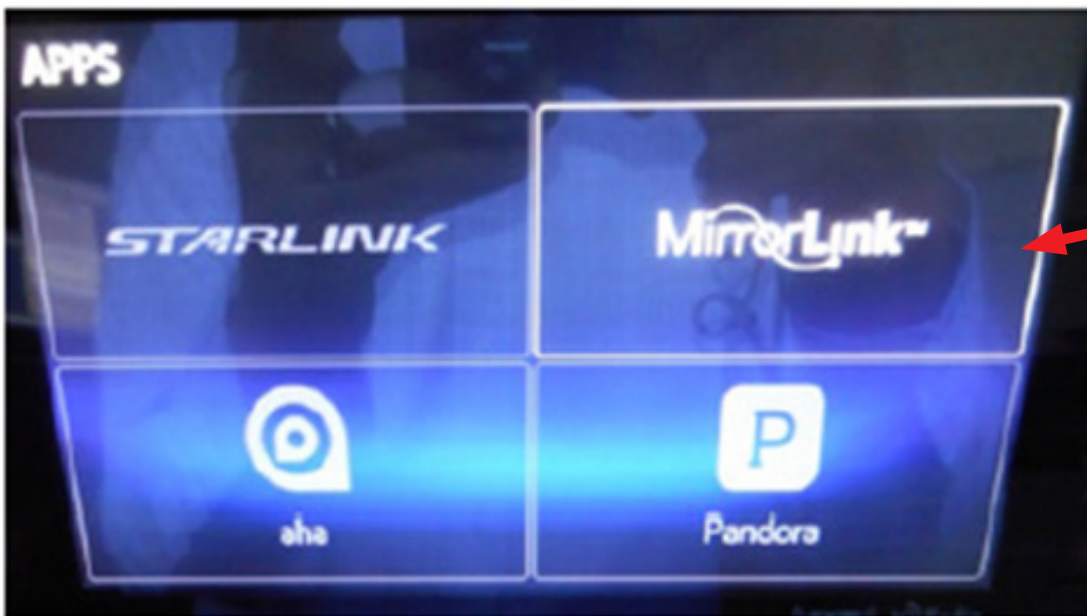
CONDITION #29: The “MirrorLink” button in the APPS screen is not active (grayed out).

- (1) Once MirrorLink compatibility with the phone has been confirmed, install MirrorLink-enabled app.
- (2) After installation is complete, connect the phone to the USB port.
- (3) Wait until the MirrorLink button becomes active on the APPS screen.

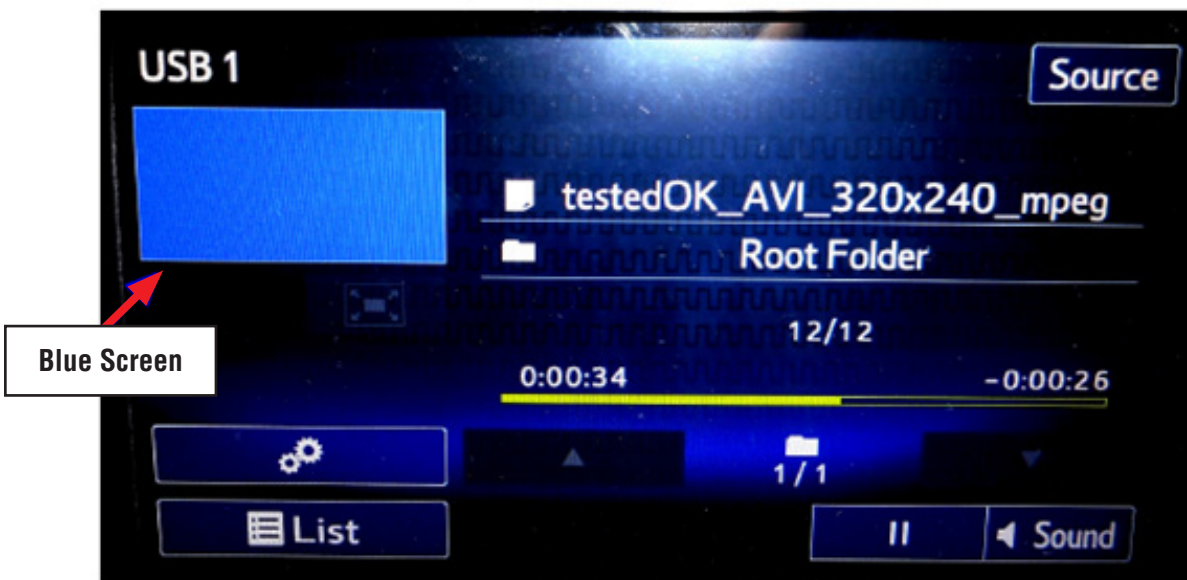
REMINDER: The parking brake must be engaged in order to watch videos. If not, the unit will display the blue screen as shown below but audio will be heard normally.

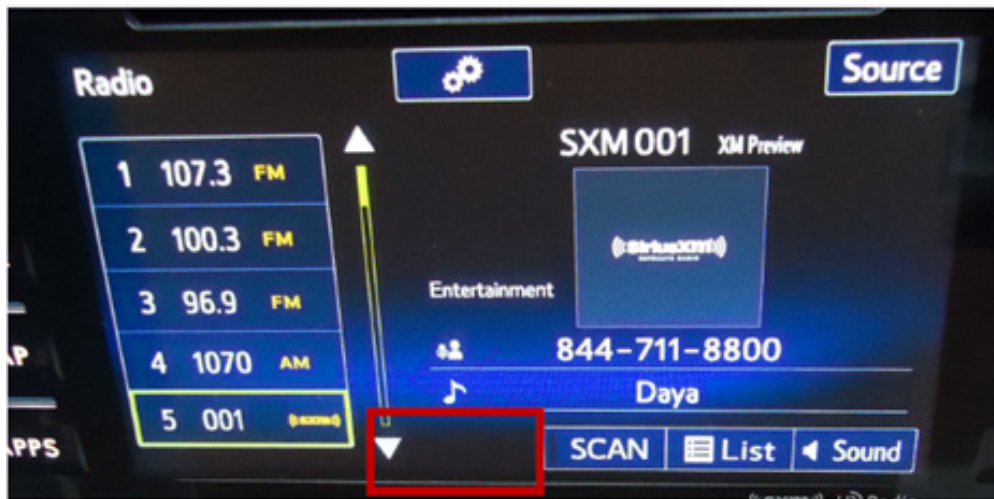
CONDITION #31: The “Tag” button cannot be selected on the Sirius XM Screen

Determine if the vehicle is Canadian or U.S. specification.

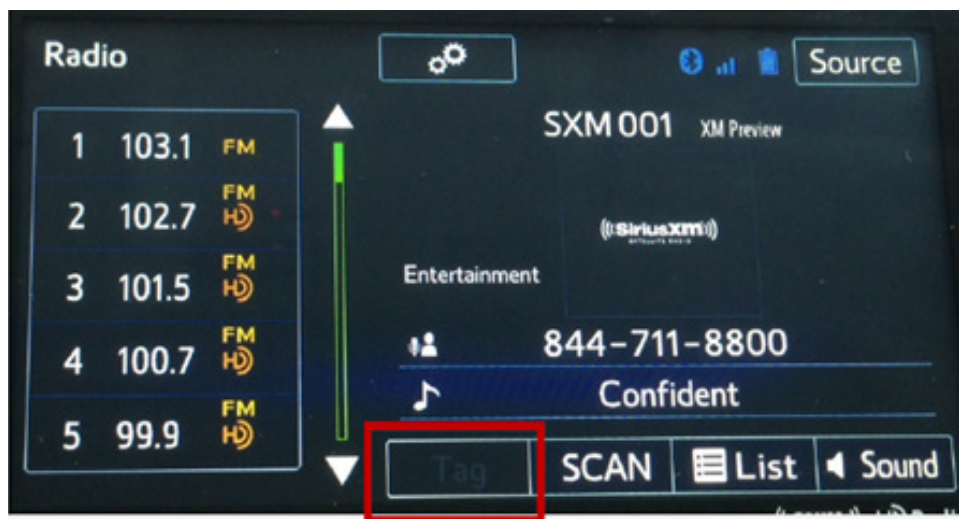
Canadian specification: NO Tag button

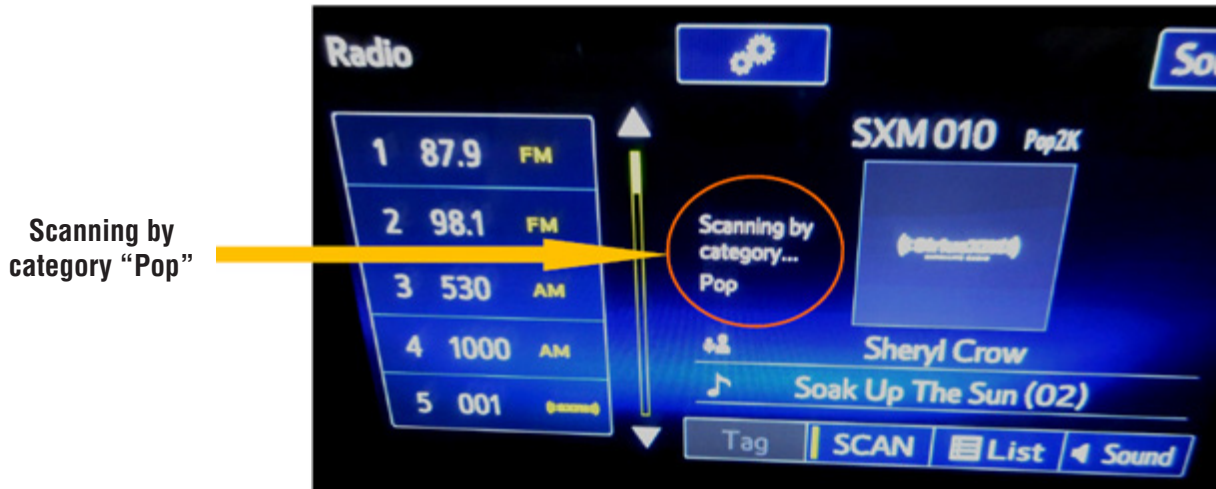
CONDITION #32: Cannot scan or seek through all SXM channels using the Seek, Scan and / or Steering Wheel buttons (2016 MY vehicles equipped with Gen 2.1 Navigation / Display Audio system)

The unit will only scan or seek through the category being listened to when it is in the SXM mode.

EXAMPLE: If you are listening to CH2, which is under a “Pop” category, and press the scan button, it will only scan channels (CH3, 4, 5, 6, 7, 8, 9, 10, 13, 14, 15, 16, 17, 18, 158, 300, 301, 302 and 2) which are under the Pop category, not all channels or categories.

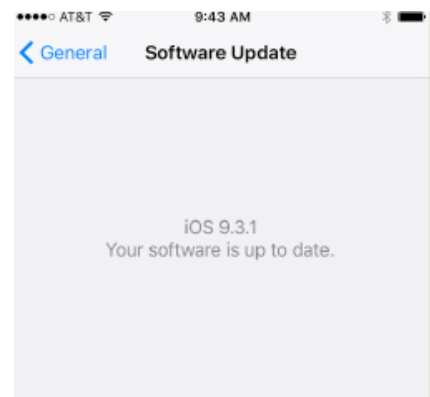
CONDITION #35: After using the Siri feature (2016 MY vehicles equipped with Gen 2.1 Navigation / Display Audio system), the head unit will automatically change from whatever audio source the user was listening to, over to the Bluetooth Audio Source. Why does that condition occur?

It is caused by iOS software versions 9.2 and 9.21.

Suggest the customer update their iPhone’s software to iOS version 9.3.

NOTE: The user may need to delete their iPhone’s Bluetooth connection then re-pair the phone after the software update is complete to verify the condition has been addressed.

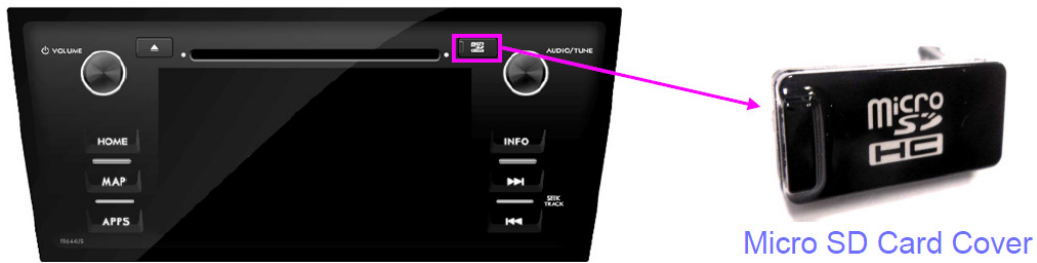
CONDITION #36: Replacement procedure for lost or damaged Micro SD Card covers

If the Micro SD card slot cover is lost or damaged, a replacement is available directly from F10

Use the existing exchange unit (web order) form. Enter “SD card cover missing” and Retailer Purchase Order number (PO#) in **Section 3: Customer Complaint / Technician Findings** box as shown below. The charge for a replacement card slot cover is \$30.00.

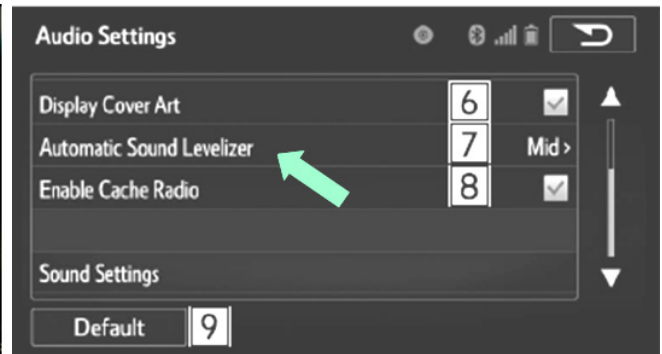
CONDITION #38: ASL (Automatic Sound Levelizer) function does not appear in Audio Settings as indicated in the Owner's Manual.

ASL function as described in Owner's Manual.
