Date: 30.04.2013

Model: Elise/Exige & Evora fitted with Bosch ESP8 brake modules

Number: 2013/04

Generation of C0460 Pressure sensor failure fault code.

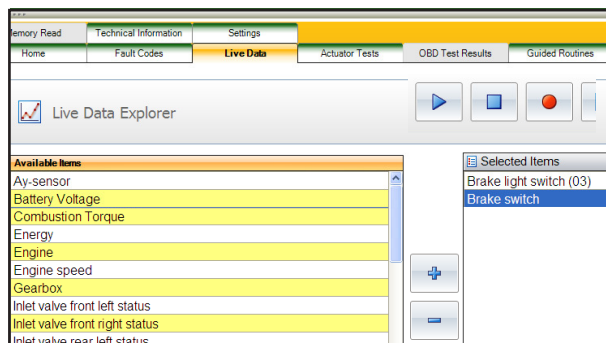
1. With TechCentre connected to the vehicle and ignition on select ABS brakes>Live Data:
2. From the 'Available Items' table, select:
 - Brake light switch (03).
 - Brake switch.

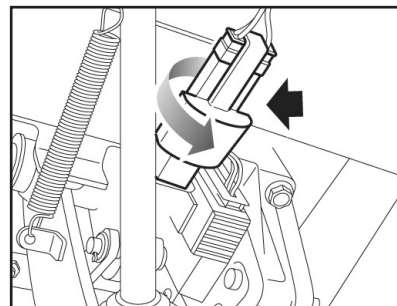
4. Gently push the brake light switch plunger inwards towards the housing until light resistance is met, select the 'play' option from Lotus TechCentre and then gently release the plunger whilst examining the readings shown on the live data screen.

If the switch is operating correctly then the TechCentre live data readings should change in this order:

- Brake switch: (1st stage) - Actuated
- Brake Light Switch (03): (2nd stage) - Actuated

If the correct readings cannot be displayed then the brake switch should be replaced, operation of the new switch checked (as above) before adjusting and fitting on the vehicle.
