SERVICE INFORMATION BULLETIN

APPLICABILITY: 2015-2017MY Legacy and Outback
 2015-2016 Impreza
 2015-2017 Crosstrek
 2016-2018MY Forester
 2016-2018MY WRX

NUMBER: 15-205-16R

SUBJECT: Reprogramming File Availability to Address Operational Concerns with “Gen 2.0” and “Gen 2.1” Fujitsu-TEN (F10) Navigation and 7” Display Audio Units

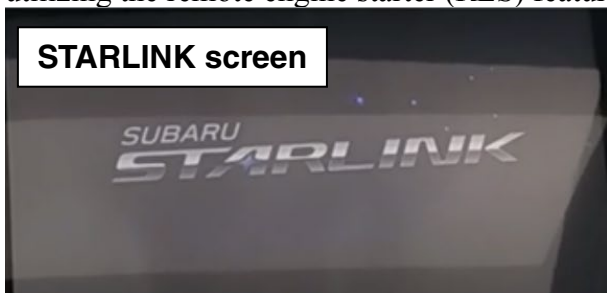
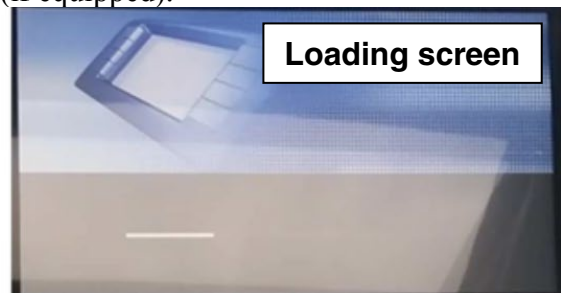
- The Navigation system re-boots from the Loading screen (not the STARLINK screen) when utilizing the remote engine starter (RES) feature (if equipped).

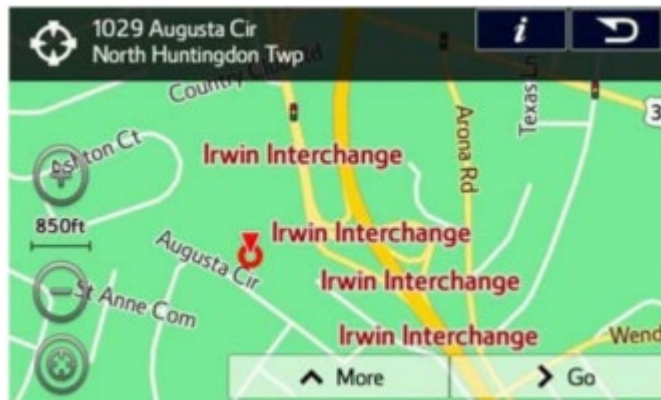
Symptom 6: Roads or interchanges have the same name displayed multiple times.

Change: Logic update to show only one road or interchange name at the same time.

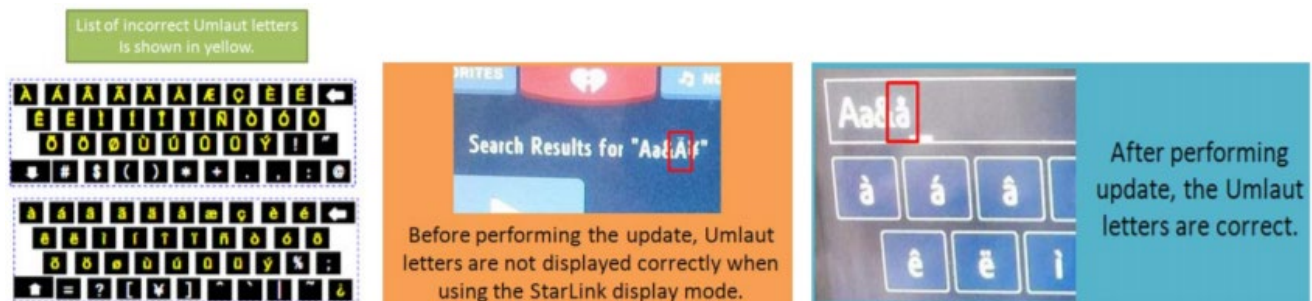
Symptom 11: Incorrect Umlaut characters are shown on STARLINK display.

Change: Logic change to allow proper display of Umlaut letters.

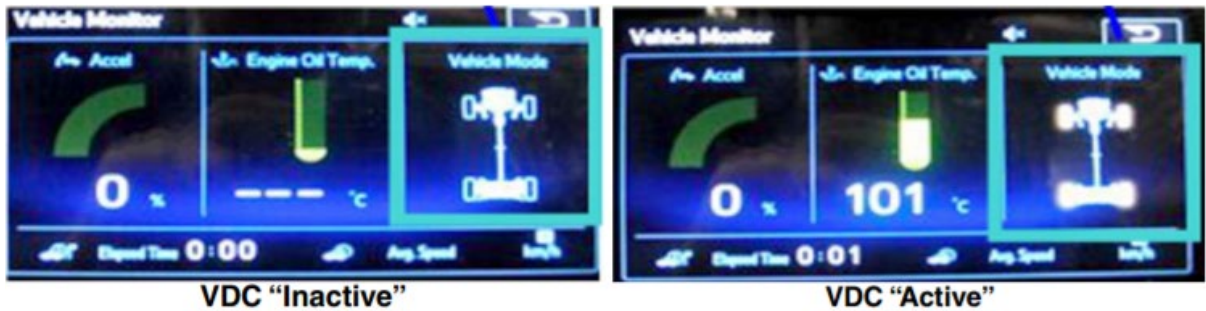
- Logic change to provide a “_” (underscore) character on the keyboard.
- Logic change to match engine oil maintenance remaining mileage on the maintenance reminder screen to the odometer meter value on the combination meter when mileage unit is set to read in “KM” (kilometers).
- Logic change to insure the Vehicle Mode indicator on the Vehicle Monitor screen matches the actual vehicle status. Example: The wheel indicators on the vehicle monitor screen no longer stay illuminated indicating VDC is “active” after VDC activation is complete.
