## SERVICE BULLETIN

**APPLICABILITY:** 2014-15MY XV Crosstrek Hybrid Electric Vehicle (HEV) **NUMBER:** 16-94-15R  
**SUBJECT:** Diagnosis and Repair of DTCs P172A and P0B0B **DATE:** 07/30/15  
**REVISED:** 07/09/18

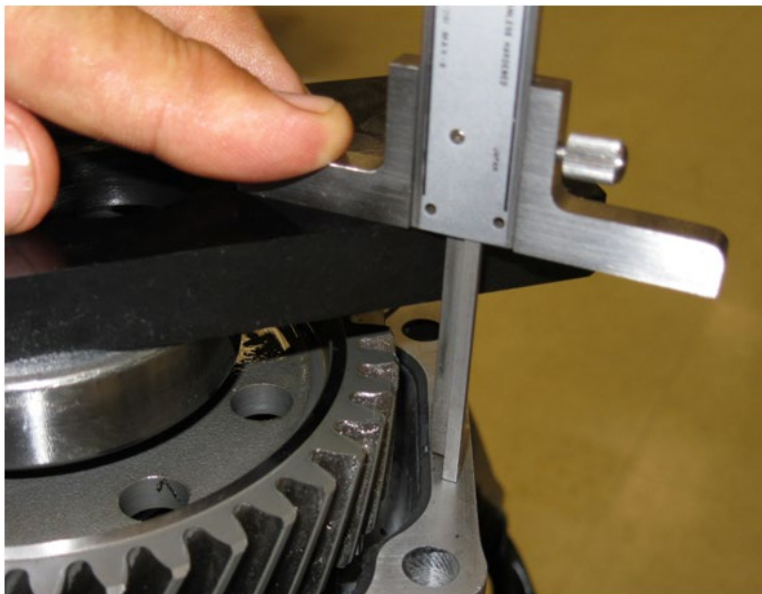
0.05 — 0.25 mm (0.002 — 0.01 in): Clearance

Transfer driven gear shim	
Part No.	Thickness mm (in)
33280AA060	0.3 (0.012)
33280AA070	0.4 (0.016)
33280AA080	0.5 (0.020)

Once all of the proper shim thicknesses have been determined, proceed with reassembly following the procedure outlined in the applicable Service Manual.
