SERVICE INFORMATION BULLETIN

APPLICABILITY: 2015-2017MY Legacy and Outback
 2015-2016 Impreza
 2015-2017 Crosstrek
 2016-2018MY Forester
 2016-2018MY WRX

NUMBER: 15-205-16R

SUBJECT: Reprogramming File Availability to Address Operational Concerns with “Gen 2.0” and “Gen 2.1” Fujitsu-TEN (F10) Navigation and 7” Display Audio Units

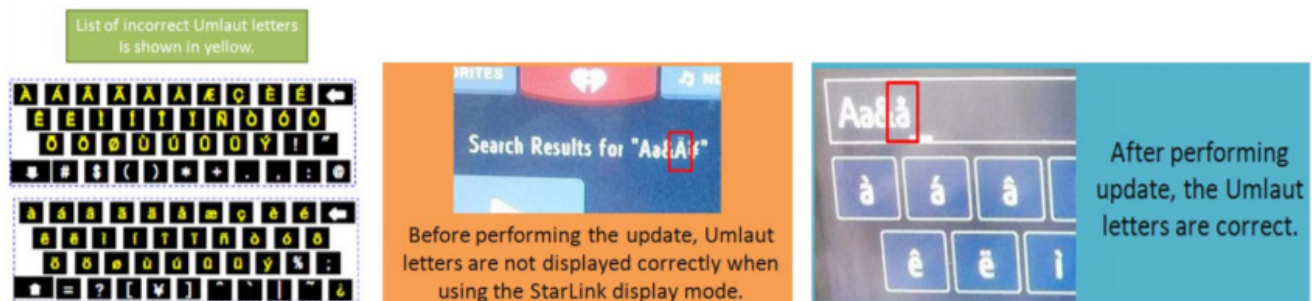
Symptom 11: Incorrect Umlaut characters are shown on STARLINK display.

Change: Logic change to allow proper display of Umlaut letters.
