## Technical Information Bulletin

### E214

MY17/18 PACCAR MX-13 EGR DTC's P103C, P1711, P1719, and/or P3818; DPF/SCR restrictions; and/or high oil consumption.

8/23/2018

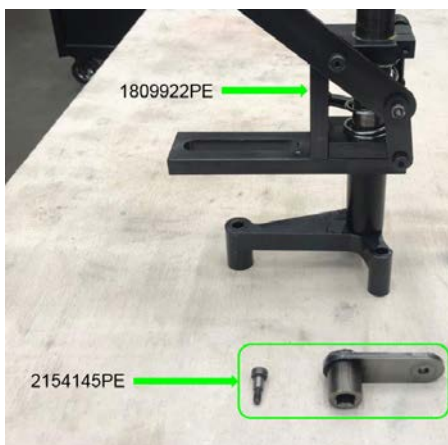
A short arm has been developed for the MX Engine Valve Spring Compressor that allows the rear cylinder valve springs to be serviced in chassis. The short arm kit allows the use of a ½ in. drive breaker bar or ratchet to operate the spring compressor.

This document provides the instructions to replace the original long arm with the short arm kit (2154145PE). The long arm and shim are not needed after installing the short arm kit.
